UNDERWATER BRIDGE INSPECTION REPORT

STRUCTURE NO. 18510
CSAH NO. 6
OVER THE
DAGGETT CHANNEL
DISTRICT 3 – CROW WING COUNTY

PREPARED FOR THE
MINNESOTA DEPARTMENT OF TRANSPORTATION
BY
COLLINS ENGINEERS, INC.
JOB NO. 3512

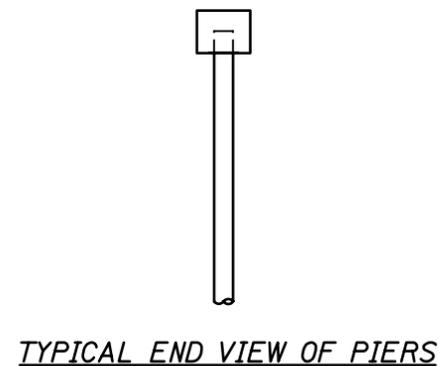
- ① The channel bottom around Pier 1 consisted of sand with with 6 to 8 inches of probe rod penetration.
- ② The channel bottom around Pier 2 consisted of sand and 6 to 8 inch diameter cobbles with 6 to 8 inches of probe rod penetration.
- ③ Pier 1 exhibited coating loss from the waterline to the mudline with 10% of the surface area covered with rust nodules that exhibited 1/2 inch maximum diameter. The piles exhibited only minor pitting and minimal section loss up to 1/32 inch deep.
- ④ Pier 2 exhibited coating loss from the waterline to the mudline with 30% of the surface area covered with rust nodules that exhibited 1/2 inch maximum diameter. The piles exhibited only minor pitting and minimal section loss up to 1/32 inch deep.

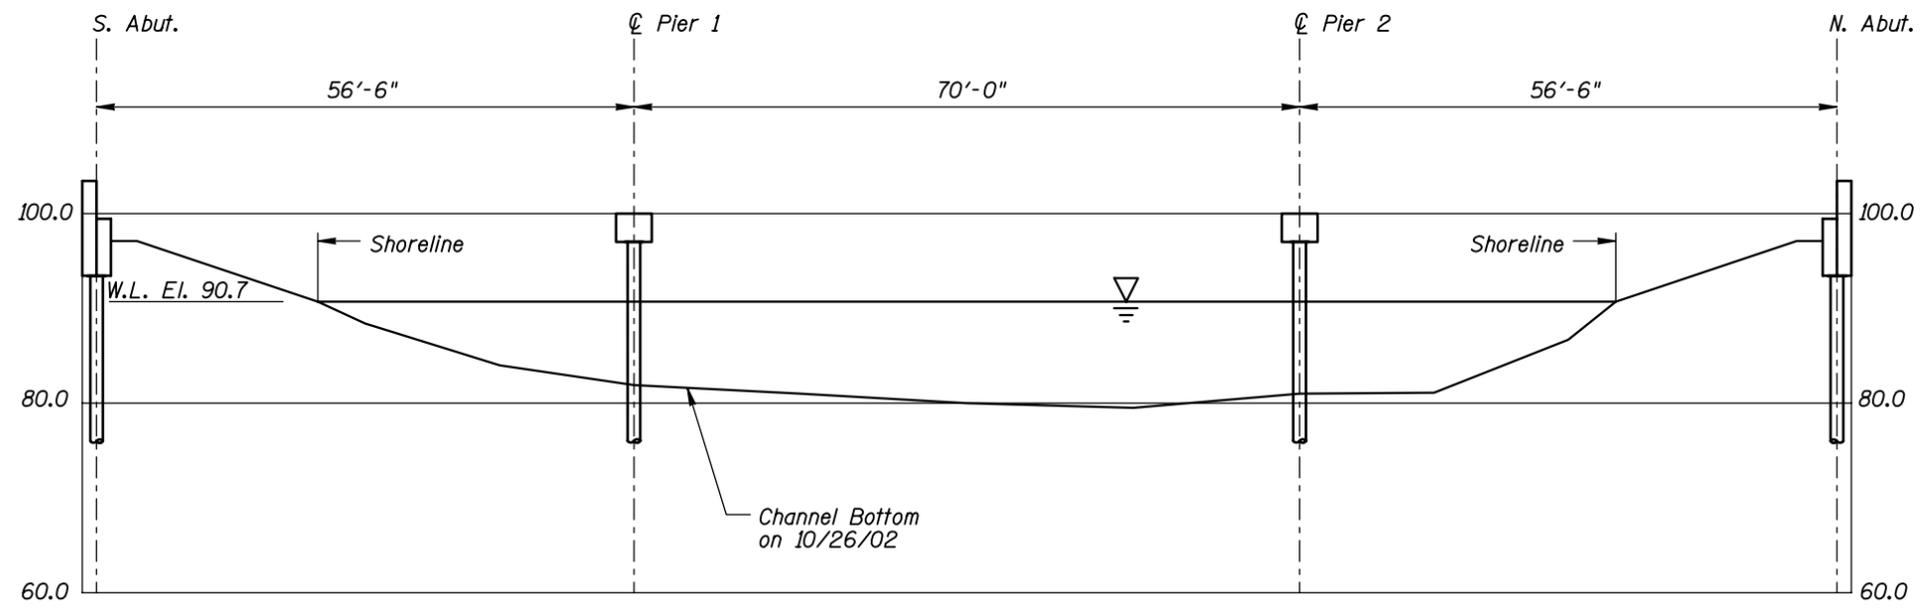
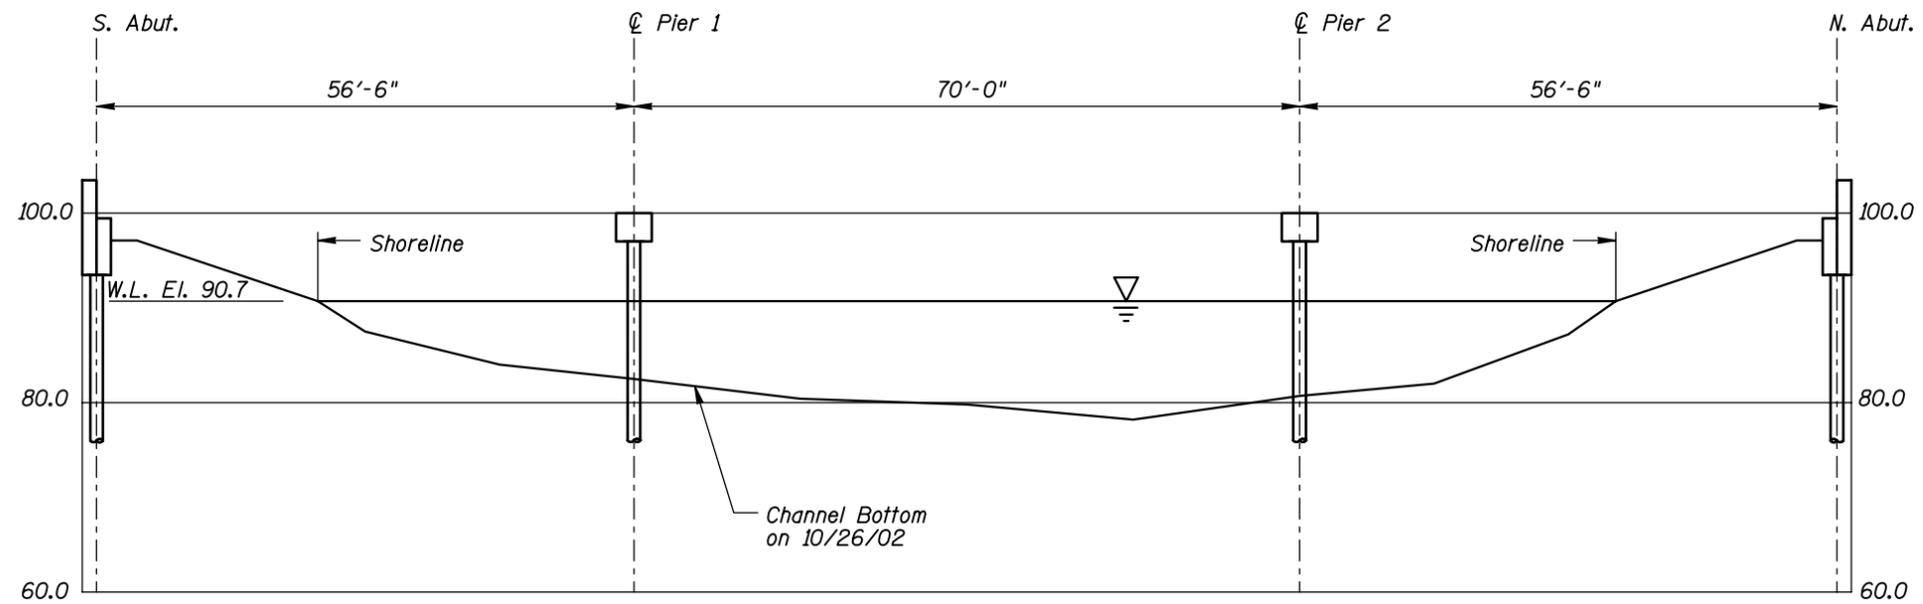
COLLINS ENGINEERS, INC. 300 W. WASHINGTON, STE. 600 CHICAGO, ILLINOIS 60606 (312) 704-9300	Date: OCT. 2002
Checked By: MDK		Scale: 1"=20'
Code: 351218510		Figure No.: 2

UPSTREAM FASCIA PROFILE

DOWNSTREAM FASCIA PROFILE

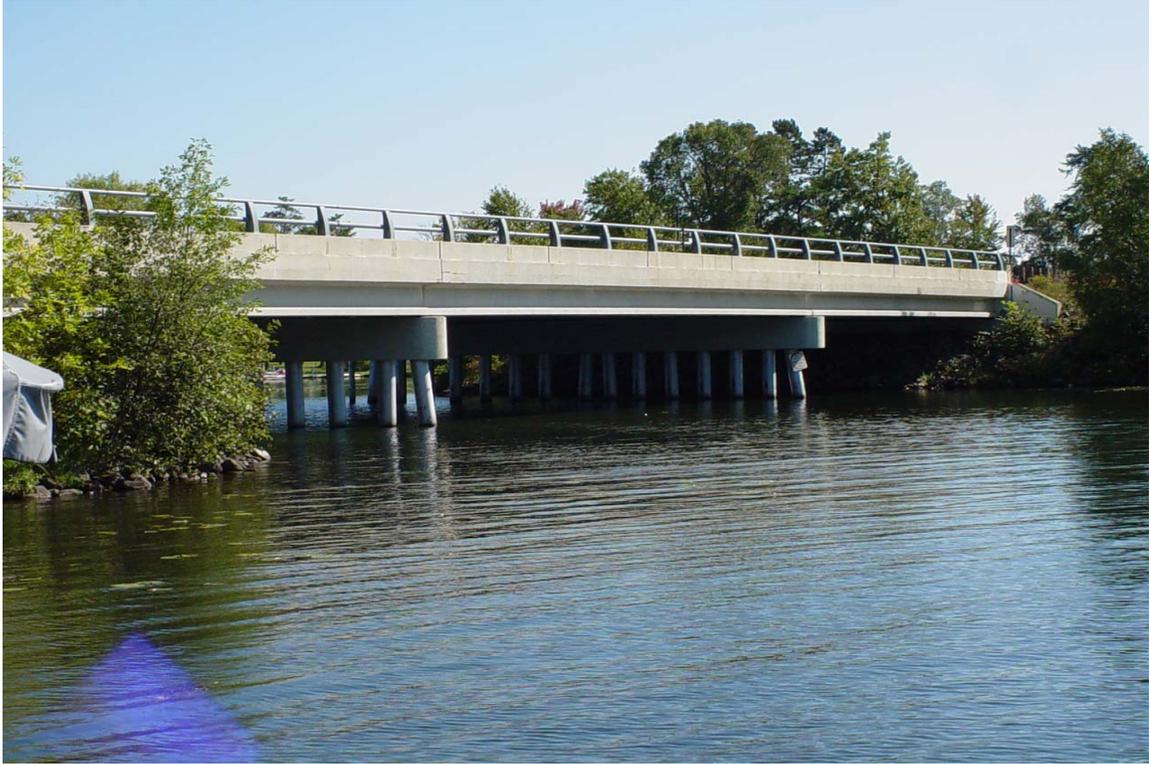
Photograph 1. Overall View of the Structure, Looking Southeast.
