UNDERWATER BRIDGE INSPECTION REPORT

STRUCTURE NO. 30506
CR NO. 63
OVER THE
STANCHFIELD CREEK
DISTRICT 3 - ISANTI COUNTY

PREPARED FOR THE
MINNESOTA DEPARTMENT OF TRANSPORTATION
BY
COLLINS ENGINEERS, INC.
JOB NO. 3512 (CEI 74)

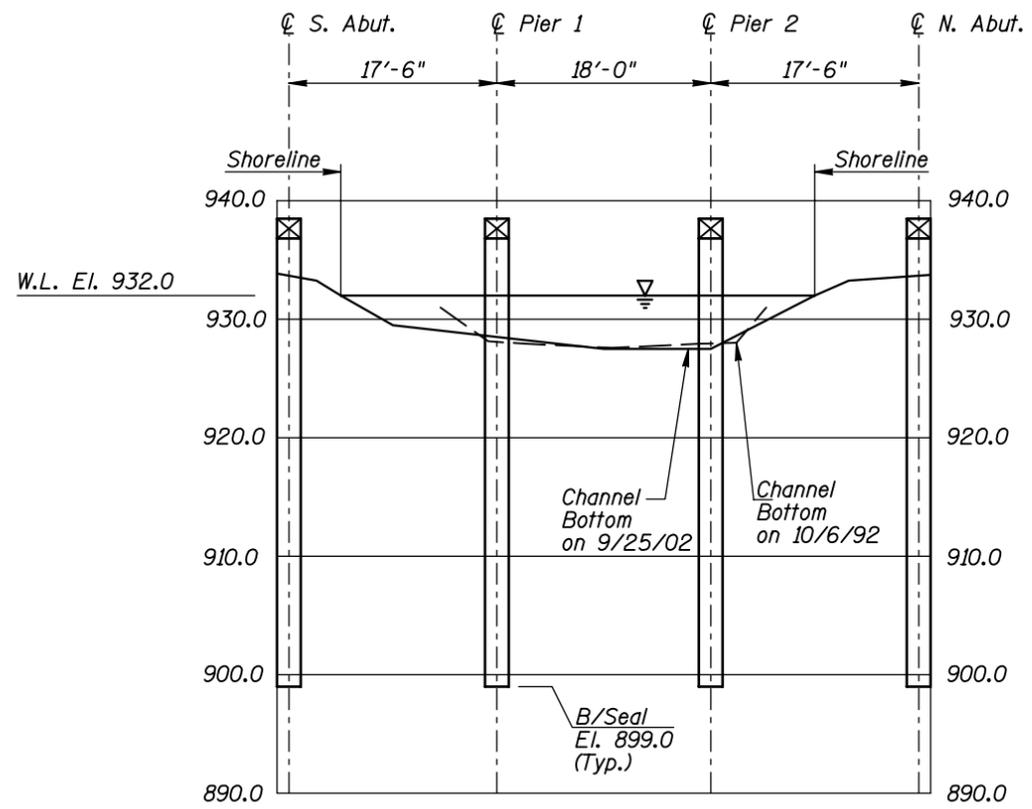
UPSTREAM FASCIA PROFILE

- ① The channel bottom consisted of 6- to 8-inch-diameter cobbles with 1 inch of penetration.
- ② The timber piles exhibited minor checking up to 1/4 inch wide.
- ③ The timber bracing located between the easternmost piles exhibited minor cracking and wood shims have been placed between the piles and the bracing.
- ④ A large amount of grassy vegetation was observed at the upstream nose of Pier 1.
- ⑤ The upstream pile was protected with a steel ice breaker.
