UNDERWATER BRIDGE INSPECTION REPORT

STRUCTURE NO. 49528  
CSAH NO. 26  
OVER THE  
MISSISSIPPI RIVER  
DISTRICT 3 - MORRISON COUNTY

MINNESOTA DEPARTMENT OF TRANSPORTATION  
UNDERWATER BRIDGE INSPECTION

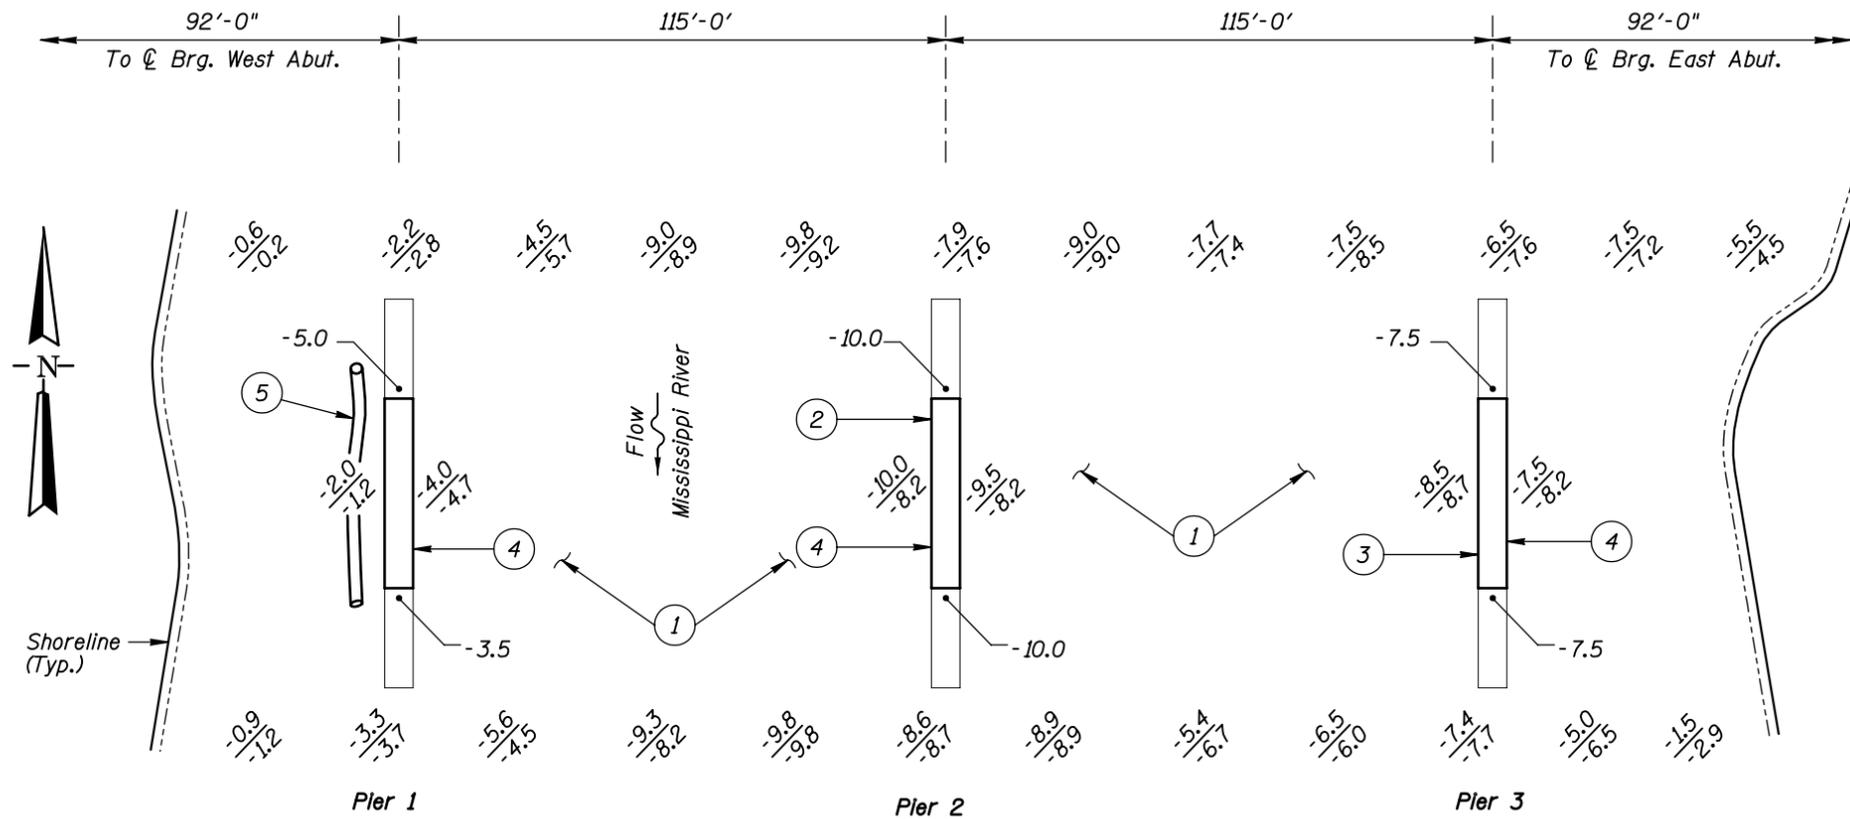
**SOUNDING PLAN**

- ① The channel bottom material consisted of gravel and up to 12 inch diameter riprap with typically 1 inch of probe rod penetration.
- ② A poorly formed construction joint was observed with the upper portion overlapping the lower portion of the pier by 1/2 to 1 inch at approximately 4 feet above the channel bottom.
- ③ A random area of poorly consolidated concrete was observed from 2 above the waterline to 1 foot below the waterline with a maximum penetration of 1/2 inch.
- ④ Light scaling was observed on all substructure units from 2 feet above the waterline to 1 foot below the waterline with 1/8 inch of maximum penetration.
- ⑤ A 1-foot-diameter log was on the channel bottom along the west face of Pier 1.

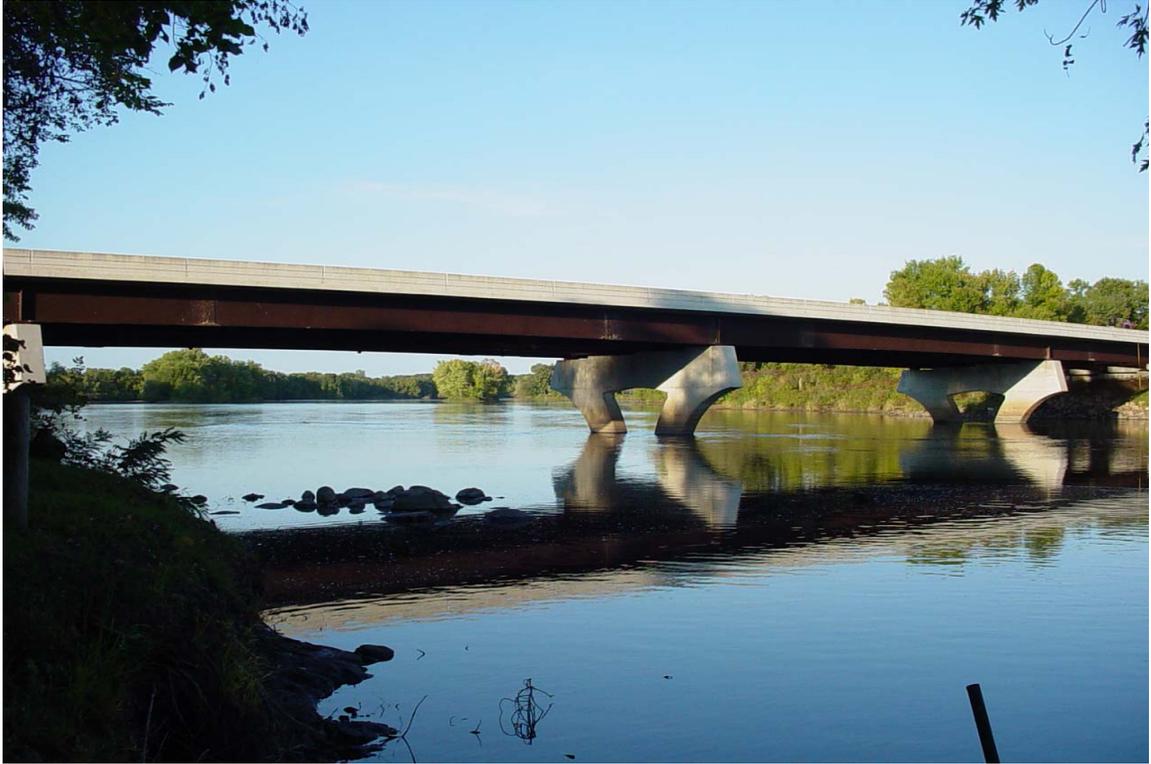
Photograph 1. Overall View of the Structure, Looking Northeast.
