UNDERWATER BRIDGE INSPECTION REPORT

STRUCTURE NO. 18509

MISSISSIPPI RIVER

COLLINS ENGINEERS, INC.

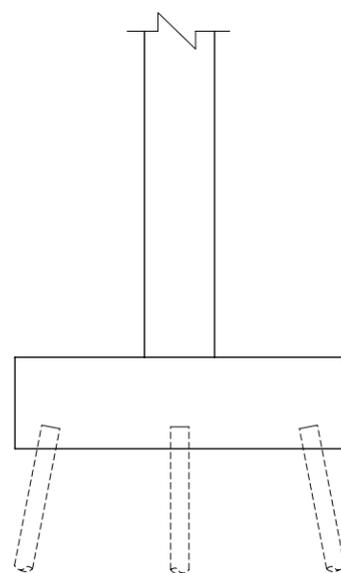
**TYPICAL END VIEW OF PIERS**

- 3 Riprap from 1 to 2 feet in diameter was located at the upstream nose of Piers 1 and 3.
- 4 A light accumulation of timber debris and a truck tire was observed along the upstream half of the east face of Pier 3 extending from the channel bottom up 3 feet and up to 6 feet off pier face.

- 5 A minor scour depression was observed at the upstream end of Pier 1 with a radius of 6 feet and a depth up to 2.5 feet.
- 6 A moderate scour depression was observed at the upstream end of Pier 2 with a radius of 6 feet and a depth up to 2 feet.

- 7 Above and below the waterline, the concrete was typically smooth and sound with random areas of delaminating and loss of section of the finishing grout. Heaviest at downstream nose of Pier 2. In addition hairline vertical cracks were observed in the webwall in all piers from top of webwall to channel bottom.
