UNDERWATER BRIDGE INSPECTION REPORT

STRUCTURE NO. 30505

RUM RIVER

DISTRICT 3 - ISANTI COUNTY

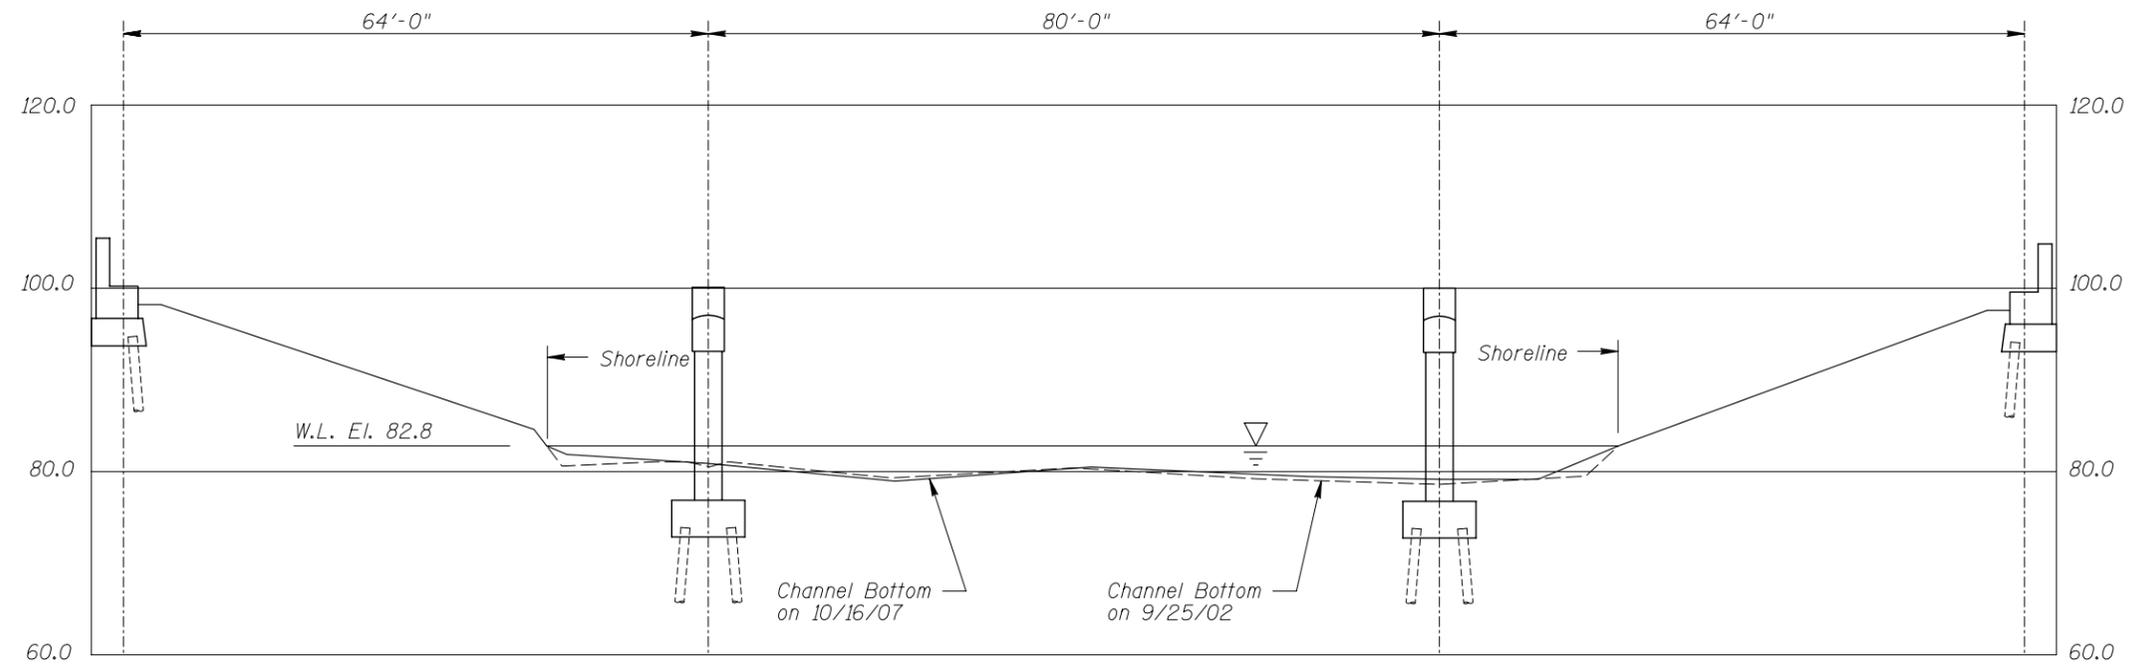
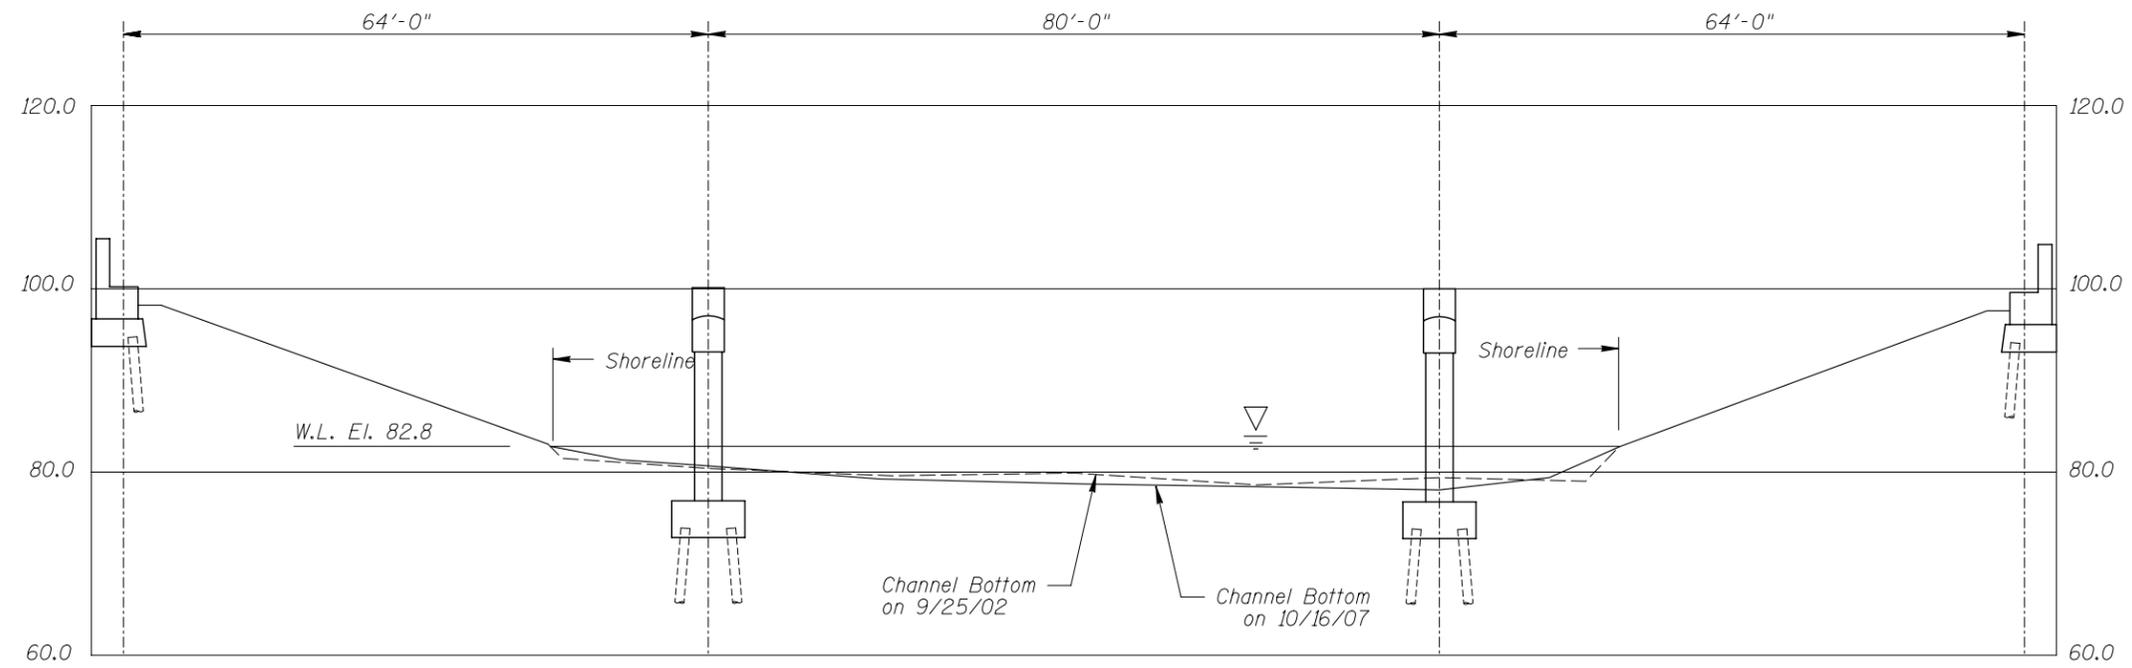
UPSTREAM FASCIA PROFILE

- 1 The channel bottom consisted of sand, gravel, and 4-inch-diameter cobbles with up to 1 inch of probe rod penetration.
- 2 The channel bottom consisted of silty sand with up to 3 inches of probe rod penetration.
- 3 A band of light scaling was observed around the entire perimeter of Piers 1 and 2 from 2 feet above to 2 feet below the waterline with typical penetrations of 1/18 inch deep and maximum penetrations up to 1/4 inch deep at the upstream noses.
- 4 The previously noted undermining along the north end of the West Abutment has been repaired with the placement of 4-foot-diameter riprap.
- 5 A light accumulation of timber debris consisting of 6-inch-diameter and smaller logs and branches was observed along the west face of Pier 1 and extended from the channel bottom to the waterline and up to 3 feet off the face of the pier.
