UNDERWATER BRIDGE INSPECTION REPORT

STRUCTURE NO. 5947

MISSISSIPPI RIVER

COLLINS ENGINEERS, INC.

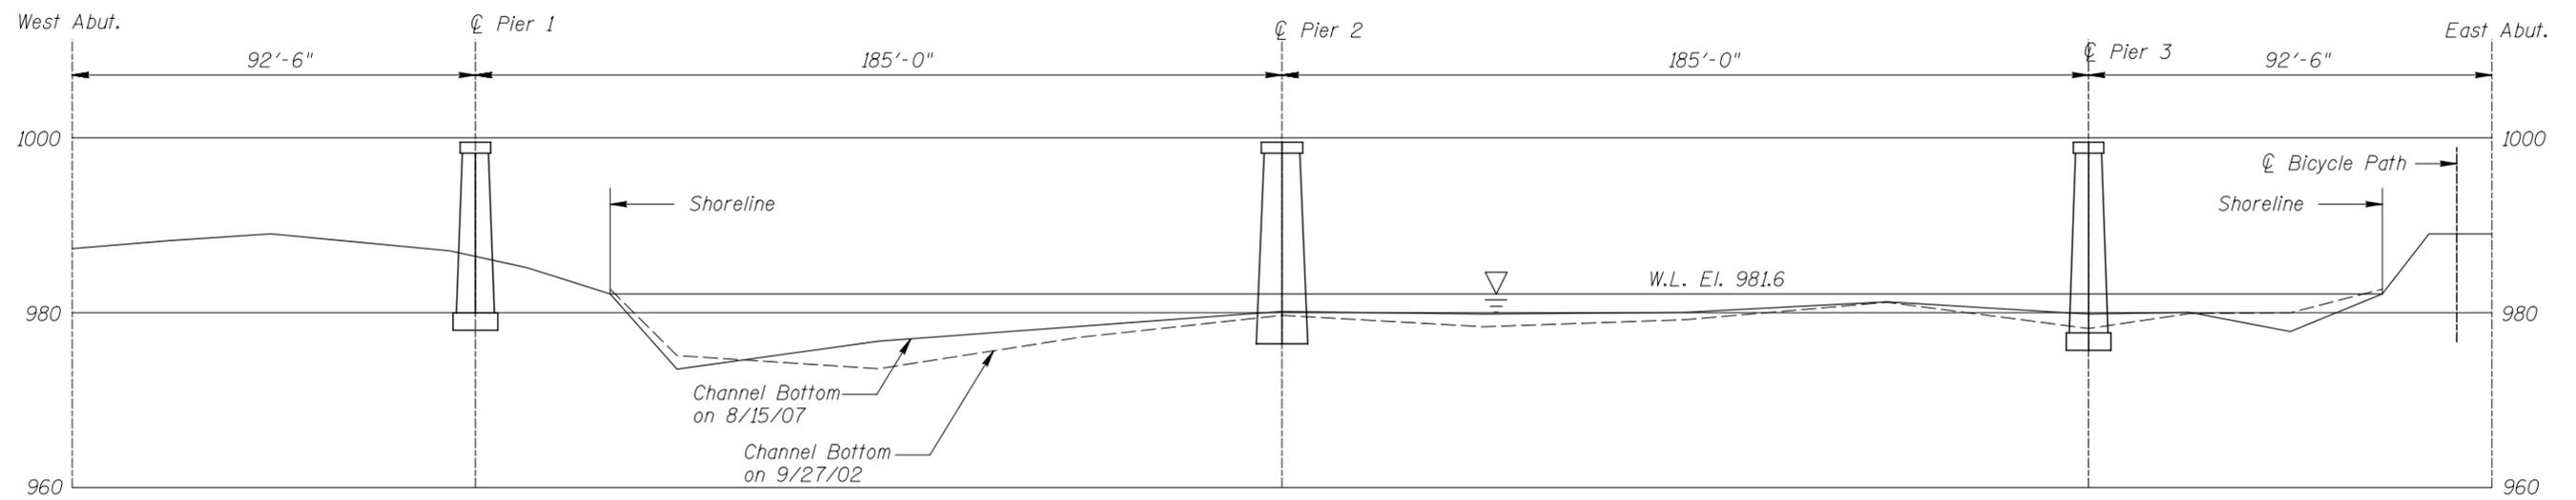
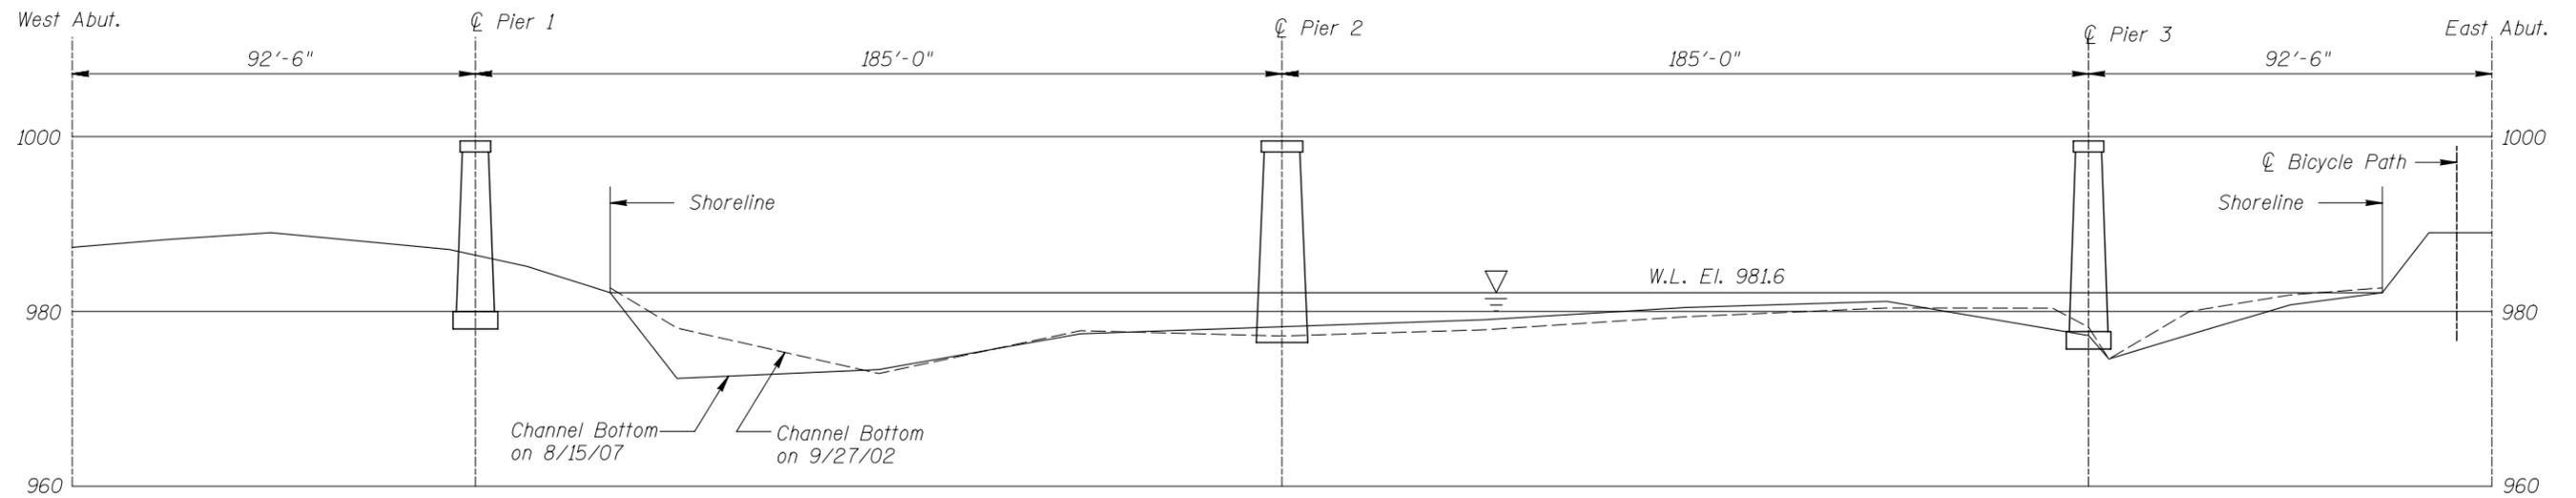
- (A) A 6-foot-long area of undermining was observed at the southeast corner of Pier 3 with a height of 1.3 feet and with 3 feet of maximum horizontal penetration. The undermining was due to the fractured bedrock channel bottom, which has shifted from under the footing.

- (B) The masonry of Piers 2 and 3 was in good condition with no defects of structural significance observed. However, there were random areas of deteriorated joint mortar with penetrations of up to 2 inches deep (deepest losses concentrated around the upstream nose).

- ① The channel bottom material around the entire perimeter of both piers consisted of large rocks and bedrock with no probe rod penetration.
- ② Undermining was observed at the southeast corner of Pier 3 due to an area of fractured bedrock. The undermining cavity was 1.3 feet high by 6 feet long with 3 feet of maximum horizontal penetration.
- ③ The masonry construction of both piers were observed to be in overall good condition, however, there were random areas of missing mortar up to 2 inches deep (heaviest at upstream nose).
- ④ 1- to 5-foot-diameter rocks scattered in the channel between Piers 2 and 3.

- (A) Repair the undermining at the southeast corner of Pier 3 by placing grout bags and/or pumped grout within the undermined area to restore the full bearing capacity of the pier.
