UNDERWATER BRIDGE INSPECTION REPORT

STRUCTURE NO. 73510

CSAH NO. 64

SAUK RIVER

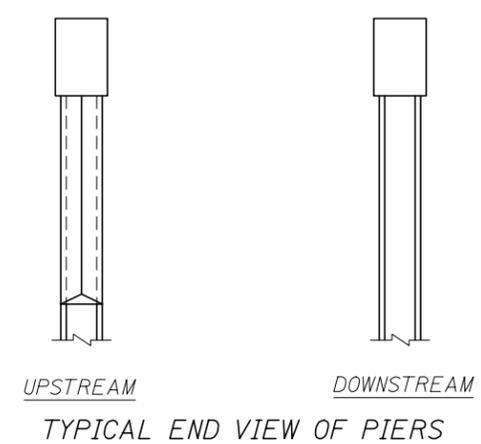
- ① The channel bottom material consisted of sand and 1 to 1.5 foot diameter rock with minimal probe rod penetration.
- ② Minor surface corrosion and light pitting in conjunction with coating failure/absence was observed on 100 percent of the surface area of the piles from 1.5 foot above to the channel bottom, with nodules 1/2 inch in diameter and 1/32 inch deep pitting on 25 to 50 percent of the surface area from the waterline to 1.5 feet above. No appreciable section loss was associated with the deterioration.
- ③ Light aquatic growth was observed on all piles below the waterline.
