UNDERWATER BRIDGE INSPECTION REPORT

STRUCTURE NO. 73540

10TH STREET BRIDGE (MSAS NO. 101)

DISTRICT 3 - STEARNS COUNTY, CITY OF ST. CLOUD

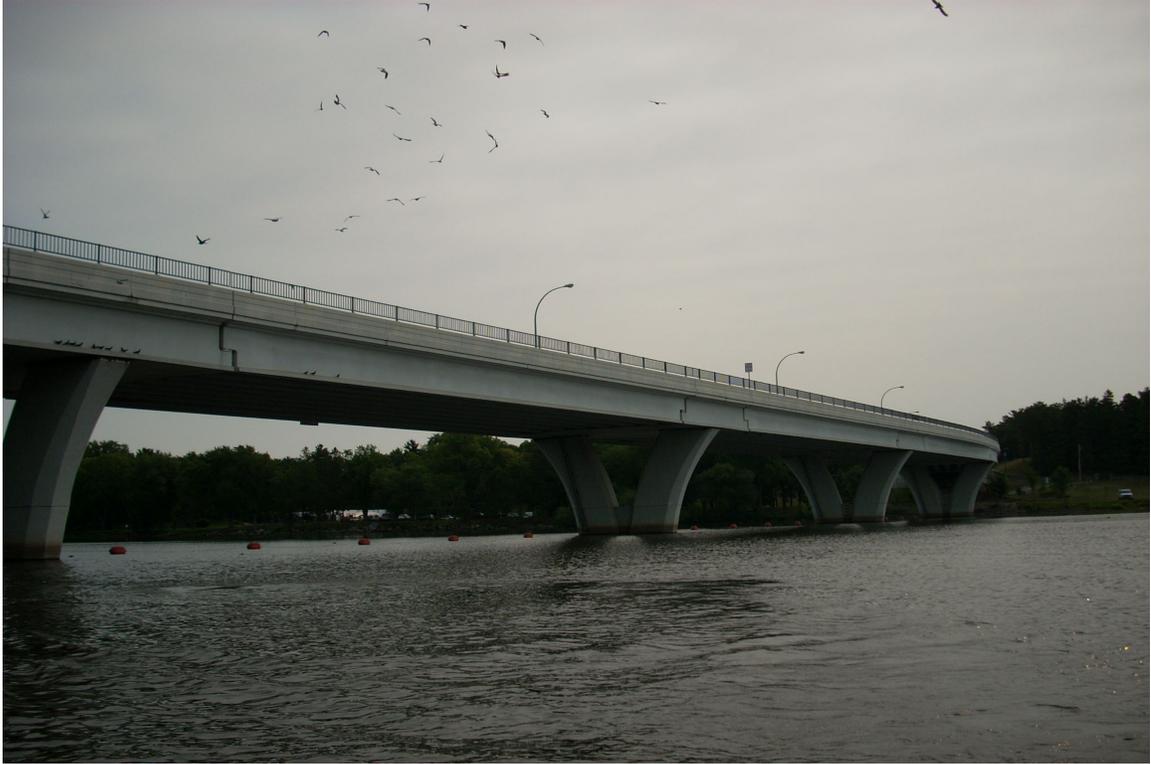
Photograph 1. Overall View of the Structure, Looking Northeast.

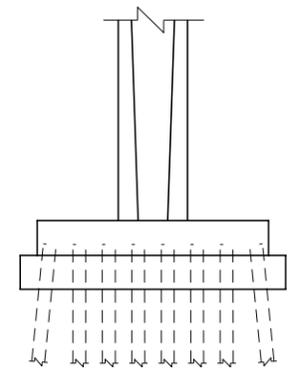
TYPICAL END VIEW OF PIERS

- 3 Footing exposure was observed at the upstream end of Pier 4, extending 8 feet downstream on the east and west sides of the pier with a maximum vertical face exposure of 2 feet at the upstream nose.

- 4 Footing exposure was observed at the upstream end of Pier 5, extending 5 feet downstream on both sides of the pier, with a maximum vertical face exposure of 3 feet at the upstream nose.

- 5 A light accumulation of 8-inch-diameter and smaller timber debris was observed around the entire perimeter of Piers 2 and 4 extending from the channel bottom to the waterline and up to 3 feet off of the noses and faces.

- 6 Minor scour depressions, typically 5 foot in radius and 2 to 3 feet deep, were observed around the upstream ends of all the piers, resulting in footing exposure at Piers 4 and 5.

- 7 The submerged concrete of the piers and exposed footings was in smooth and sound condition with minor random areas of poor consolidation with 1/4 inch maximum penetration.

- 8 A light accumulation of timber debris, consisting of up to 8-inch-diameter branches, was observed at the upstream nose of Pier 3 from the channel bottom up 2 feet. The debris was approximately 8 feet long (E/W) by 3 feet wide (N/S).
