UNDERWATER BRIDGE INSPECTION REPORT

STRUCTURE NO. 86515
CSAH NO. 42
OVER THE
MISSISSIPPI RIVER
DISTRICT 3 - WRIGHT COUNTY

PREPARED FOR THE
MINNESOTA DEPARTMENT OF TRANSPORTATION
BY
COLLINS ENGINEERS, INC.
JOB NO. 5221 (CEI 102)

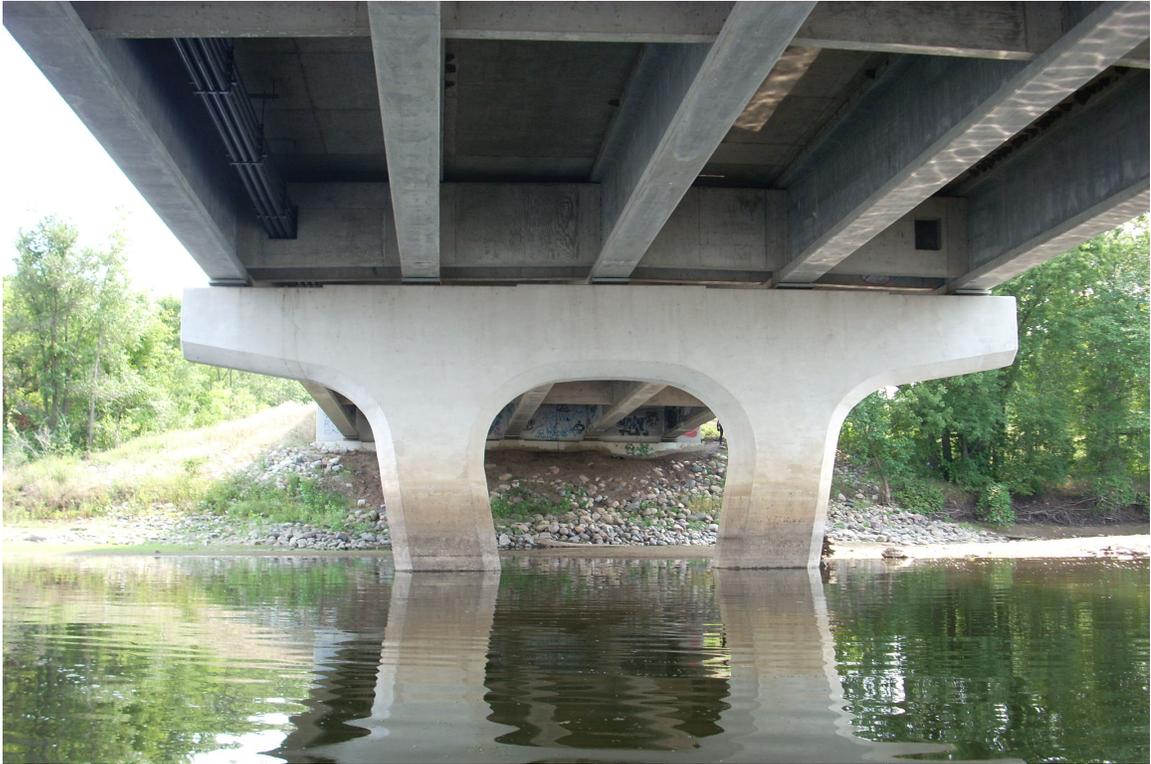
Photograph 1. Overall View of the Structure, Looking Northwest.

Photograph 2. View of Pier 1 and South Abutment, Looking South.

- ⑦ 1-foot-deep scour pocket was observed around the entire perimeter of both the upstream and downstream columns of Pier 1. The pockets typically extended up to 4 feet off the column faces.

- ⑧ A light accumulation of 10-inch-diameter and smaller timber debris was observed at the upstream end of the Pier 1. The debris extended from channel bottom to 2 feet above waterline and was approximately 5 feet wide in the East-West direction by 15 feet long in the North-South direction.

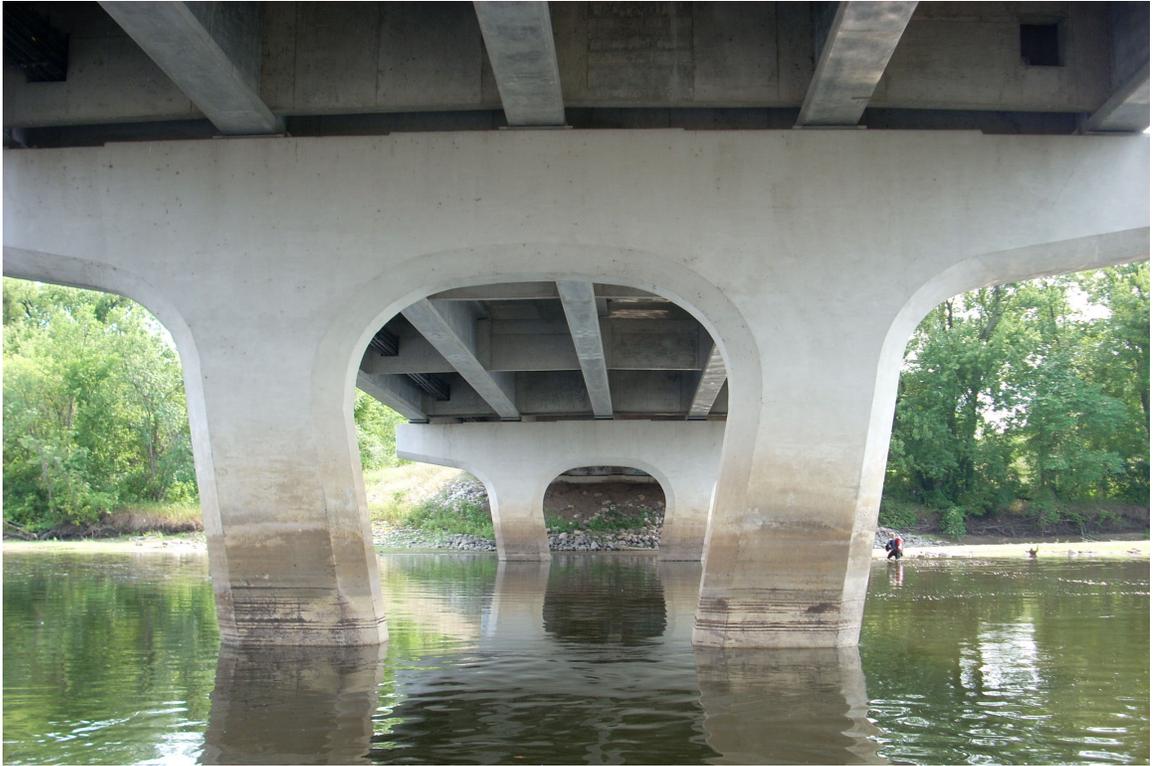
Photograph 3. View of Pier 2, Looking South.

- ② A light accumulation of timber debris consisting of logs 1-foot-diameter or smaller was observed at the upstream nose of Pier 2. Accumulation extended from channel bottom up 2 feet, 5 feet long in the North-South direction by 3 feet wide in the East-West direction.

- ④ A 4-foot-radius, 1.5-foot-deep scour pocket was observed at the upstream nose of the Pier 2.
- ⑤ The embankments consisted of 1- to 2-foot-diameter cobbles.

Monitor the accumulation of timber debris around the piers, and if found to be increasing, removal may become necessary during future routine bridge maintenance.

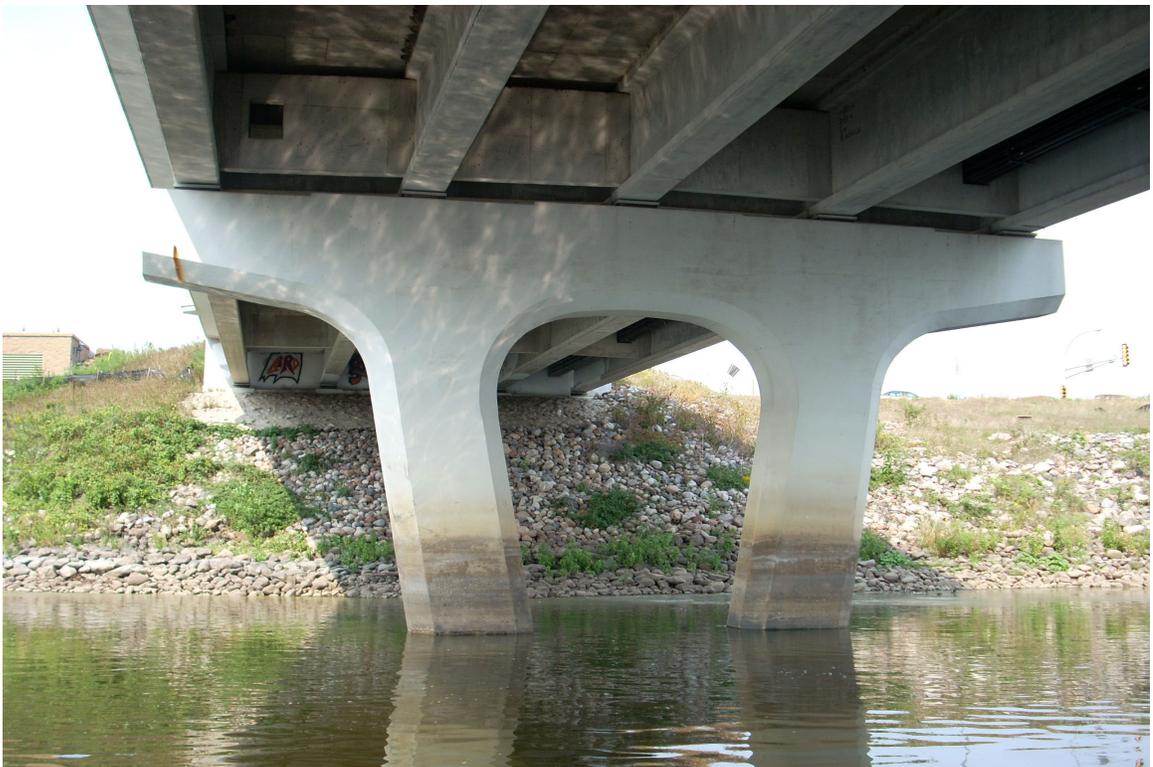
Photograph 4. View of Pier 3 and North Abutment, Looking North.

- ③ A moderate accumulation of 2-foot-diameter and smaller timber debris was observed at the upstream nose of the pier extending from the channel bottom up 4 feet, 10 feet long in the North-South direction and 4 feet wide in the East-West direction.
