UNDERWATER BRIDGE INSPECTION REPORT

STRUCTURE NO. 05525
CSAH NO. 29
OVER THE
MISSISSIPPI RIVER
DISTRICT 3 - BENTON COUNTY

OCTOBER 26, 2012

BY
COLLINS ENGINEERS, INC.

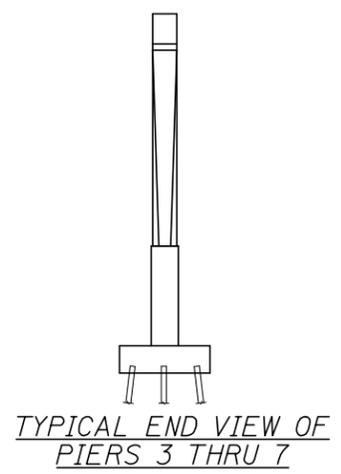
- Piers 3 through 7 exhibited random hairline cracks on each face extending from the top of the shaft to the channel bottom.
 - The footing at Pier 3 was exposed at the upstream nose and along the entire east face with up to 2.2 feet of vertical face exposed at the northeast corner.

- The footing at Pier 5 was exposed along the entire east face and around the upstream nose with up to 7 inches of vertical face exposed at the southeast corner.

- A band of light scaling was observed around the entire perimeter of all the piers with a maximum penetration of 1/8 inch, extending 1.5 feet below to 1.5 feet above the waterline.

- (A) Monitor the extent of footing exposure during future underwater inspections.
- (B) Reinspect the submerged substructure units at the normal maximum recommended (NBIS) interval of sixty (60) months.
