UNDERWATER BRIDGE INSPECTION REPORT

STRUCTURE NO. 18510  
CSAH NO. 66  
OVER THE  
DAGGETT CHANNEL  
DISTRICT 3 – CROW WING COUNTY

SEPTEMBER 9, 2012  
PREPARED FOR THE  
MINNESOTA DEPARTMENT OF TRANSPORTATION  
BY  
COLLINS ENGINEERS, INC.  
AND  
WSB & ASSOCIATES, INC.  
JOB NO. 2107

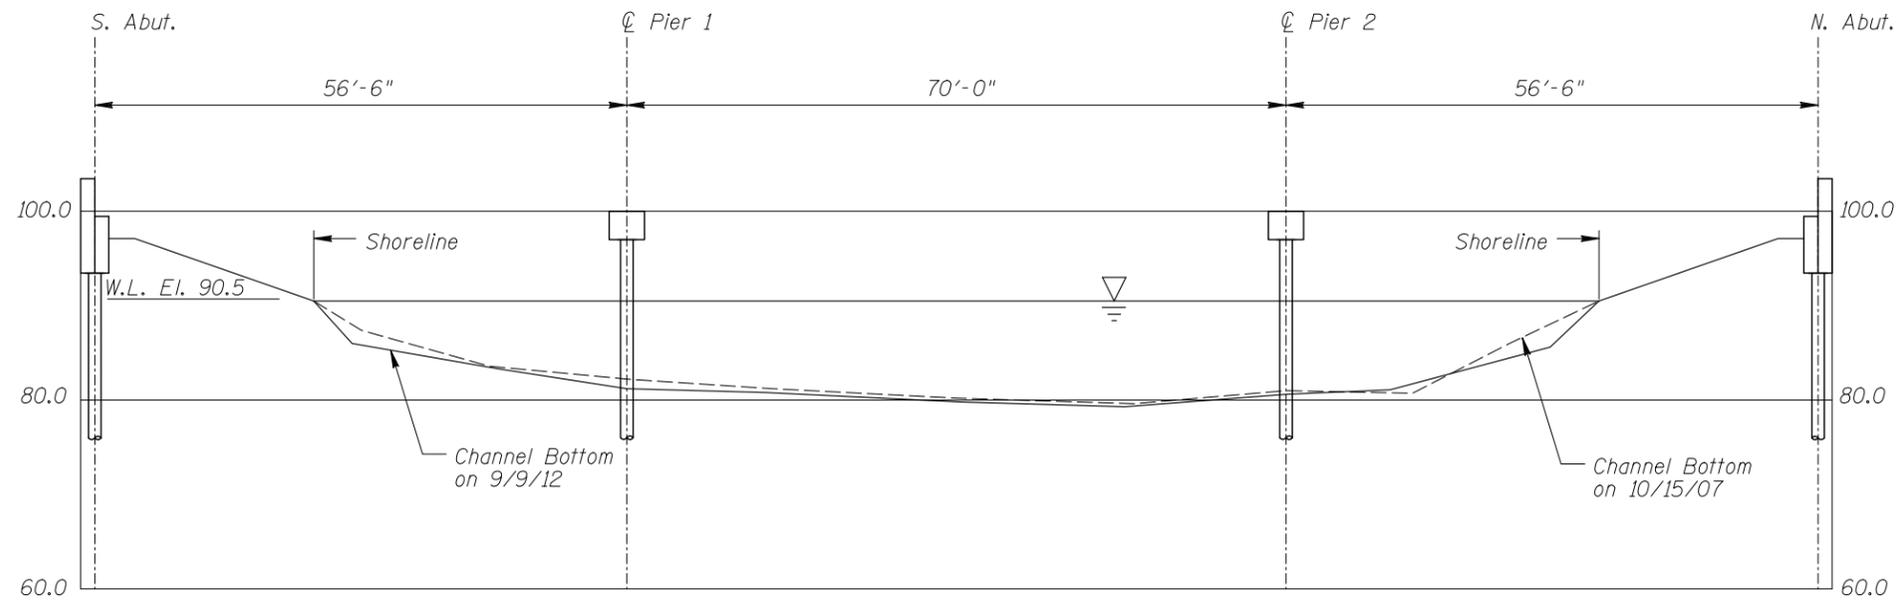
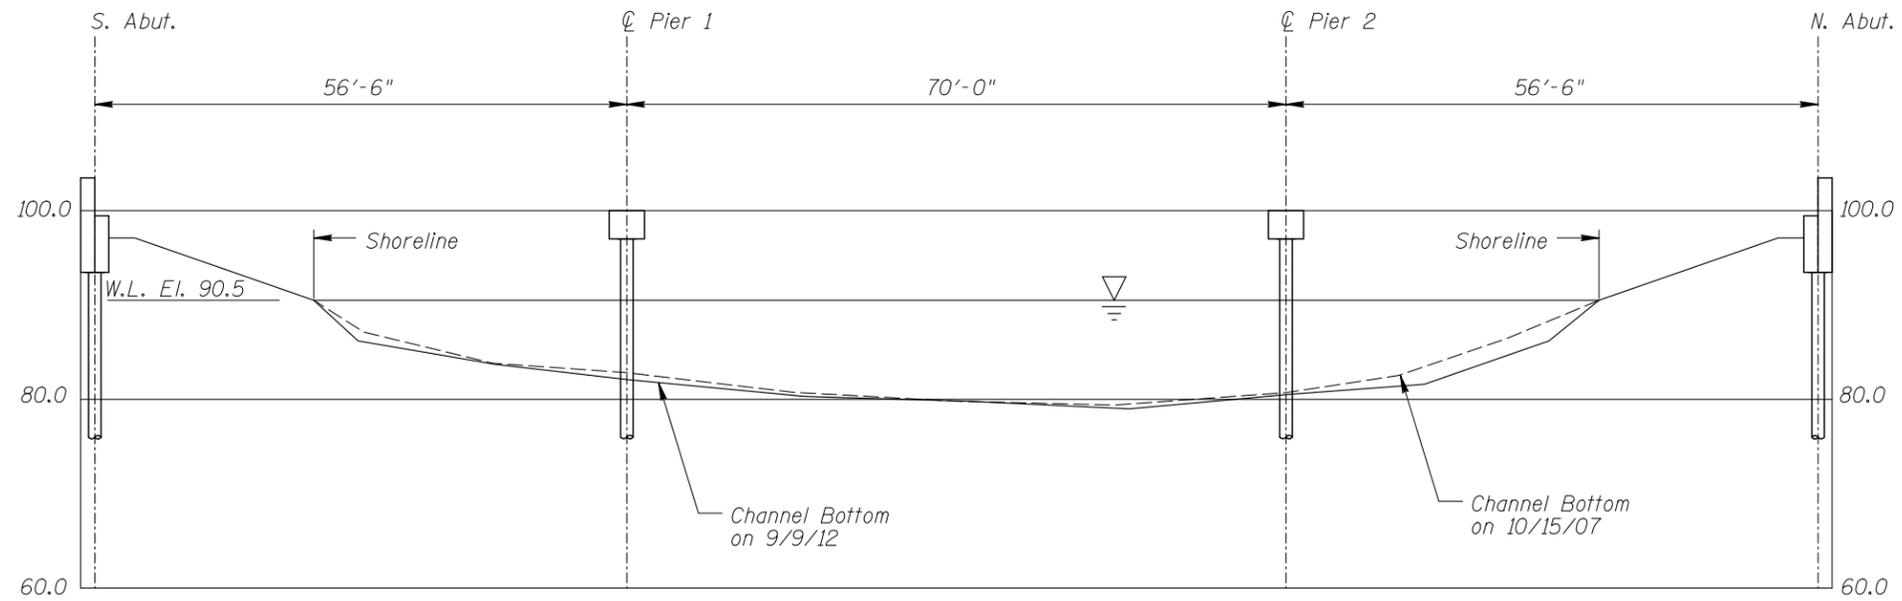
<b>MINNESOTA DEPARTMENT OF TRANSPORTATION UNDERWATER BRIDGE INSPECTION</b>		
STRUCTURE NO. 18510 OVER DAGGETT CHANNEL DISTRICT 3, CROW WING COUNTY		
<b>INSPECTION AND SOUNDING PLAN</b>		
Drawn By: BJR	<b>COLLINS ENGINEERS</b>	Date: SEP. 2012
Checked By: BRL		Scale: NTS
Code: 522118510		Figure No.: 1

- 1 The channel bottom around Pier 1 consisted of sand with 6 to 8 inches of probe rod penetration.
- 2 The channel bottom around Pier 2 consisted of sand and 6- to 8-inch-diameter cobbles with 6 to 8 inches of probe rod penetration.
- 3 Piers 1 and 2 exhibited coating failure and surface corrosion from approximately 9 inches above the waterline to the channel bottom on approximately 30 percent of the surface area with 1/2-inch to 1.5-inch-diameter rust nodules and minimal section loss with pitting up to 1/32 inches deep.
