UNDERWATER BRIDGE INSPECTION REPORT

STRUCTURE NO. 30506
CR NO. 63
OVER THE
STANCHFIELD CREEK
DISTRICT 3 - ISANTI COUNTY

JULY 27, 2012

BY
COLLINS ENGINEERS, INC.

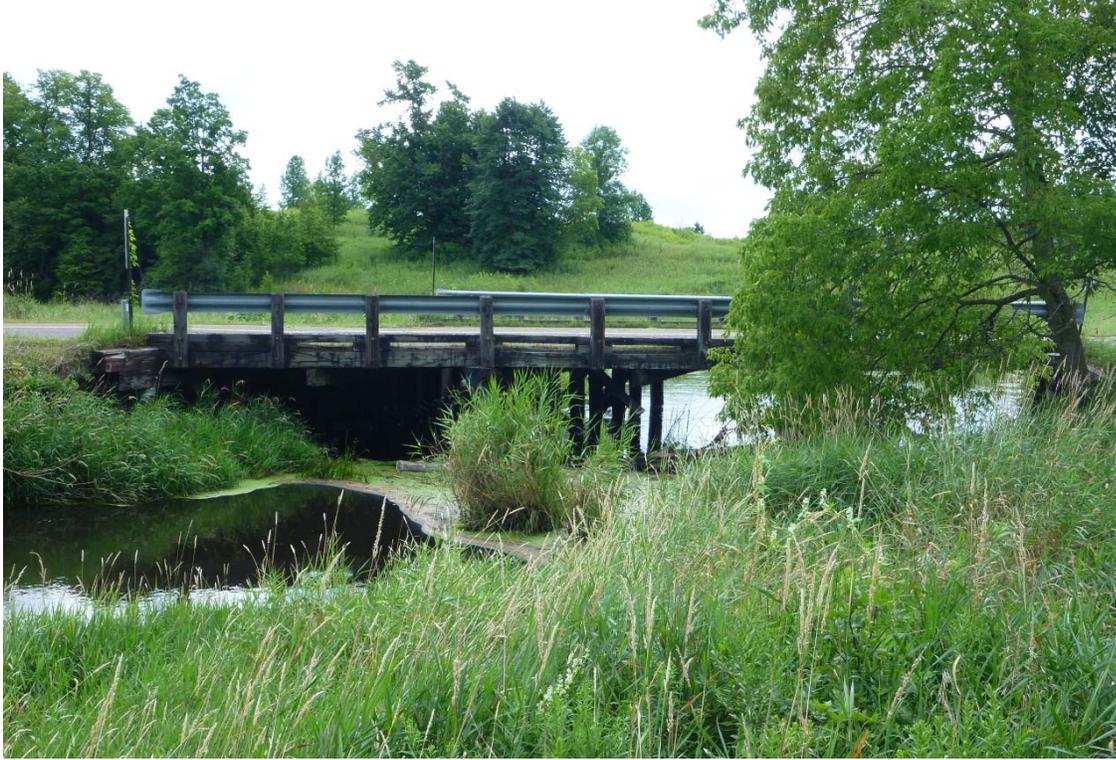
Photograph 1. Overall View of the Structure, Looking East.

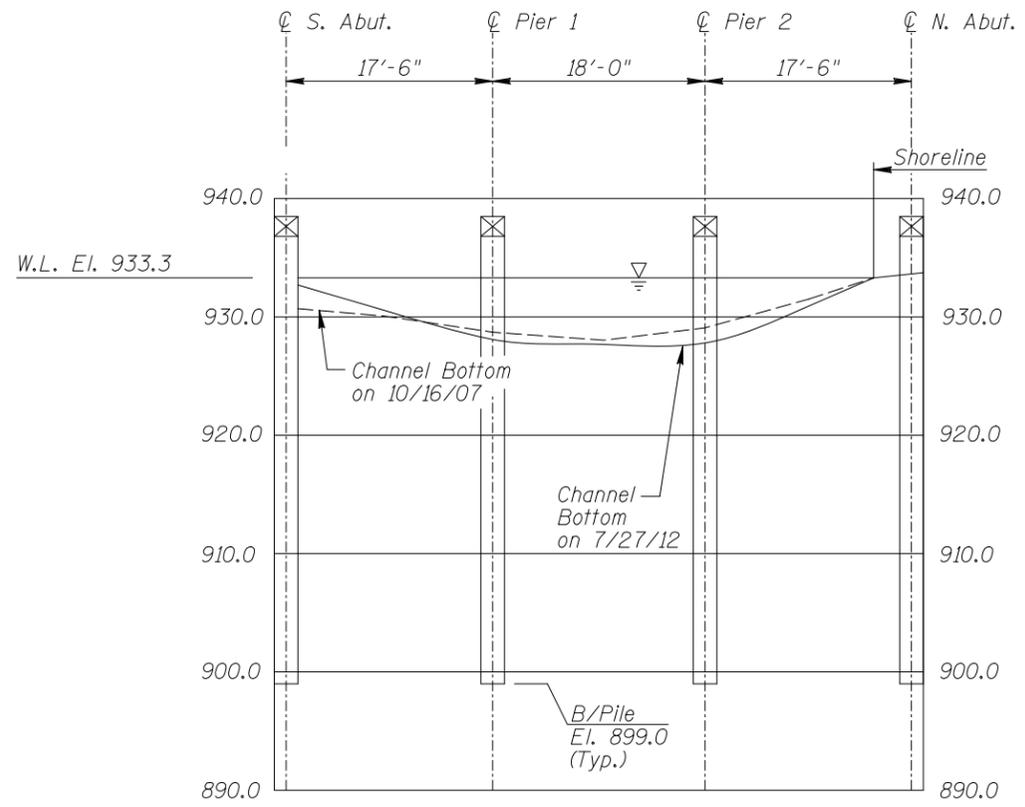
UPSTREAM FASCIA PROFILE

- 1 The channel bottom consisted silty sand and of 6- to 8-inch-diameter cobbles with up to 1 inch of probe rod penetration.
- 2 The timber piles exhibited minor checking up to 1/4 inch wide.
- 3 The upper and lower cross bracing connection to the easternmost pile of Pier 2 exhibited minor splits.
- 4 A moderate accumulation of timber debris consisting of 12-inch-diameter and smaller logs along with some vegetation was observed at the upstream fascia from Pier 1 to the north shore, extending 5 feet upstream off the fascia and from the channel bottom to 1 foot above the waterline.
- 5 The upstream piles were protected with a steel ice breaker that exhibited moderate corrosion with rust nodules up to 1/4 inch in diameter with 1/16-inch-deep pitting from the channel bottom to the waterline.
