UNDERWATER BRIDGE INSPECTION REPORT

STRUCTURE NO. 73510

SAUK RIVER

JULY 29, 2012

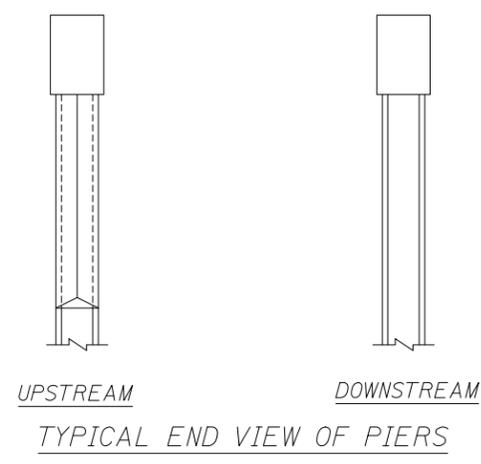
- The channel bottom material consisted of sand and 1 to 1.5 foot diameter rock with minimal probe rod penetration.
- Minor surface corrosion and light pitting in conjunction with coating failure/absence was observed on 100 percent of the surface area of the piles from 1 foot above the waterline to the channel bottom, with nodules 1/2 inch in diameter and 1/16 inch deep pitting on 25 to 50 percent of the surface area from the waterline to 1 foot above. No appreciable section loss was associated with the deterioration.
- Light aquatic growth was observed on all piles below the waterline.
- Light timber debris accumulation, consisting of 6 inch diameter and smaller logs and branches, was observed along the north face of Pier 2, extending 4 feet off the face of the pier from channel bottom to waterline.
