UNDERWATER BRIDGE INSPECTION REPORT

STRUCTURE NO. 73540

10TH STREET BRIDGE (MSAS NO. 101)

MINNESOTA DEPARTMENT OF TRANSPORTATION
UNDERWATER BRIDGE INSPECTION

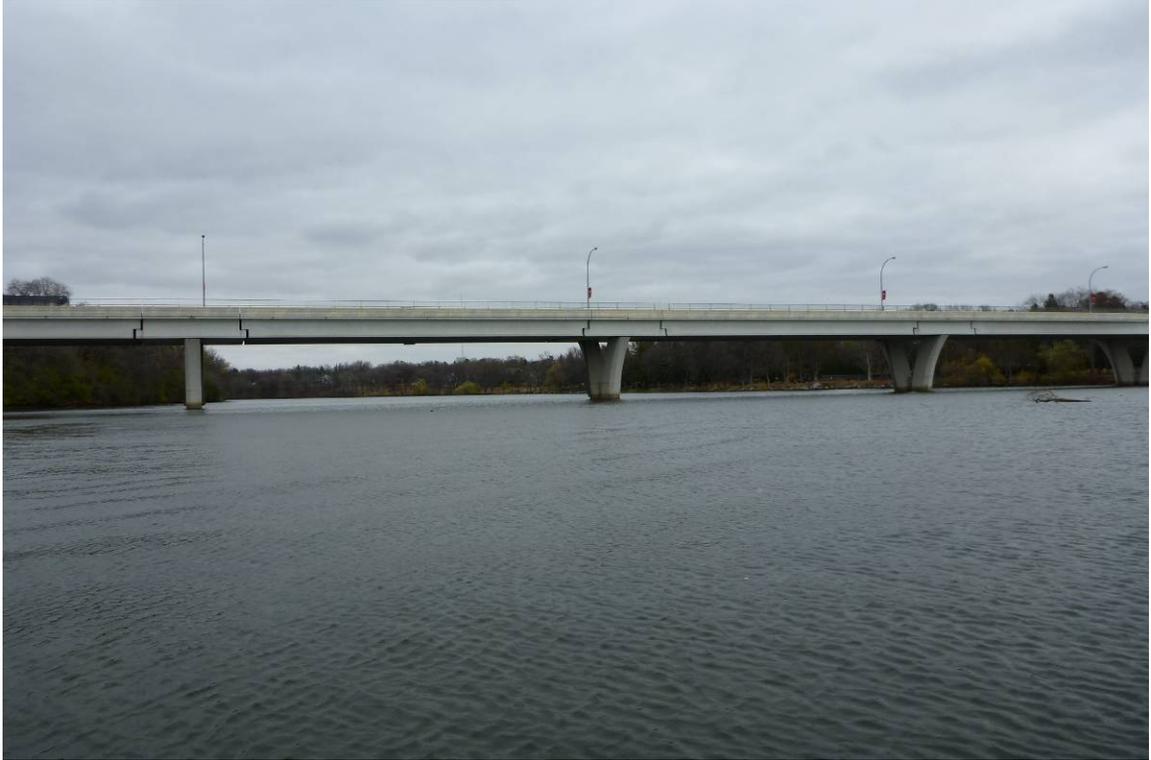
Photograph 1. Overall View of the Structure, Looking Northeast.

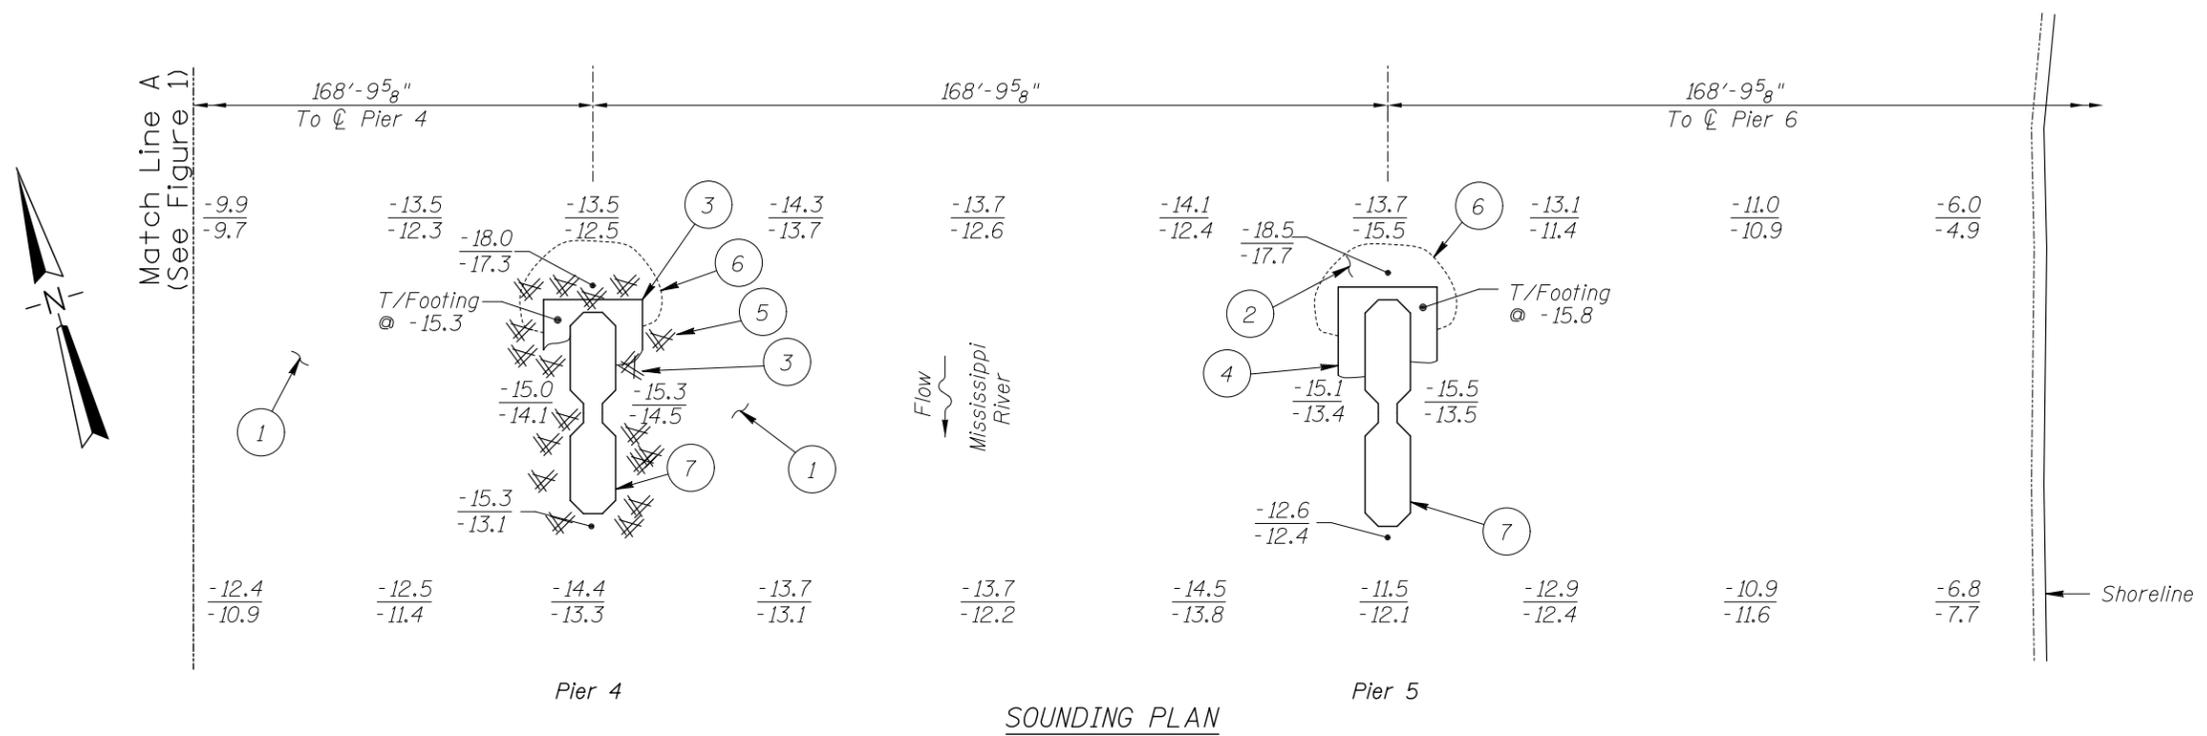
- ③ Footing exposure was observed at the upstream end of Pier 4, extending approximately 8 feet downstream on the east and west sides of the pier with a maximum vertical face exposure of 2.5 feet at the upstream nose.

- ④ Footing exposure was observed at the upstream end of Pier 5, extending approximately 15 feet downstream on both sides of the pier, with a maximum vertical face exposure of 3 feet at the upstream nose.

- ⑤ A light accumulation of 8-inch-diameter and smaller timber debris was observed around the entire perimeter of Piers 2 and 4 extending from the channel bottom up 6 feet and up to 3 feet off the pier noses and faces.

- ⑥ Minor scour depressions, typically 5 feet in radius and 2 to 3 feet deep, were observed around the upstream ends of Piers 3, 4, and 5, resulting in footing exposure at Piers 4 and 5.

- ⑦ The submerged concrete of the piers and exposed footings was in smooth and sound condition with minor random areas of poor consolidation with 1/4 inch maximum penetration.

- ⑧ A light accumulation of timber debris, consisting of up to 8-inch-diameter branches, was observed at the upstream nose of Pier 3 from the channel bottom up 2 feet. The debris was approximately 8 feet long (E/W) by 3 feet wide (N/S).
