UNDERWATER BRIDGE INSPECTION REPORT

STRUCTURE NO. 73551

SAUK RIVER

DISTRICT 3 - STEARNS COUNTY

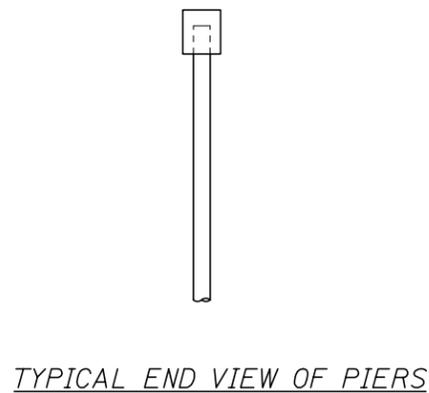
MINNESOTA DEPARTMENT OF TRANSPORTATION UNDERWATER BRIDGE INSPECTION	
STRUCTURE NO. 73551 OVER THE SAUK RIVER DISTRICT 3, STEARNS COUNTY	
INSPECTION AND SOUNDING PLAN	
Drawn By: JAC Checked By: BKS Code: 522173551	 Date: JULY 2012 Scale: NTS Figure No.: 1

- ① The channel bottom material around Piers 1 and 4 consisted of up to 1 foot diameter riprap and sand.
- ② The channel bottom material around Piers 2 and 3 consisted of sand and some stones with up to 4 inches of probe rod penetration.
- ③ All of the piles for Piers 1 through 4 had coating loss from 1 foot above the waterline to the channel bottom with minimal overall steel deterioration and with light aquatic growth on the surfaces below the waterline. Minor surface corrosion with small rust nodules, 1/8 inch in diameter, were observed below water on less than 10 percent of surface area with no related section loss.
