UNDERWATER BRIDGE INSPECTION REPORT

STRUCTURE NO. 14511

RED RIVER OF THE NORTH

JOB NO. 3512 (CEI 45)

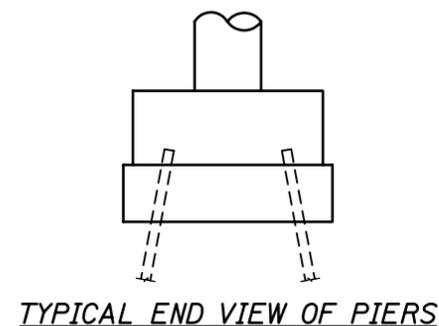
- The channel bottom material consisted of soft clay, gravel, and scattered branches with up to 1.5 feet of probe rod penetration.
- Random hairline to 1/16 inch wide vertical cracks were observed on the diaphragm wall of both piers, extending from the top of the diaphragm to the channel bottom.
- A 4 foot wide section of undermining was observed along the east side of the Pier 3 diaphragm exhibiting up to 6 inches of vertical exposure and 1.5 feet of maximum horizontal penetration at 3.2 feet below the waterline.
- A minor accumulation of timber debris, consisting of 6 inch diameter and smaller branches, was observed along the west side of Pier 4, extending from 0.5 feet below the waterline to the channel bottom.
