UNDERWATER BRIDGE INSPECTION REPORT

STRUCTURE NO. 92453
CSAH NO. 15
OVER THE
SOUTH BRANCH OF THE BUFFALO RIVER
DISTRICT 4 - CLAY COUNTY

PREPARED FOR THE
MINNESOTA DEPARTMENT OF TRANSPORTATION
BY
COLLINS ENGINEERS, INC.
JOB NO. 3512 (CEI 53)

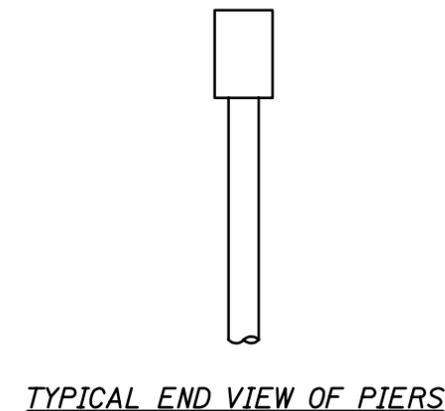
TYPICAL END VIEW OF PIERS

- 1 The channel bottom consisted of firm, silty clay with up to 2 inches of probe rod penetration.
- 2 The timber piles exhibited vertical checking with a typical width of 1/16 and a maximum width of 1/8 inch.
- 3 The gaps between the timber planking along the backwall and wingwalls have been repaired with metal bands to halt backfill loss.
- 4 The horizontal timber brace directly below the pier cap was broken and no longer engaged at the upstream pile at Pier 2.
- 5 The diagonal timber bracing at Pier 2 was completely missing.
- 6 The diagonal timber brace at Pier 1 was attached only at the upstream pile and no longer contributed to the lateral stability of the structure.

Repair missing and/or broken timber bracing at Piers 1 and 2 to reestablish the lateral stability of the structures.
