UNDERWATER BRIDGE INSPECTION REPORT

STRUCTURE NO. L0888  
DIVERSION STREET  
OVER THE  
CHANNEL TO THE OTTER TAIL POWER COMPANY  
DISTRICT 4 – OTTER TAIL COUNTY

PREPARED FOR THE  
MINNESOTA DEPARTMENT OF TRANSPORTATION  
BY  
COLLINS ENGINEERS, INC.  
JOB NO. 3512

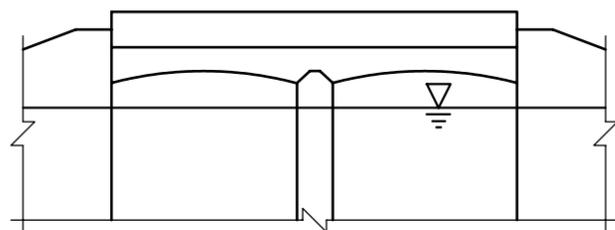
**SOUNDING PLAN**

- 1 The channel bottom material consisted of gravel with 8 to 12 inch diameter stones allowing minimal probe rod penetration.
- 2 The concrete along the pier and abutments exhibited heavy scaling from 1 foot above the waterline to 2 feet below the waterline with 3 inches of penetration typical and maximum penetrations of 6 inches.
- 3 The entire top corner of the pier exhibited heavy section loss with up to 12 inches of penetration, but with no exposed reinforcing steel.
- 4 A 1/4 inch wide vertical crack was observed from 2 feet to 5 feet below the waterline.

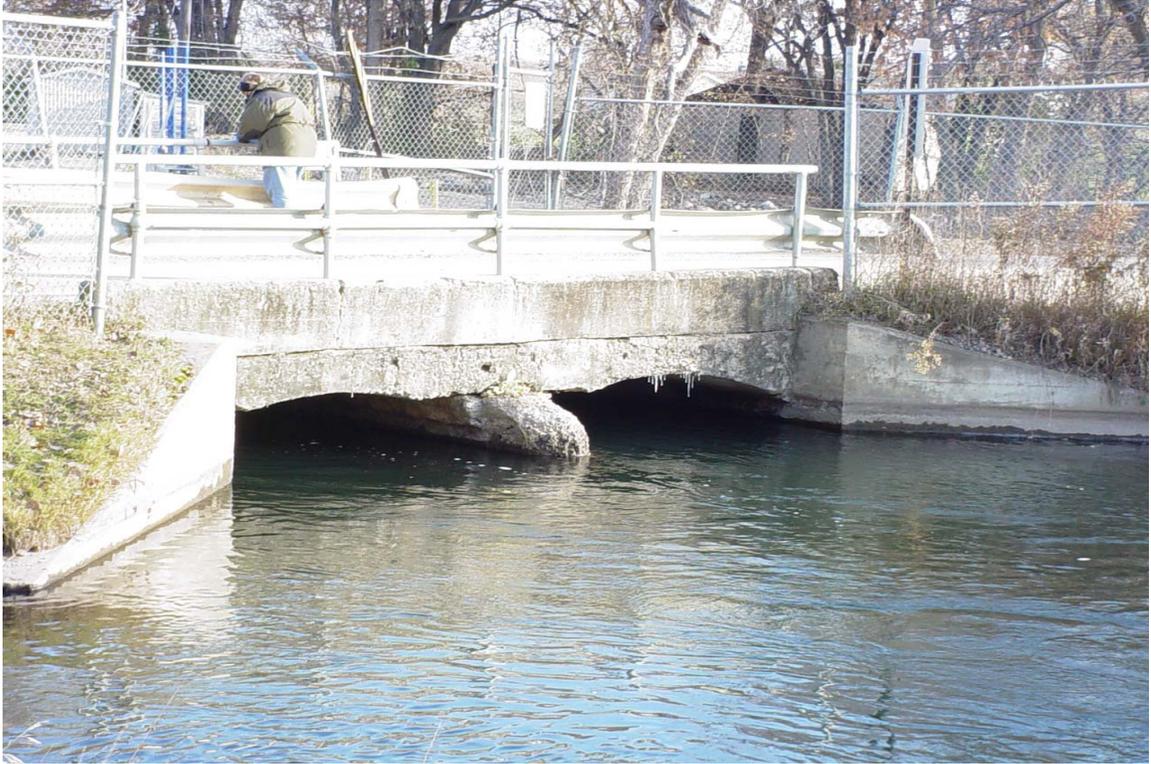
Photograph 1. Overall View of Structure, Looking Northeast.
