UNDERWATER BRIDGE INSPECTION REPORT

STRUCTURE NO. 4237

BUFFALO RIVER

MINNESOTA DEPARTMENT OF TRANSPORTATION  
UNDERWATER BRIDGE INSPECTION

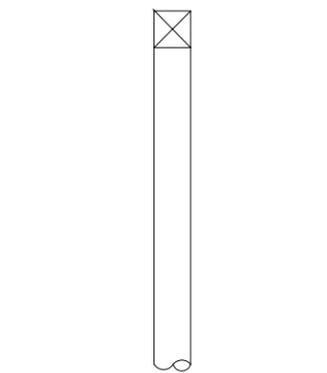
TYPICAL END VIEW OF PIERS 1 & 4

- 3 The timber piles, caps and bracing of Piers 1 and 2 were lightly weathered with checks up to 1/8 inch wide. Awl penetrations into the timber were between 1/4 and 1/2 inch. The galvanized steel connection hardware exhibited light surface corrosion with no appreciable loss of section. There were two broken and one missing horizontal timbers at the upstream and two broke and two missing horizontal timbers at the downstream truss support elements of Pier 2.

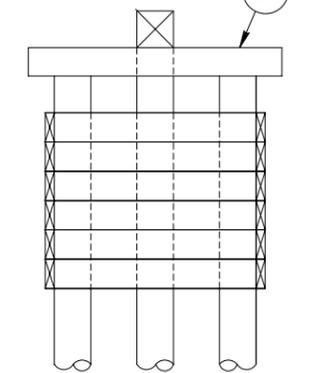
TYPICAL END VIEW OF PIERS 2 & 3

- 4 A moderate accumulation of timber debris, consisting of logs up to 18 inches in diameter, was observed along the entire south face, around the upstream nose, and along the north face to the upstream 1/4 point of Pier 2. The debris extended from the channel bottom to 2 feet above the waterline, and extended up to 3 feet from the upstream nose, up to 4 feet from the north face, and from the south face to Pier 1.

- (A) Remove timber debris accumulated at Pier 2 and on the north shoreline upstream of bridge.
