UNDERWATER BRIDGE INSPECTION REPORT

STRUCTURE NO. 92453
CSAH NO. 15
OVER THE
SOUTH BRANCH OF THE BUFFALO RIVER
DISTRICT 4 - CLAY COUNTY

PREPARED FOR THE
MINNESOTA DEPARTMENT OF TRANSPORTATION
BY
COLLINS ENGINEERS, INC.
JOB NO. 5221 (CEI 53)

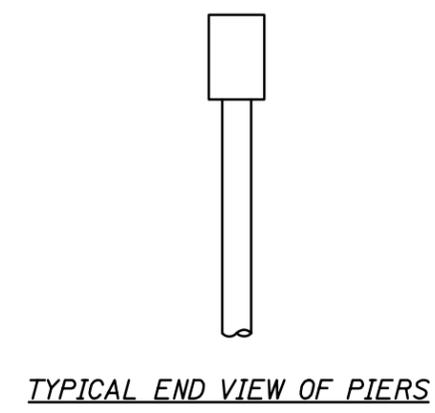
SOUNDING PLAN

- 5 The diagonal timber bracing at Piers 1 and 2 was completely missing.
 - 6 A light accumulation of timber debris consisting of 4 inch diameter and smaller limbs and branches of Pier 1 extending from channel bottom to waterline with a radius of 5 feet off the upstream pile.

- 7 Cut off timber piles were observed at 8 feet North of the South Abutment from channel bottom to 3 feet above the waterline and 2 feet North of Pier 1 from channel bottom to 1 foot below the waterline.

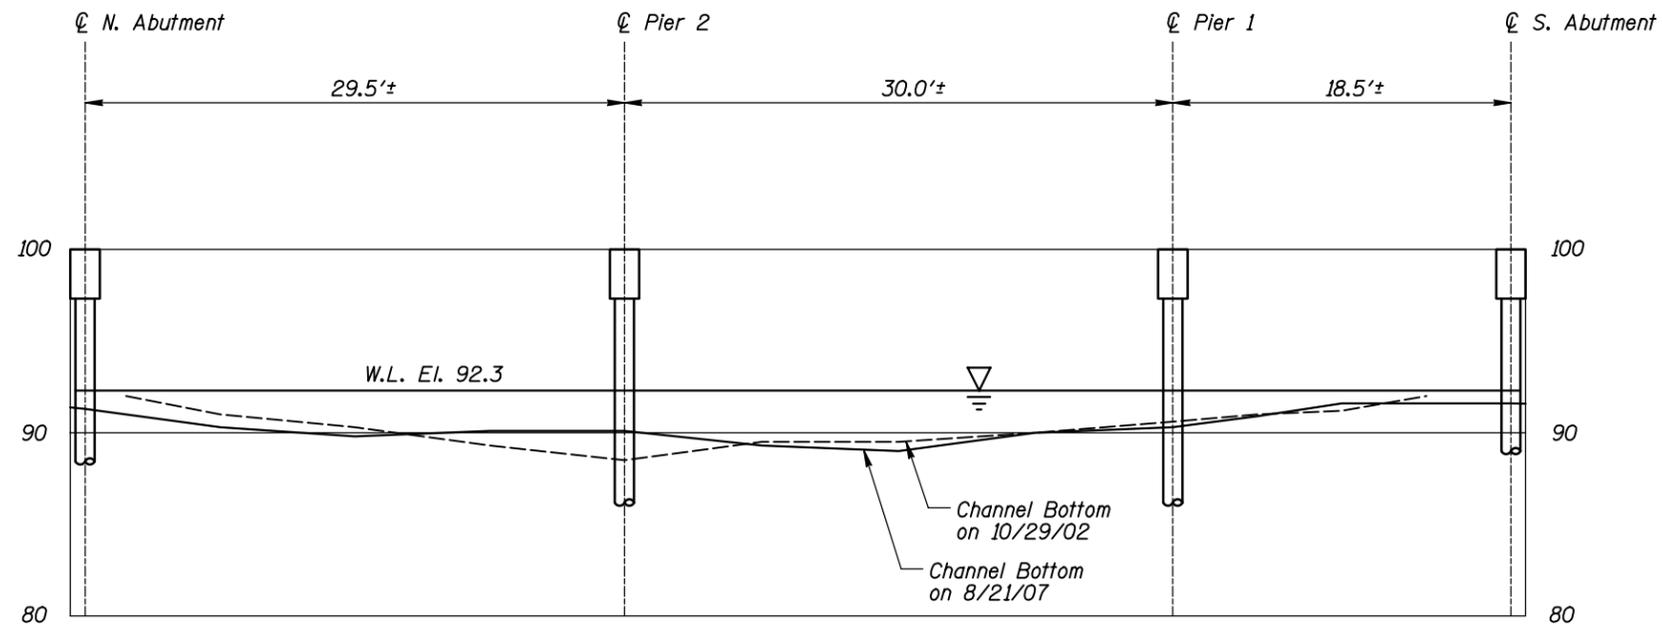
UPSTREAM FASCIA PROFILE

- 3 The gaps between the timber planking along the backwall and wingwalls have been repaired with metal strips to halt backfill loss.
 - 4 The horizontal timber brace directly below the pier cap was broken and no longer engaged at the upstream pile at Piers 1 and 2 on both north and south sides.
