UNDERWATER BRIDGE INSPECTION REPORT

STRUCTURE NO. L7352
TWP NO. 140
OVER THE
RABBIT RIVER
DISTRICT 4 - WILKIN COUNTY

PREPARED FOR THE
MINNESOTA DEPARTMENT OF TRANSPORTATION
BY
COLLINS ENGINEERS, INC.
JOB NO. 5221 (CEI 59)

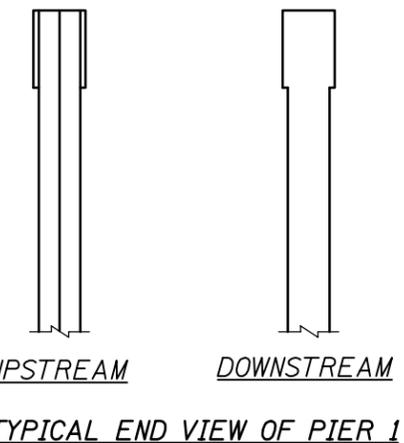
- INSPECTION NOTES:**
- The channel bottom material consisted of hard clay overlaid with silt and random gravel with a maximum probe rod penetration of 6 inches.

- Light to moderate scaling was observed around the perimeter of the pier and along the breastwalls of both abutments, with a maximum penetration of 1 inch, extending from the waterline to 2 feet above.

- A moderate accumulation of 1-foot-diameter and smaller timber debris was observed along the upstream fascia, extending from the North Abutment to midway between the pier and the South Abutment. A 2.5-foot-diameter tree along with a heavy accumulation of timber debris was also observed extending from the north embankment of Pier 1.

- Vertical crack, extending from the beam seat to the channel bottom with a maximum width of 1/8 inch, was observed on both sides of the pier.
 - Vertical crack, extending from the beam seat to the channel bottom with a maximum width of 1/8 inch, was observed on the breast wall.

- Steel ice damage nosing protection extended from the top of the pier cap to 2 foot above the waterline.
 - Footing exposure was observed along the North Abutment with no vertical face exposure observed.

- Area of section loss, 6 inches in diameter, was observed 2 feet above the waterline with a penetration of 1 inch.
 - Vertical crack, extending from the beam seat to the channel bottom with a maximum width of 1/16 inch, was observed on the breast wall.

- Vertical crack, extending from the beam seat to the channel bottom with a maximum width of 1/32 inch, was observed on the breast wall.
 - Scattered timber debris consisting of 3-inch-diameter and smaller branches was observed along the North Abutment and the north face of Pier 1.

- Backfill behind wingwalls was eroded making it steeply sloped.
 - A 1.5-foot-diameter log was observed along the face of the North Abutment.
