UNDERWATER BRIDGE INSPECTION REPORT

STRUCTURE NO. 03503

CSAH NO. 24

JULY 12, 2012

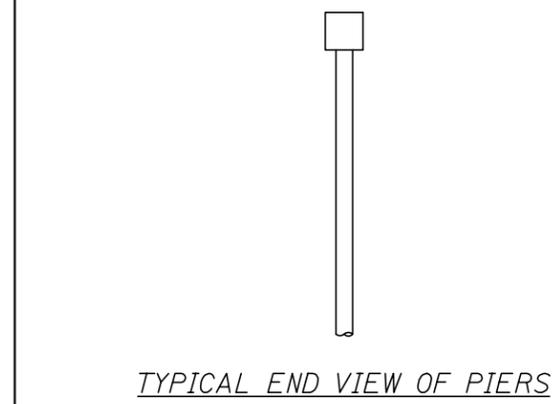
- 1 The channel bottom consisted of 6 inch diameter cobbles and sandy silt with up to 1 foot of probe rod penetration.
- 2 The channel bottom consisted of sand with up to 6 inches of probe rod penetration.
- 3 The steel pipe piles had coating failure with light surface corrosion from top of pile to the channel bottom.
- 4 The steel pipe piles had rust nodules, typically 1/4 inch in diameter and up to 1 inch in diameter, over 50 percent of the surface area from 10 feet below the waterline to the channel bottom and over 10 to 20 percent from the top pile to 10 feet below the waterline.
- 5 Timber debris was scattered throughout the piles of all the piers.
