UNDERWATER BRIDGE INSPECTION REPORT

STRUCTURE NO. 14550  
CSAH NO. 19  
OVER THE  
BUFFALO RIVER  
DISTRICT 4 - CLAY COUNTY

SEPTEMBER 21, 2012  
PREPARED FOR THE  
MINNESOTA DEPARTMENT OF TRANSPORTATION  
BY  
AYRES ASSOCIATES & COLLINS ENGINEERS, INC.  
JOB NO. 7423

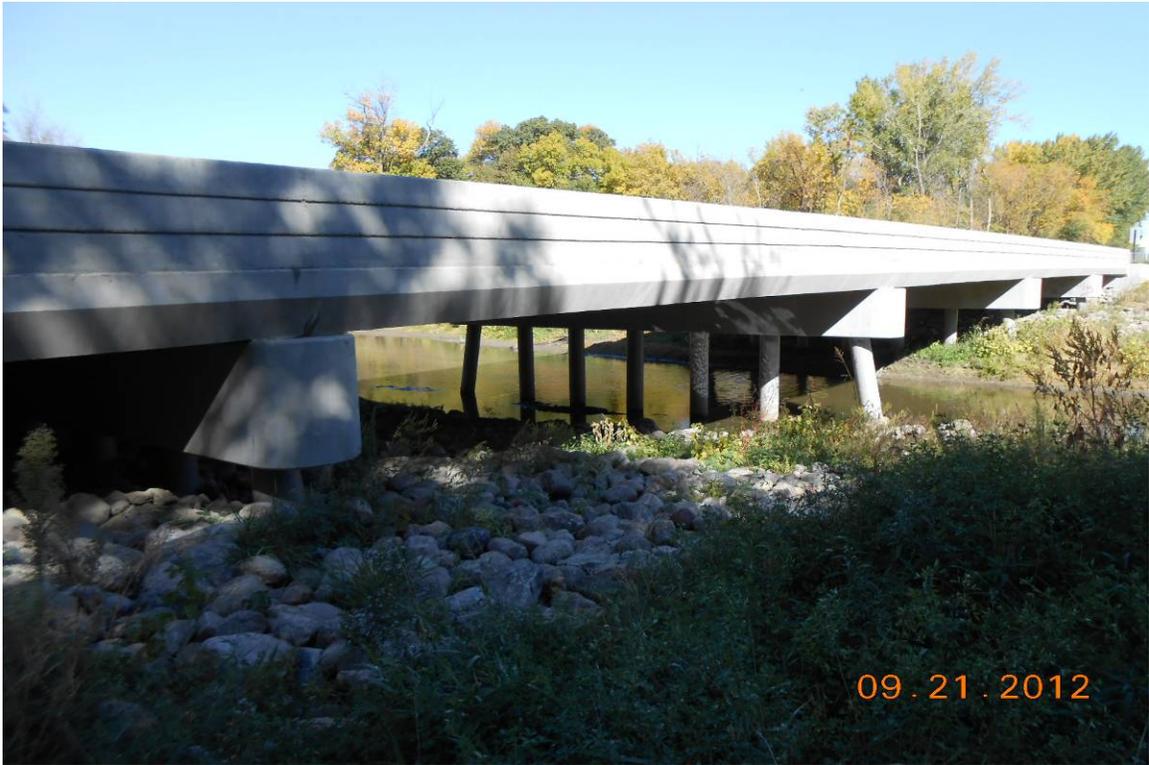
Photograph 1. Overall View of the Structure, Looking Northwest.

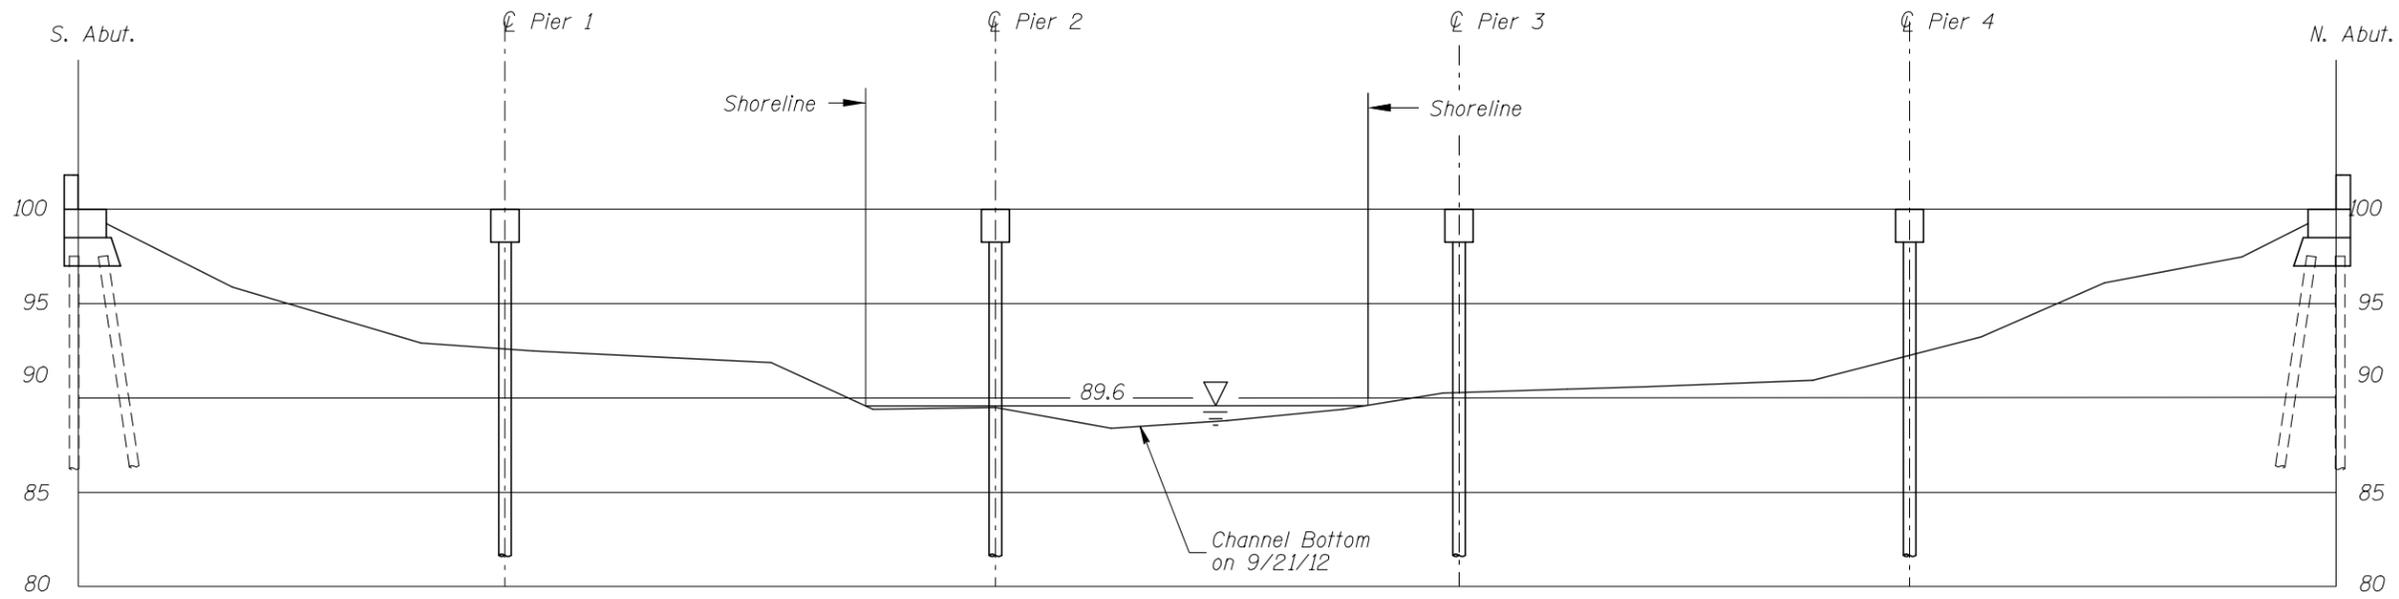
**UPSTREAM FASCIA PROFILE**  
Vertical Scale: 1"=10'-0"

- ① The channel bottom material consisted of silt with a maximum probe rod penetration of 1.5 feet.
- ② The cast-in-place concrete piles were sound and in good condition.
