UNDERWATER BRIDGE INSPECTION REPORT

STRUCTURE NO. 1232

4th STREET BRIDGE

CANNON RIVER

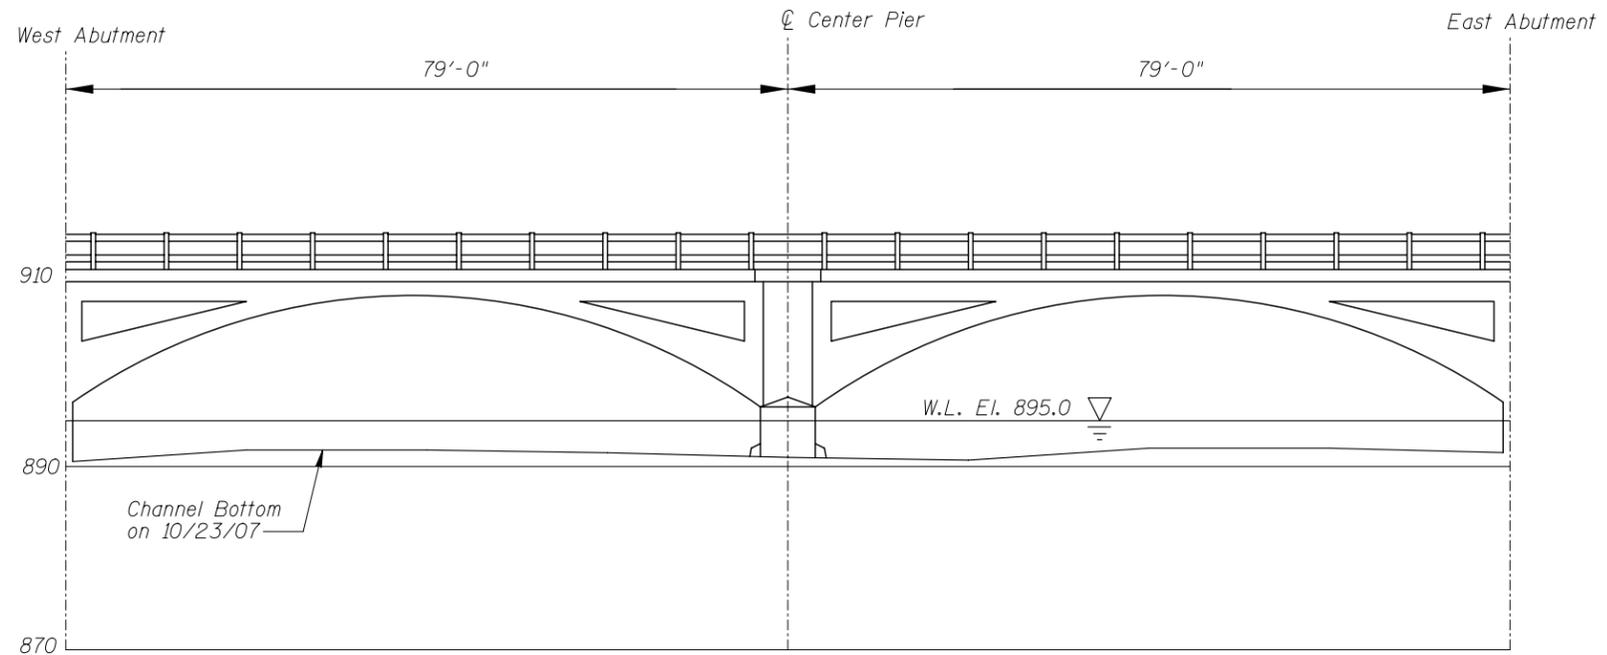
UPSTREAM FASCIA PROFILE

- ① The channel bottom consisted of stone and natural bedrock with no probe rod penetration possible.
- ② The concrete was in smooth and sound condition with only random minor cracking of the resurfacing repairs.
