UNDERWATER BRIDGE INSPECTION REPORT

STRUCTURE NO. 23513

CSAH NO. 36

ROOT RIVER

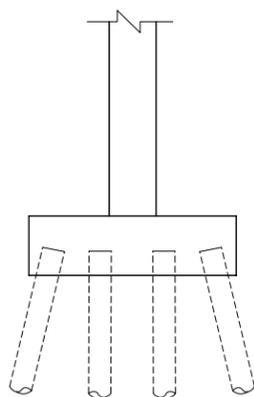
TYPICAL END VIEW OF PIERS

- 4 A scour depression, 3 foot deep and 6 feet in radius, was observed at the upstream nose of Pier 1.
- 5 The top of the footing was exposed around the entire perimeter of Pier 1 with up to 3.5 feet of vertical footing exposure at the upstream end of the pier with no undermining observed.

- 6 A scour depression, 6 inches deep and 2 feet in radius, was observed at the upstream nose of Pier 3.
- 7 A light accumulation of branchy timber debris was observed along the east face and downstream nose of Pier 3.

- 8 A 2 feet diameter tree was observed at the upstream end of Pier 1 on the top of footing.
- 9 A 1 foot diameter log was observed along the west face of Pier 4.

- 10 A scour depression 4 feet deep, 3 feet in radius was observed at the west face of Pier 4.
