UNDERWATER BRIDGE INSPECTION REPORT

STRUCTURE NO. 66505
5th STREET
OVER THE
CANNON RIVER
DISTRICT 6 - RICE COUNTY

PREPARED FOR THE
MINNESOTA DEPARTMENT OF TRANSPORTATION
BY
COLLINS ENGINEERS, INC.
JOB NO.5221

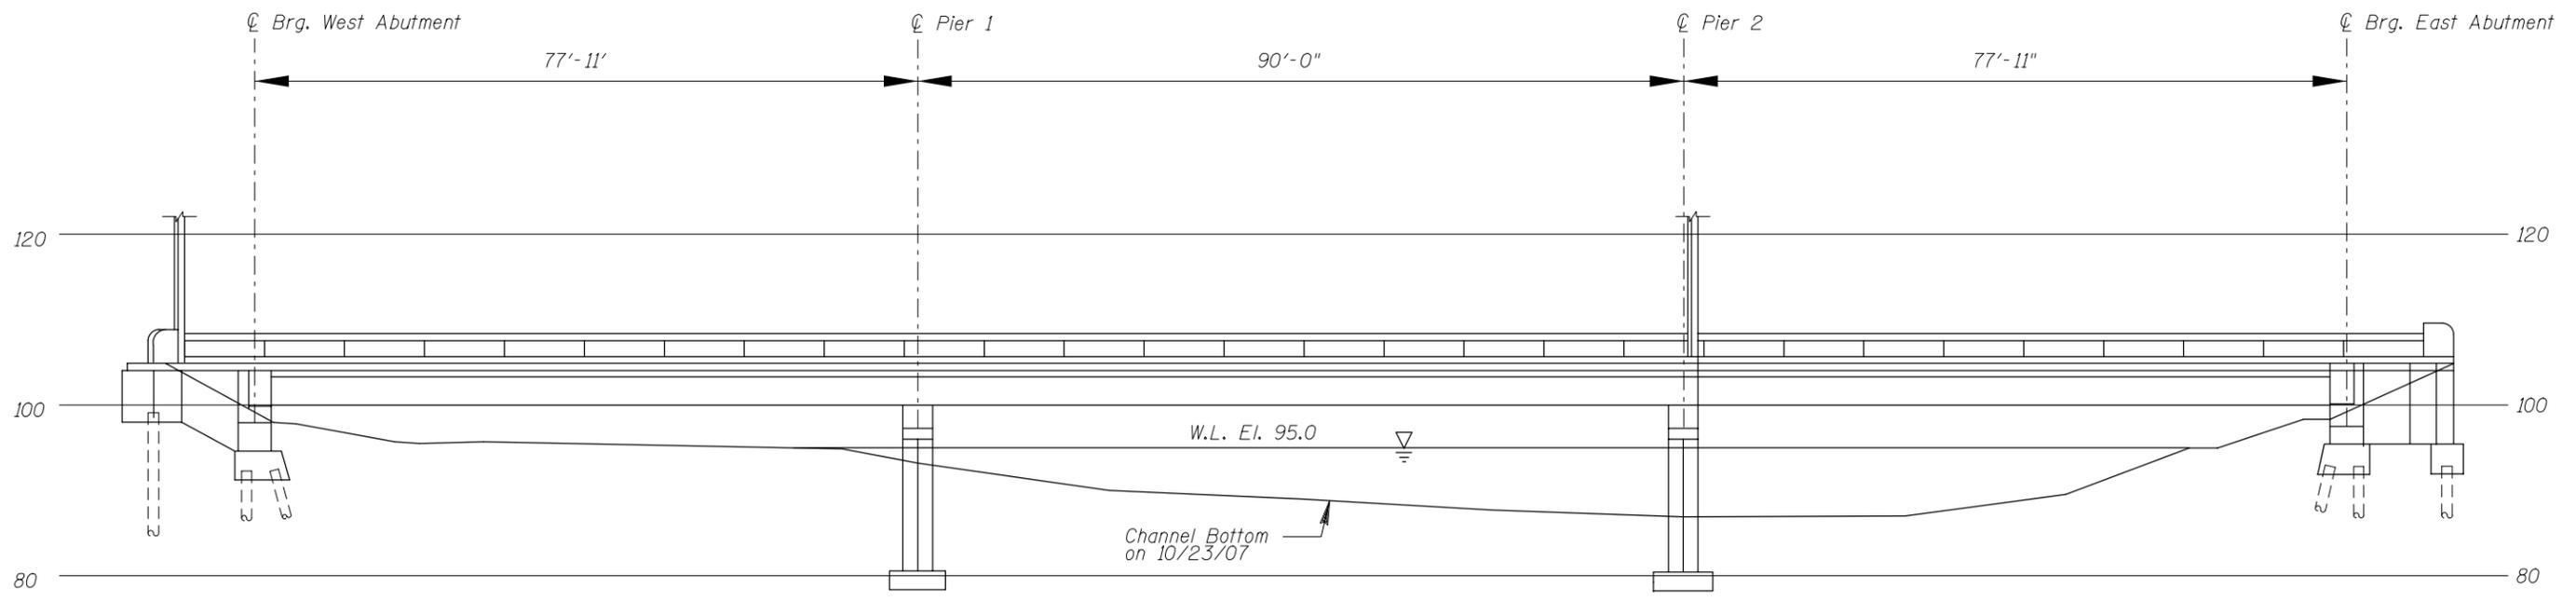
UPSTREAM FASCIA PROFILE

- ① A light accumulation of 4-inch-diameter and smaller timber debris was observed on the channel bottom along the center column at Pier 1 and at the upstream column at Pier 2.
- ② The channel bottom consisted of silty clay and sand with up to 8 inches of probe rod penetration.
- ③ The concrete of the columns was typically in smooth and sound condition.
