UNDERWATER BRIDGE INSPECTION REPORT

STRUCTURE NO. 66506
CSAH NO. 11
OVER THE
CANNON RIVER
DISTRICT 6 - RICE COUNTY

PREPARED FOR THE
MINNESOTA DEPARTMENT OF TRANSPORTATION
BY
COLLINS ENGINEERS, INC.
JOB NO. 5221 (CEI 23A)

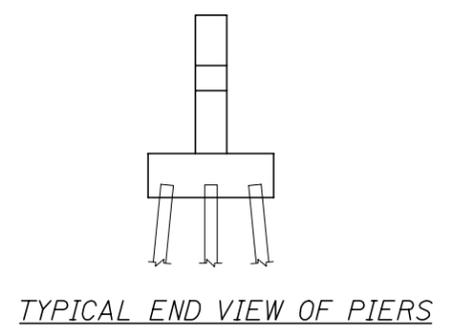
SOUNDING PLAN

- 1 The channel bottom material consisted of gravel and cobbles, 1 foot diameter and smaller, with no appreciable probe rod penetration possible.
- 2 Light to moderate concrete scaling from the channel bottom to 2 feet above the waterline, 1/4 inch maximum penetration.
