UNDERWATER BRIDGE INSPECTION REPORT

STRUCTURE NO. 66548
C.S.A.H. 29
OVER THE
CANNON RIVER
DISTRICT 6 - RICE COUNTY

PREPARED FOR THE
MINNESOTA DEPARTMENT OF TRANSPORTATION
BY
COLLINS ENGINEERS, INC.
JOB NO.5221

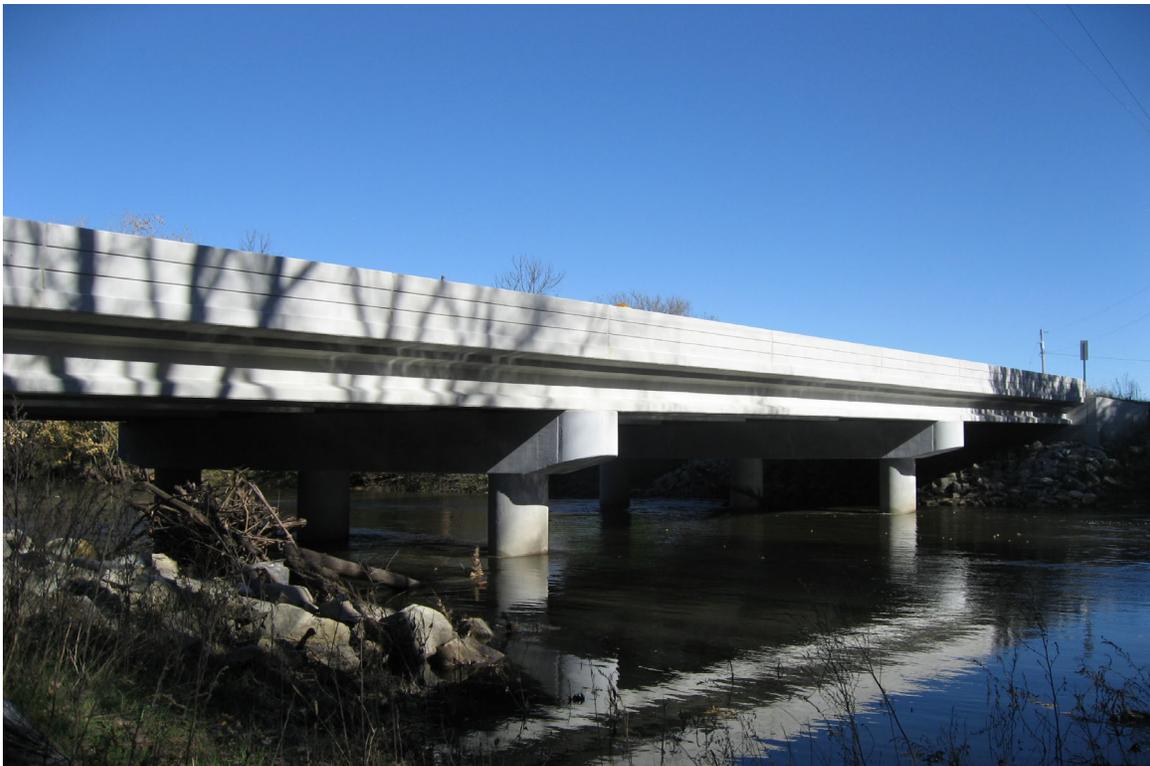
The substructure units inspected below water at Bridge No. 66548, Piers 1 and 2, were found to be in good condition with no defects of structural significance observed. The channel bottom appeared to be stable with no significant deficiencies or conditions.
