UNDERWATER BRIDGE INSPECTION REPORT

STRUCTURE NO. 89188
7th STREET
OVER THE
ZUMBRO RIVER
DISTRICT 6 - RICE COUNTY

PREPARED FOR THE
MINNESOTA DEPARTMENT OF TRANSPORTATION
BY
COLLINS ENGINEERS, INC.
JOB NO.5221

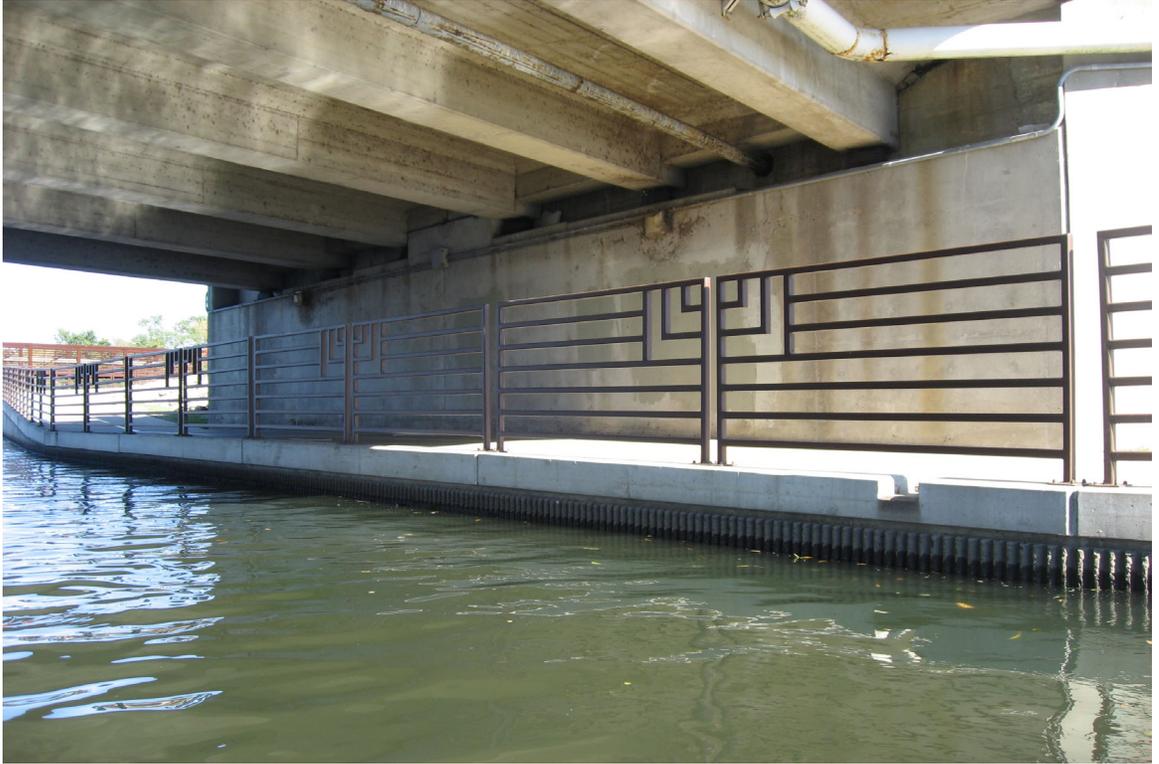
Photograph 5. View of the East Abutment, Looking North.

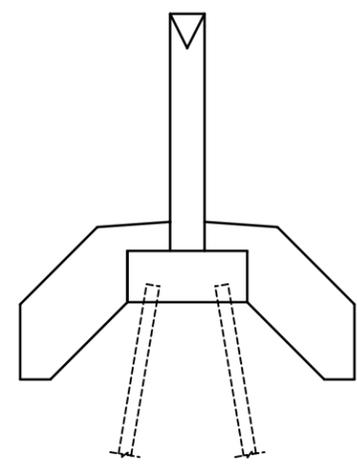
TYPICAL END VIEW OF EACH PIER SECTION

- 1 The concrete piers were typically in smooth and sound condition.
- 2 Two vertical 1/8-inch-wide cracks were observed at the upstream and downstream 1/4 points along the pier shaft and extended from the top of the pier to the top of the concrete scour protection. Both cracks extended through the full depth of the pier shaft.

- 3 A light accumulation of 3-inch-diameter and smaller timber debris was observed at the upstream end of Pier 2.
- 4 The channel bottom consisted of gravel and silty sand outside of the concrete scour protection around the substructure units.

- 5 Four vertical hairline to 1/4-inch-wide cracks were observed along pier shaft and extended from the top of the pier to top of the concrete scour protection. All cracks extended through the full depth of the pier shaft.

- 6 A 1/16-inch differential (east / west) was observed at the top of the pier shaft at the northern 1/4 point along the southernmost 1/4-inch wide crack.

- 7 A moderate accumulation of 3-inch-diameter and smaller timber debris was observed at the upstream end of Pier 1 and extended from the channel bottom up 2 feet.

- 8 A vertical 1/8-inch-wide crack was observed at the upstream 1/4 point along West Abutment and extended from the top of the abutment to the concrete scour protection.

- 9 A 4-inch-diameter spall was observed near the outfall at the upstream 1/4 point along the West Abutment with up to 2 inches of penetration and an associated hairline crack that extended to the wingwall.

- 10 A 1/16-inchwide vertical crack was observed at along the middle joint of the West Abutment.
- 11 A hairline crack was observed at the downstream 1/4 point of the West Abutment and extended from the top of abutment to top of concrete scour protection.

Monitor the cracking along the pier shafts at Piers 1, 2 and 3 and the West Abutment, with special attention to the minor 1/16-inch-wide differential along the northern end of Pier 1 for any further progression and/or movement.
