UNDERWATER BRIDGE INSPECTION REPORT

STRUCTURE NO. 1232

4th STREET BRIDGE

MAY 23, 2012

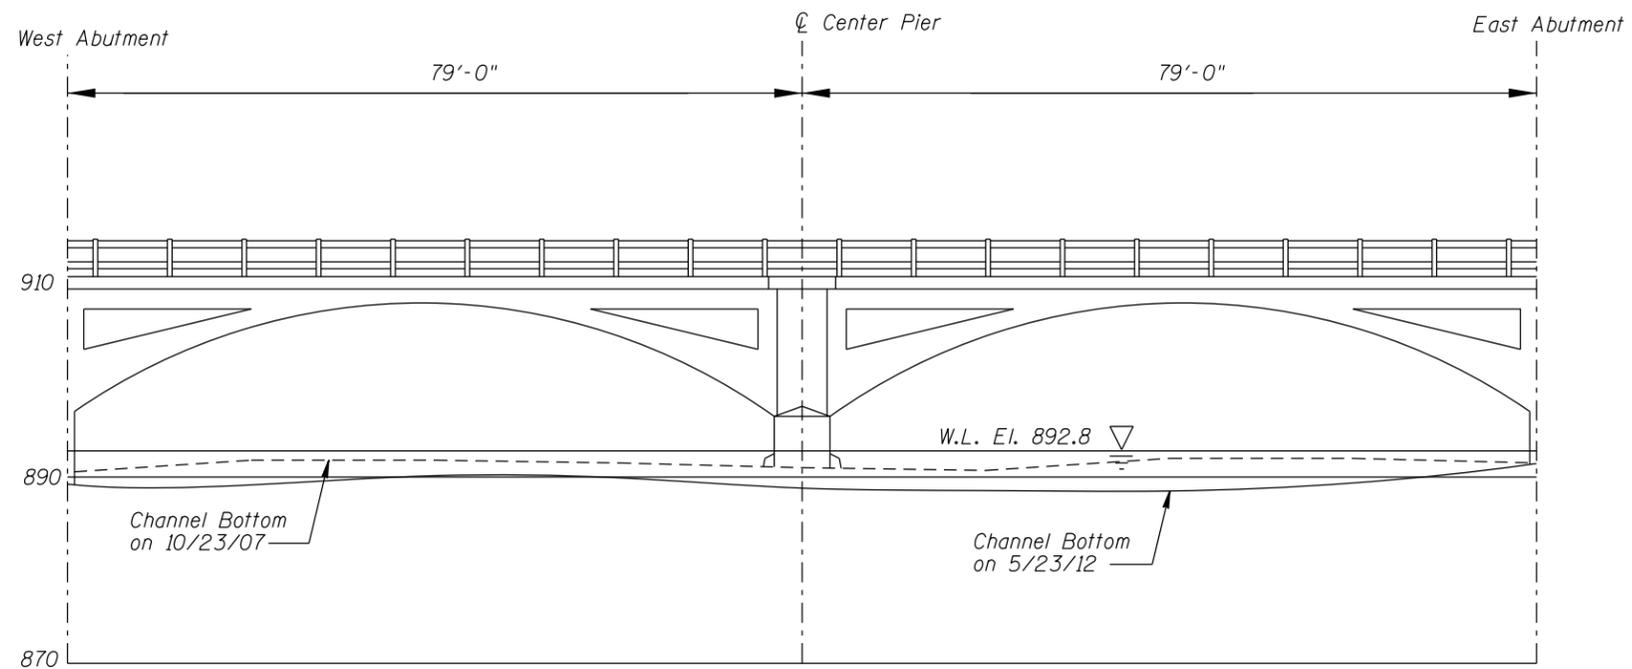
UPSTREAM FASCIA PROFILE

- 1 The channel bottom consisted of stone and natural bedrock with no probe rod penetration possible.
- 2 The concrete was generally smooth and sound with only random minor cracking of the resurfacing repairs.
- 3 Vertical crack 1/4 inch wide extended from 4 feet above waterline to channel bottom with a 4 inch by 4 inch spall at the waterline on the downstream nose of the center pier with a maximum penetration of 1 inch.
- 4 Vertical crack located on the downstream nose of the center pier was 1/8 inch wide and extended from channel bottom to 2 feet above the waterline.
- 5 Spall had a diameter of 2 feet at waterline and was located on west face of the center pier near the downstream nose. Maximum penetration was 2 inches. No steel reinforcement was exposed.
- 6 Random hairline cracks with efflorescence were observed at the waterline extending 5 feet above the waterline.

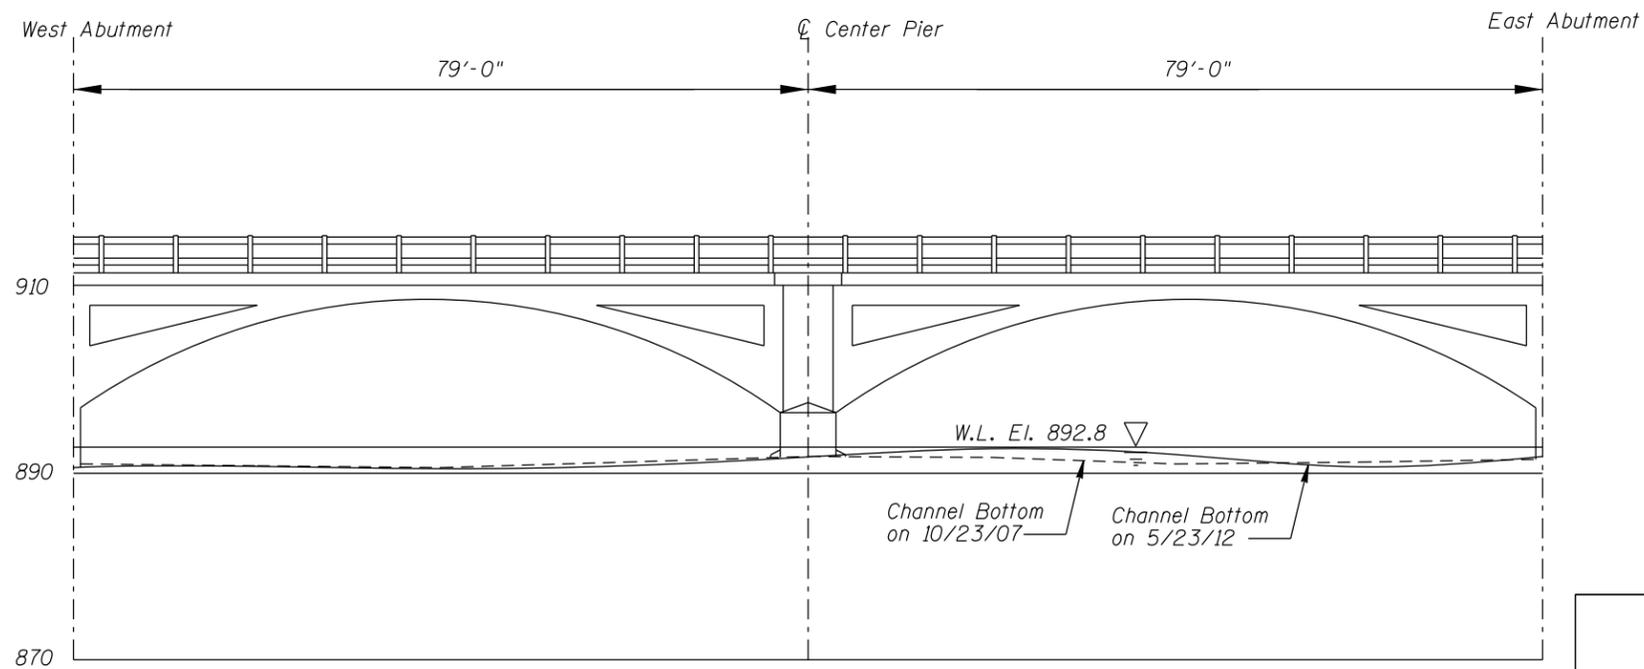
DOWNSTREAM FASCIA PROFILE

- (B) A 1/4-inch vertical crack was observed at the downstream nose of the center pier and extended from the channel bottom to 4 feet above the water line. A 4 inch wide by 4 inch long spall was observed along the crack near the water line with a maximum penetration of 1 inch.

- (C) A 1/8-inch vertical crack was observed at the downstream nose of the center pier and extended from the channel bottom to 2 feet above the water line.

- (D) A 2-foot diameter spall was observed on the downstream west face of the center pier at the water line with a maximum penetration of 2 inches. No reinforcing steel was exposed.
