UNDERWATER BRIDGE INSPECTION REPORT

STRUCTURE NO. 23501

ROOT RIVER

COLLINS ENGINEERS, INC.

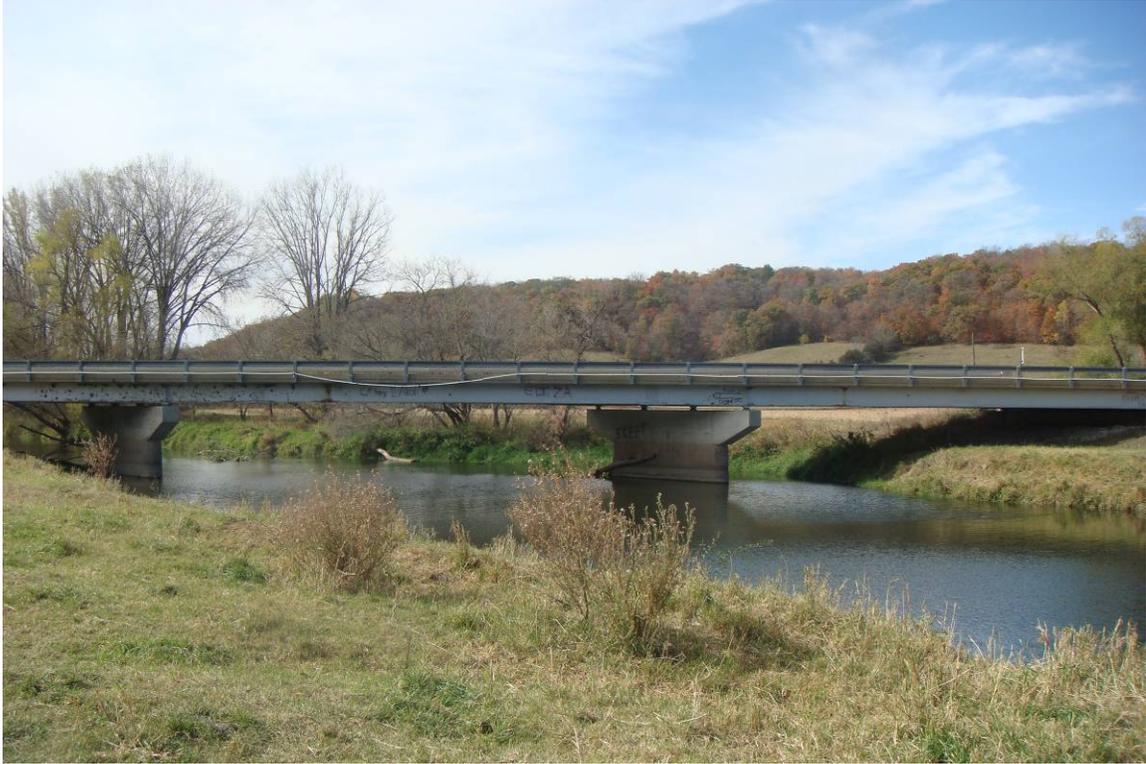
Photograph 1. Overall View of the Structure, Looking Northwest.

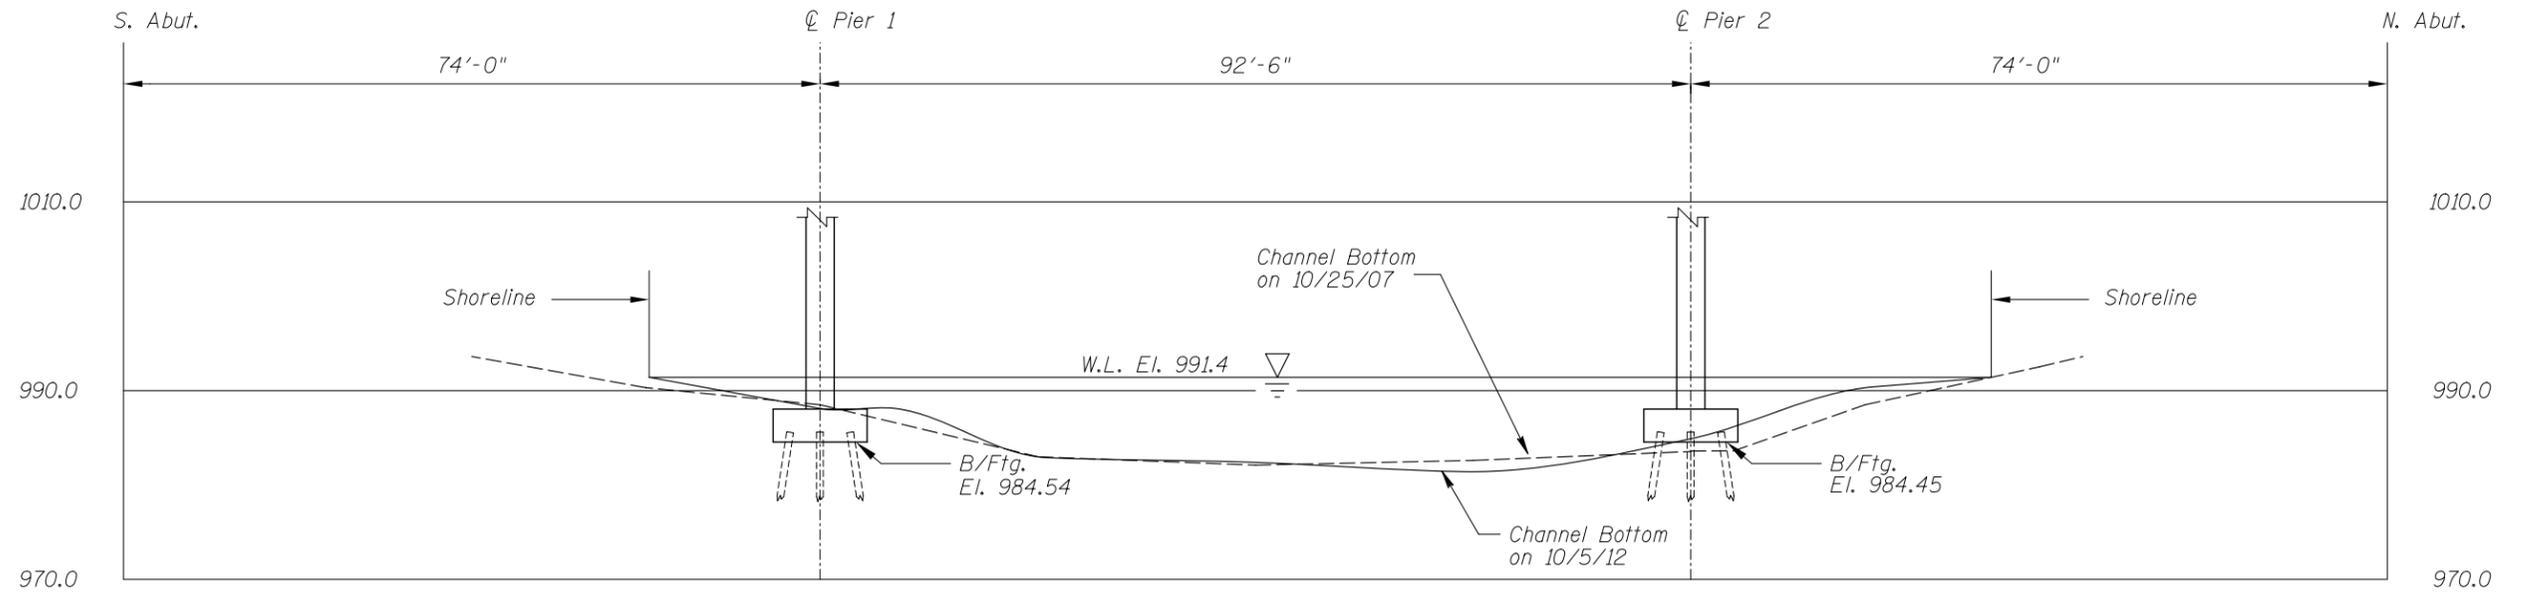
UPSTREAM FASCIA PROFILE

3. The channel bottom consisted of soft silt allowing up to 1.5 feet of probe rod penetration.
4. A vertical hairline crack was observed at the midpoint of Pier 2 that extended from the top of the pier cap to 2 feet below the waterline.

5. A vertical hairline crack was observed at the midpoint of Pier 2 that extended from the top of the pier cap to the top of the footing.
6. Light scaling was observed along all pier faces from 1 foot above to 1 foot below the waterline with a maximum penetration of 1/16 inch.

7. A heavy accumulation of 2-foot-diameter-and-smaller timber debris was observed extending from the channel bottom to 8 feet above the waterline at the upstream end and along both faces of Pier 1.

8. A 1.5-foot-diameter tree trunk (forked around the pier nose) was observed extending from the channel bottom to 4 feet above the waterline at the upstream end of Pier 2.

9. The footing was exposed along the east face of Pier 2 with undermining and steel H-piles observed from the midpoint along the downstream nose, around the upstream southeast corner, and extending to the upstream southwest corner, with a maximum height of approximately 1.5 feet along most of the undermined area on the east side of the pier, and 4 to 5 feet of maximum horizontal penetration. The exposed steel H-piles (4) were sound without any notable deterioration (just spotty surface corrosion).

Giving the undermining, consideration may need to be given for riprap to be properly designed and placed around the piers (especially Pier 2) and in the scour/undermining areas to armor against further channel bottom degradation, unless further scour analysis indicates differently.
