UNDERWATER BRIDGE INSPECTION REPORT

STRUCTURE NO. 23513

CSAH NO. 36

MINNESOTA DEPARTMENT OF TRANSPORTATION
UNDERWATER BRIDGE INSPECTION

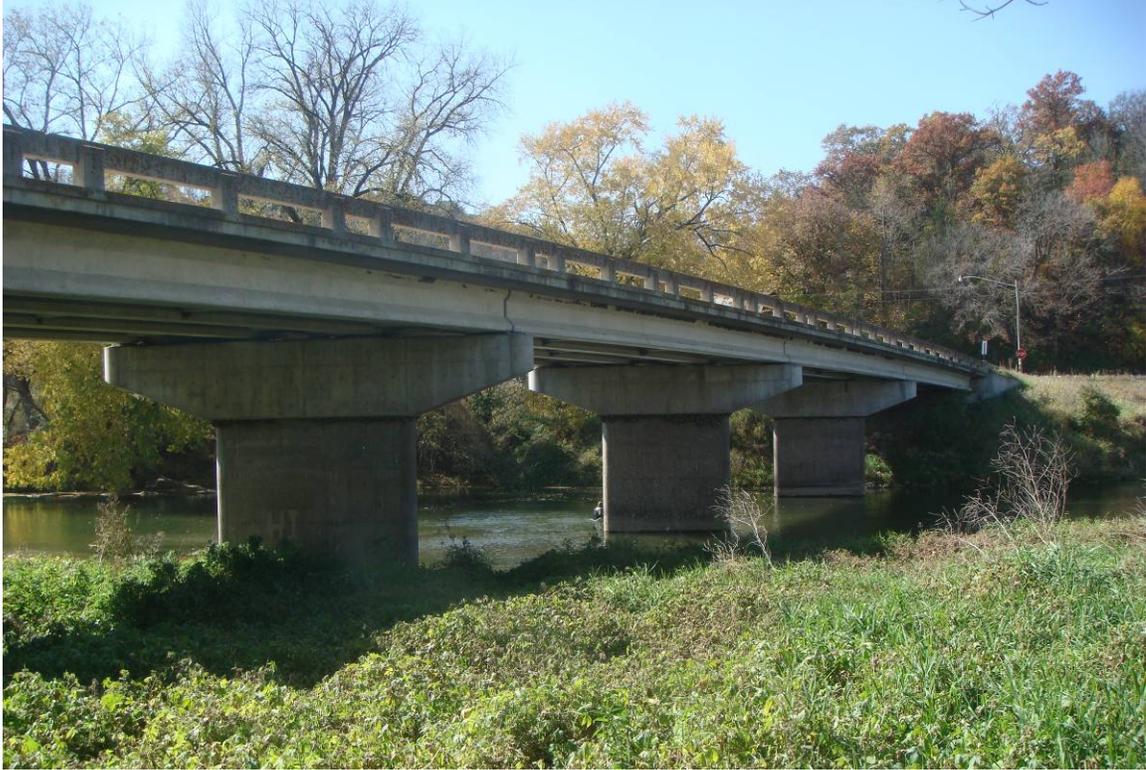
Photograph 1. Overall View of the Structure, Looking Southwest.

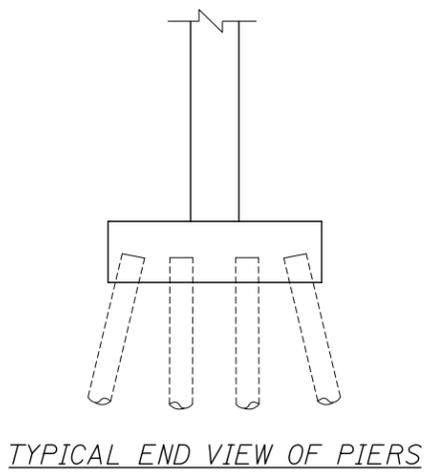
MINNESOTA DEPARTMENT OF TRANSPORTATION UNDERWATER BRIDGE INSPECTION		
STRUCTURE NO. 23513 CSAH 36 OVER THE ROOT RIVER FILLMORE COUNTY		
INSPECTION AND SOUNDING PLAN		
Drawn By: MBP	COLLINS ENGINEERS	Date: JAN., 2013
Checked By: LJ		Scale: NTS
Code: 742323513		Figure No.: 1

- A scour depression, 1.5 feet deep and 10 feet in radius, was observed at the upstream nose of Pier 1.
 - The top of the footing was exposed around the entire perimeter of Pier 1 with up to 3.5 feet of vertical footing exposure at the upstream end of the pier with no undermining observed.

- A scour depression, 1 foot deep and 6 feet in radius, was observed at the upstream nose of Pier 2.
 - A moderate accumulation of timber debris was observed at the upstream nose of Pier 2 consisting of 1.5 feet diameter and smaller trees and branches (including a tree trunk forked around the nose) that extends from the channel bottom to the waterline.

Monitor the timber debris, and if found to be increasing in the future, removal operations may become warranted.
