UNDERWATER BRIDGE INSPECTION REPORT

STRUCTURE NO. 24506

MSAS NO. 107 (BRIDGE AVE.)

MINNESOTA DEPARTMENT OF TRANSPORTATION  
UNDERWATER BRIDGE INSPECTION

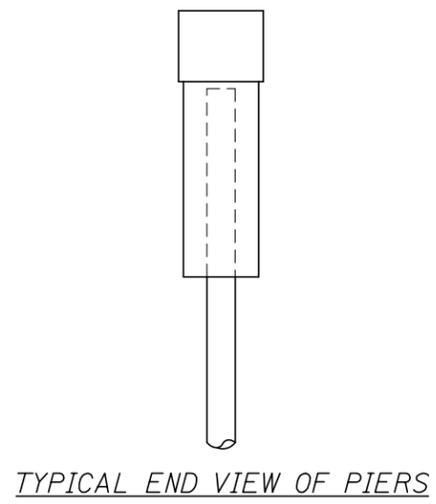
**TYPICAL END VIEW OF PIERS**

- 1 The channel bottom material consisted of sand and gravel with random riprap up to 1 foot in diameter.
- 2 The channel bottom material along the downstream fascia consisted of silty gravel with scattered cobbles at the end of the concrete apron.
- 3 The channel bottom consisted of a concrete apron. The apron was in good condition with no undermining observed.
- 4 Random light scaling was observed near the waterline on both piers.
- 5 The concrete apron exhibited a 3 to 4 feet long area of poorly formed concrete and section loss with 6 inches of penetration and exposed reinforcing steel near the downstream end of Pier 2.
