UNDERWATER BRIDGE INSPECTION REPORT

STRUCTURE NO. 4260

NORTH CHANNEL OF THE MISSISSIPPI

AUGUST 16, 2012

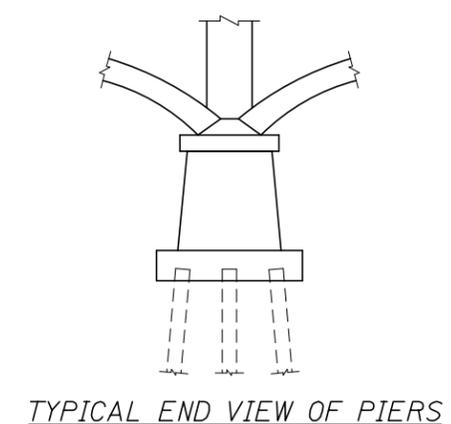
- 1 The channel bottom at Pier 13 consisted of silt with small stones and no riprap. Stone and rubble was observed at the upstream and downstream ends.

- 2 The channel bottom at Piers 1 through 12 consisted of riprap typically 1 to 2 feet in diameter with a maximum diameter of up to 3 feet. It was observed around the entire perimeter of all piers typically extending to top of footing or to no lower than 3 feet below top of footing.

- 3 The submerged concrete was typically in satisfactory condition with moderate scaling from 1 foot above the waterline to 1 foot below the waterline with typical penetrations of 1 inch and maximum penetrations of up to 6 inch. Random vertical and horizontal hairline cracks were also observed on the concrete shaft surfaces widespread throughout all piers. Cracking often had efflorescence associated with it. The concrete footing (where exposed) typically exhibited rough surfaces with up to 3 inch maximum penetration.
