UNDERWATER BRIDGE INSPECTION REPORT

STRUCTURE NO. 6564

ZUMBRO RIVER

WABASHA COUNTY

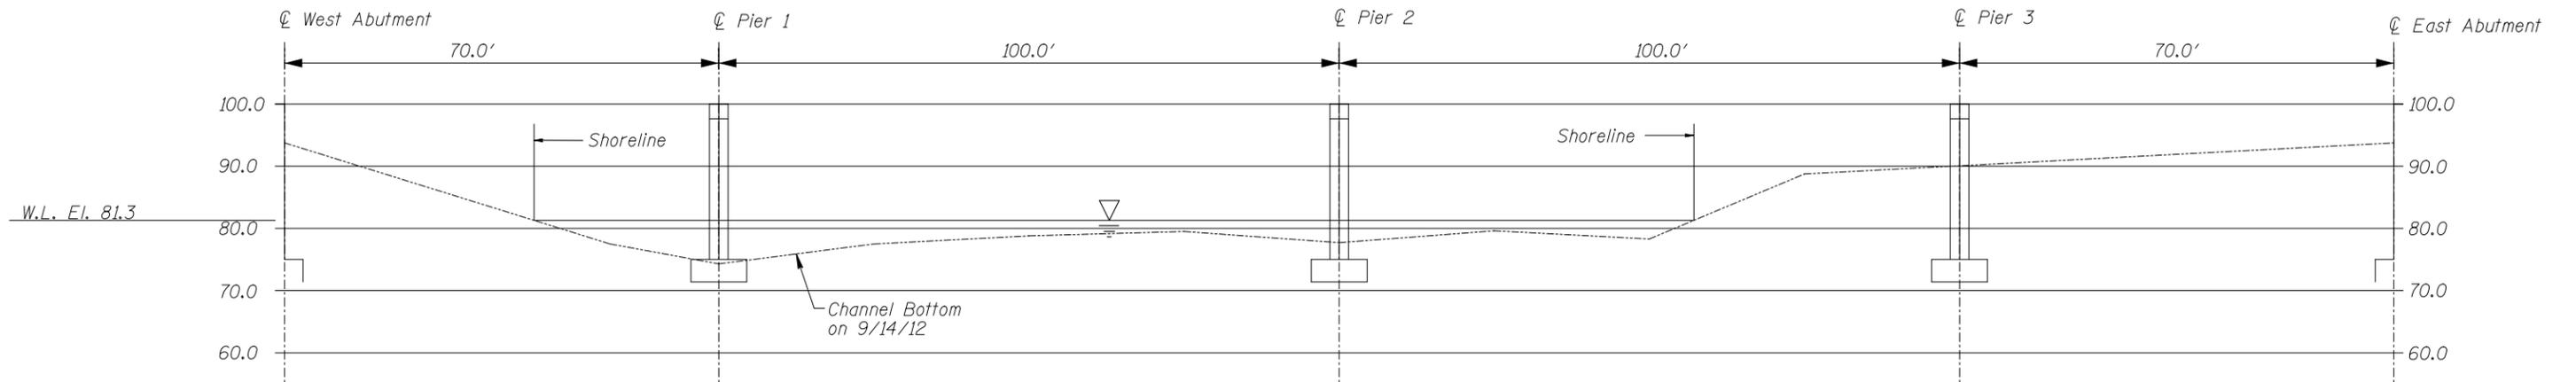
UPSTREAM FASCIA PROFILE

- ① There was a 3 foot radius by 2 foot deep scour depression at the upstream nose of Pier 2.
- ② The channel bottom material consisted of silty sand and gravel allowing 2 inches of probe rod penetration.
- ③ Moderate accumulation of timber debris, consisting of 1 foot diameter and smaller drift pieces, was observed from the channel bottom to 5 feet above waterline between the shore and the west face of Pier 1.
- ④ The footing was partially exposed from the northwest corner of Pier 1 around the upstream nose to the upstream 1/4-point along the east face of the pier with a maximum vertical face exposure of 1.5 feet. The top of the footing was located at approximately 5.5 feet below the water surface.

- (A) Monitor the extent of footing exposure as well as timber debris accumulation during future underwater inspections.
- (B) Reinspect the submerged substructure units at the normal maximum recommended (NBIS) interval of sixty (60) months.
