UNDERWATER BRIDGE INSPECTION REPORT

STRUCTURE NO. 66506

CANNON RIVER

SEPTEMBER 13, 2012

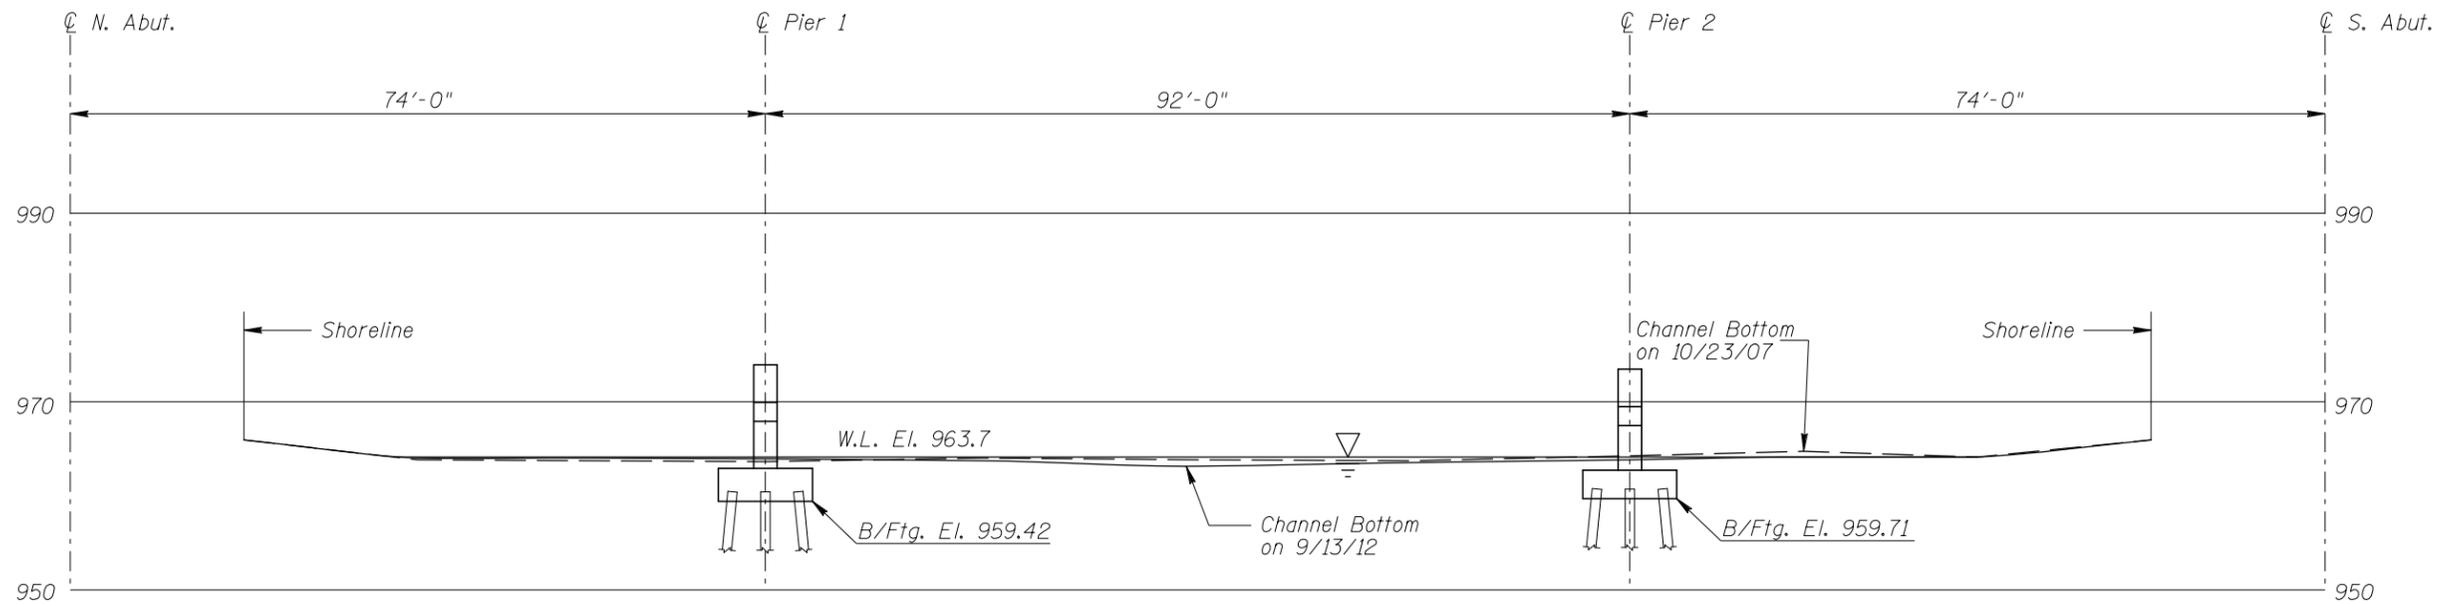
UPSTREAM FASCIA PROFILE

- ① The channel bottom material consisted of gravel and 1 foot diameter and smaller cobbles, with no appreciable probe rod penetration.
- ② The concrete was in smooth and sound condition.
