UNDERWATER BRIDGE INSPECTION REPORT

STRUCTURE NO. 66513  
14<sup>th</sup> STREET (MSAS NO. 103)  
OVER THE  
STRAIGHT RIVER  
CITY OF FARIBAULT, RICE COUNTY

SEPTEMBER 14, 2012  
PREPARED FOR THE  
MINNESOTA DEPARTMENT OF TRANSPORTATION  
BY  
COLLINS ENGINEERS, INC.  
JOB NO. 7423

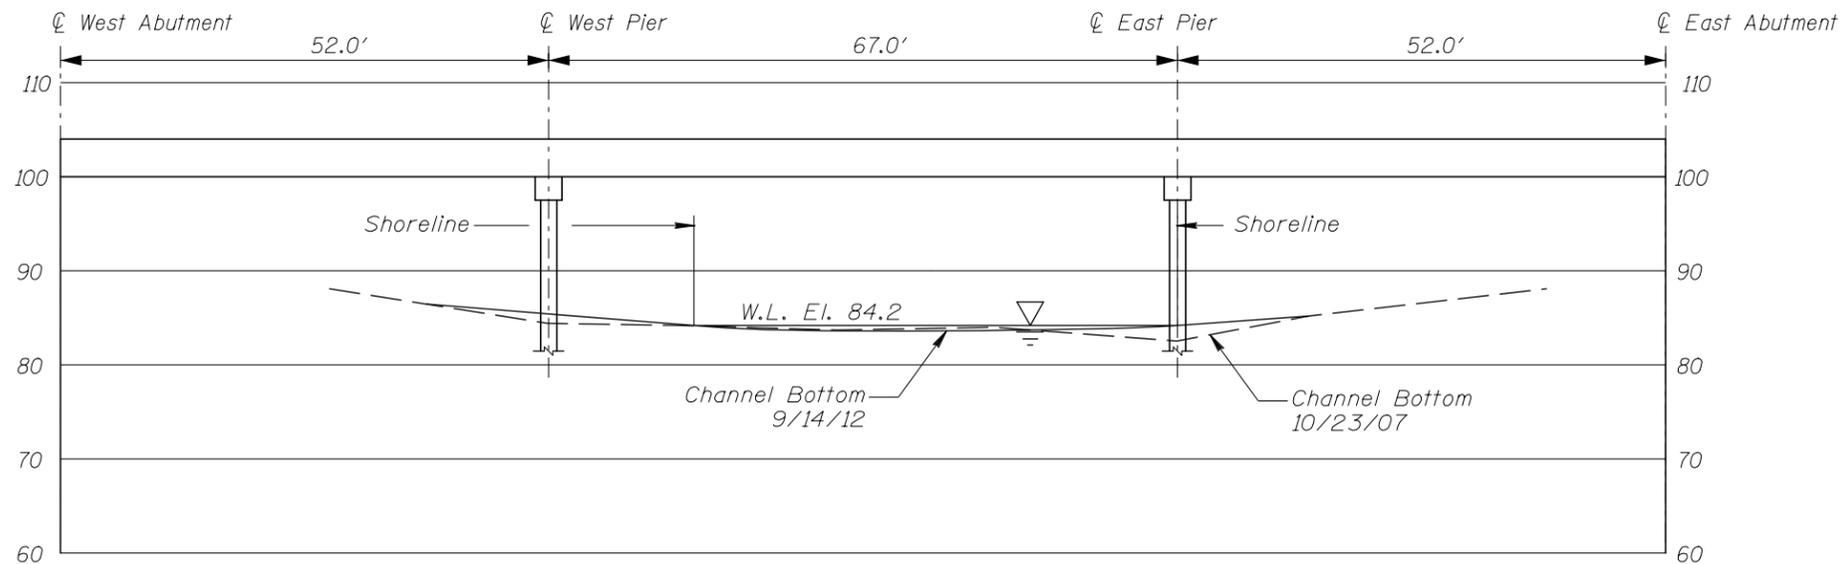
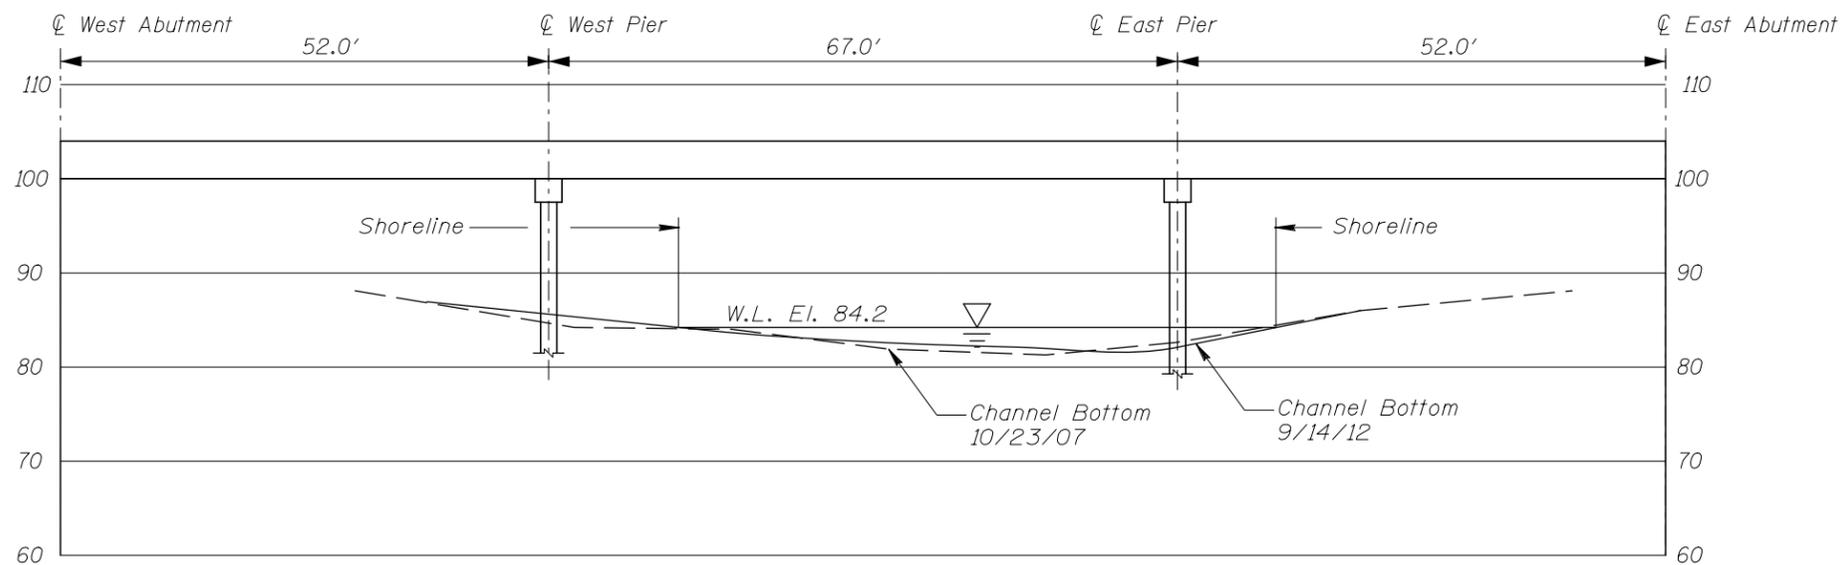
- 1 The top of the footing was partially exposed along the west face of the East Pier extending from the upstream 1/4-point to the downstream 1/4-point of the pier. No vertical face/footing edge exposure was present.
- 2 The concrete was in smooth and sound condition with no notable deterioration.
- 3 The channel bottom material consisted of 1 foot and smaller diameter stone.

- 0.4 Sounding Depth (9/14/12)
- 0.4 Sounding Depth (10/23/07)
- Timber Debris
