UNDERWATER BRIDGE INSPECTION REPORT

STRUCTURE NO. 66520  
TWP NO. 51 (220<sup>th</sup> STREET)  
OVER THE  
STRAIGHT RIVER  
DISTRICT 6 - RICE COUNTY

SEPTEMBER 12, 2012  
PREPARED FOR THE  
MINNESOTA DEPARTMENT OF TRANSPORTATION  
BY  
COLLINS ENGINEERS, INC.  
JOB NO. 7423

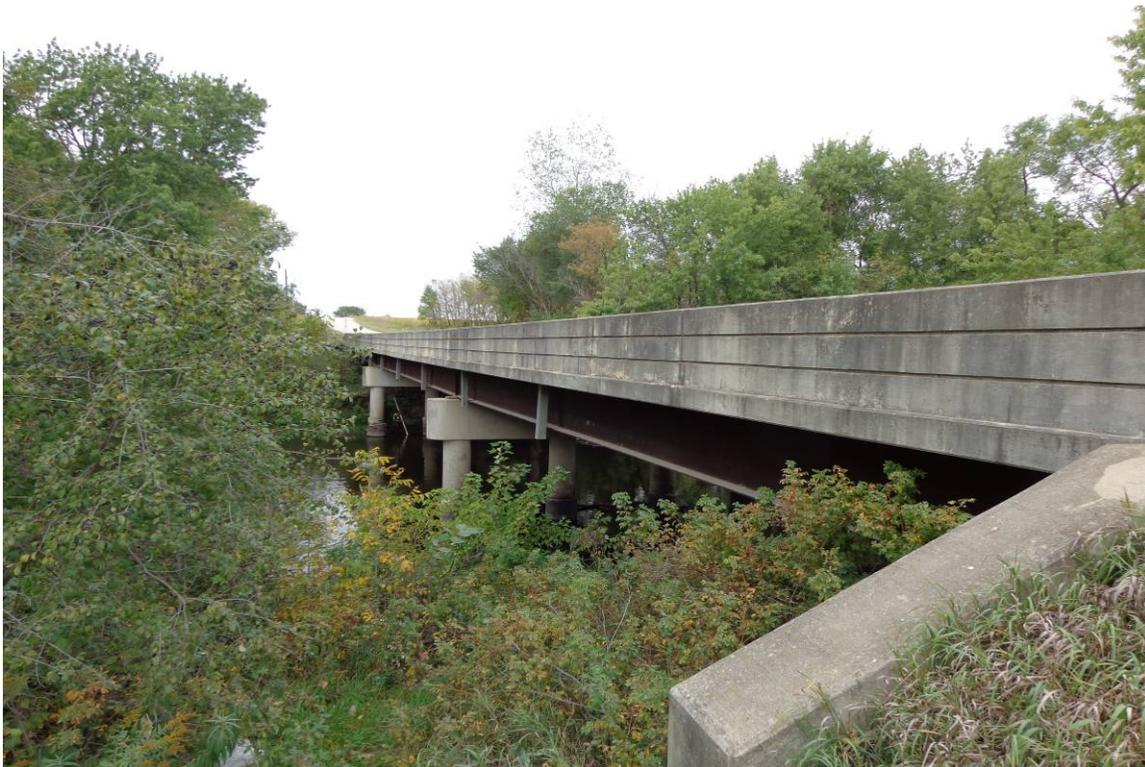
Photograph 1. Overall view of the Bridge, Looking Northwest.

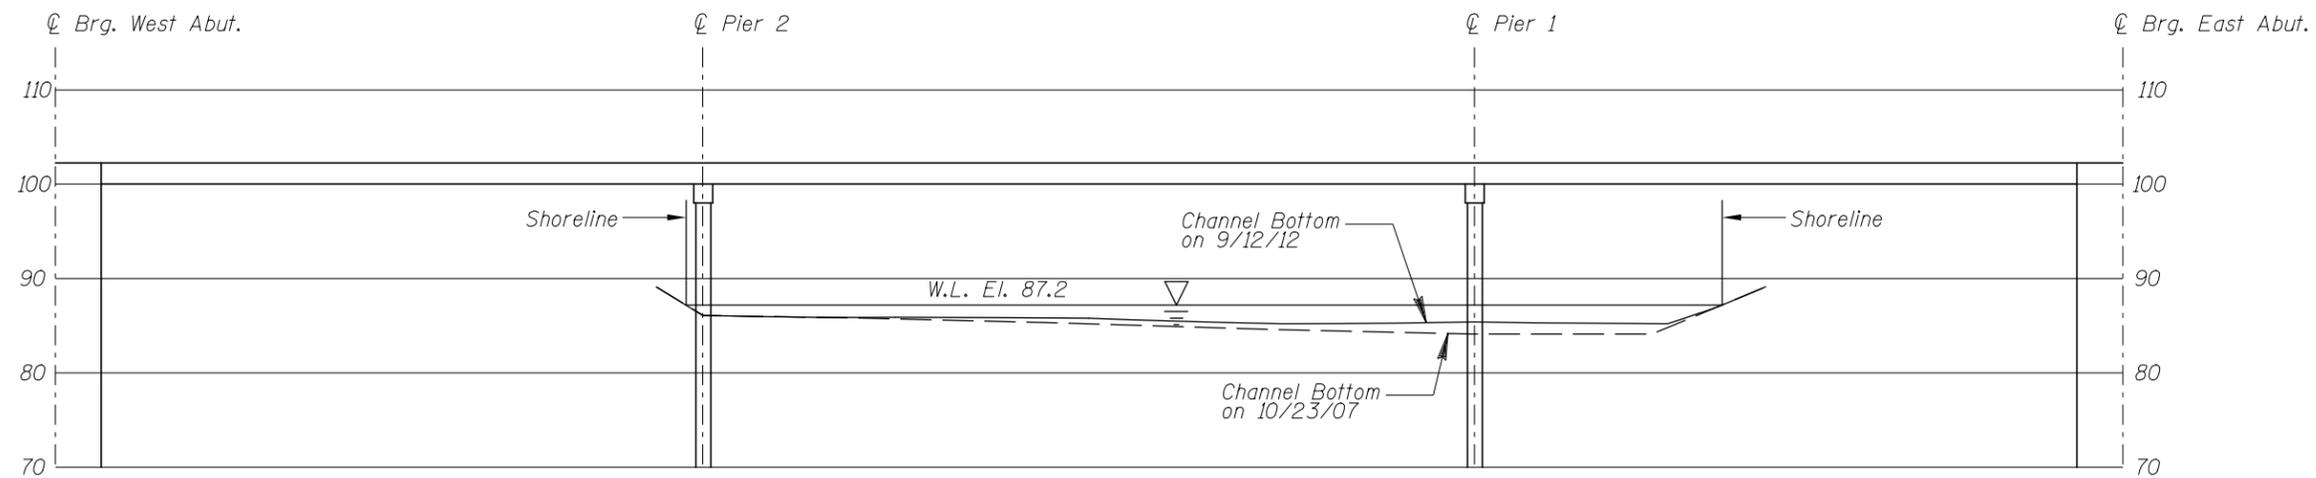
UPSTREAM FASCIA PROFILE

- 1 Timber debris was observed along the west face of Pier 1 that consisted of 6 inch diameter and smaller branches and extended from the channel bottom to 1 foot above the waterline.

- 2 The columns of Pier 1 were encased in up to 6 inches of additional concrete from the channel bottom to 2.3 feet above the waterline. The encasements exhibited form irregularities (embedded form boards) and spalling with up to 3 inches of penetration.

- 3 The columns of Pier 1 were encased in up to 6 inches of additional concrete from the channel bottom to 4.0 feet above the waterline. The encasements exhibited form irregularities (embedded form boards) and spalling with up to 6 inches of penetration.

Monitor concrete deterioration at the concrete column encasements during future underwater inspections.
