UNDERWATER BRIDGE INSPECTION REPORT

STRUCTURE NO. L0775

TWP NO. 386 (147<sup>th</sup> AVE)

NORTH BRANCH MIDDLE FORK OF THE ZUMBRO RIVER

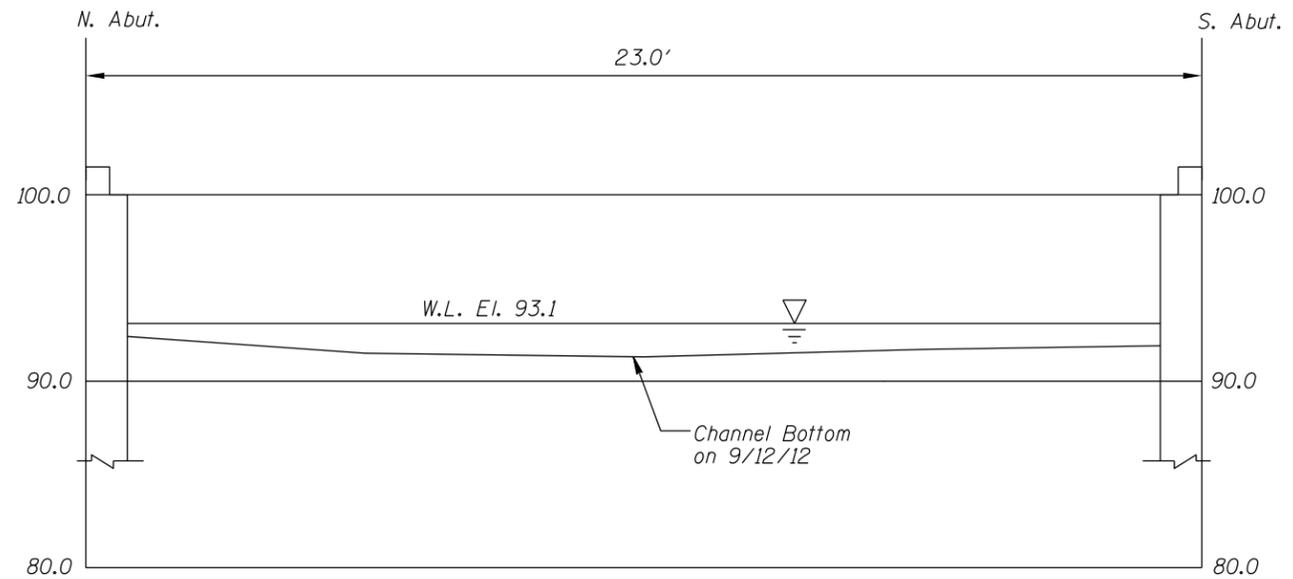
UPSTREAM FASCIA PROFILE  
Vertical Scale: 1"=10'-0"

- ① Pile 1 at the North Abutment and Pile 1 at the South Abutment have failed.
- ② All piles exhibited a soft outer shell with 3 inches of awl penetration and sounded hollow from the waterline up 2 feet.
- ③ Pile 6 at the South Abutment exhibited a soft outer shell with 3 inches of awl penetration and sounded hollow from the waterline up 4 feet.
- ④ The channel bottom material consisted of 1 foot diameter and smaller stone with 2 inches of silt infilling.
- ⑤ The northeast wingwall had a 4 inch wide gap along the backwall planking located 6 inches above the waterline with loss of fill material evident.

Replace failed timber piles to restore the design bearing capacity of the substructure.
