UNDERWATER BRIDGE INSPECTION REPORT

STRUCTURE NO. L4665
TWP 48
OVER THE
SOUTH FORK ROOT RIVER
FILLMORE COUNTY

OCTOBER 4, 2012
PREPARED FOR THE
MINNESOTA DEPARTMENT OF TRANSPORTATION
BY
COLLINS ENGINEERS, INC.
JOB NO. 7423

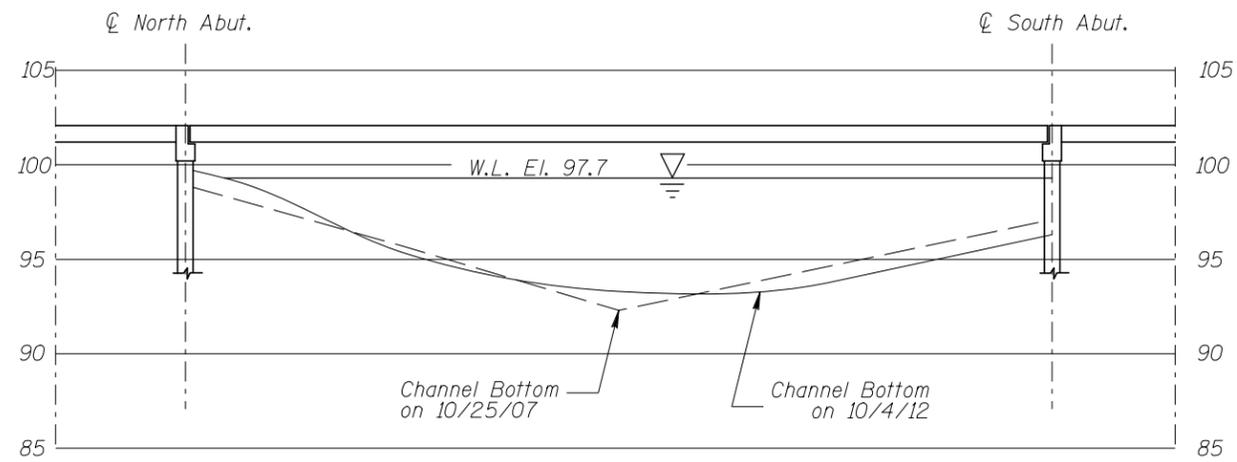
DOWNSTREAM FASCIA PROFILE

- 7 A moderate accumulation of 1 foot diameter and smaller timber debris was observed extending from the channel bottom to 1 foot above the waterline at Beams 4 and 5 along the North Abutment.

- 8 A moderate accumulation of 6 inch diameter and smaller timber debris was observed extending from the channel bottom to the waterline all along the South Abutment.

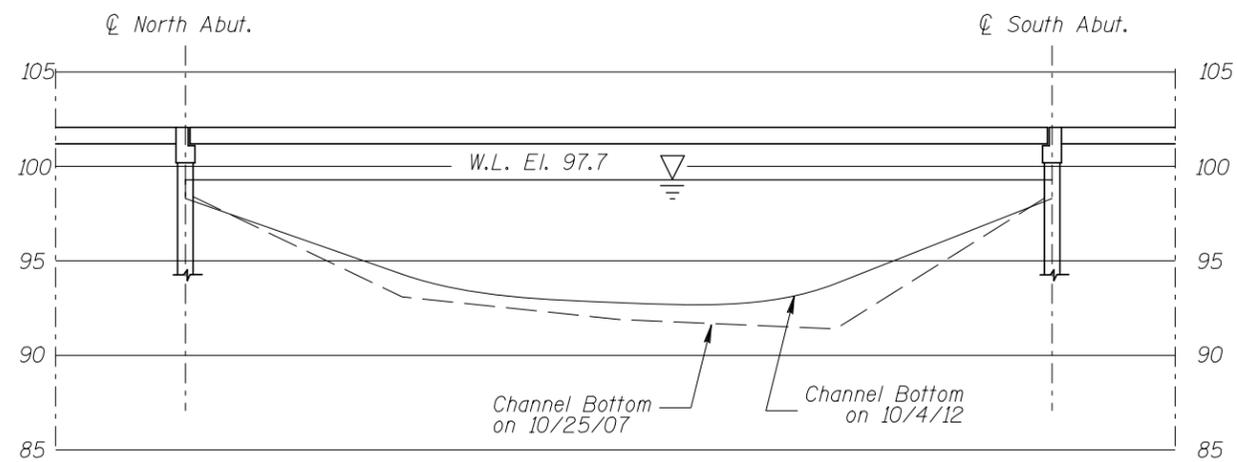
UPSTREAM FASCIA PROFILE

- 2 A heavy accumulation of timber debris was observed under the bridge span, at the upstream fascia of the bridge, and extended approximately 10 to 15 feet upstream of the bridge. The timber debris consisted of 1 foot diameter and smaller logs and branches and extended from the channel to 1 foot above the waterline.

- (A) Remove the heavy accumulation of timber debris, which is significantly restricting the channel at the bridge and has the potential to exert considerable lateral load on the bridge superstructure.
- (B) The cavity in the South Abutment backwall should be filled with a suitable repair material to inhibit further section loss and to restore the abutment wall section and the bridge superstructure support.
- (C) Reinspect the submerged substructure units at the normal maximum recommended (NBIS) interval of sixty (60) months.
