UNDERWATER BRIDGE INSPECTION REPORT

STRUCTURE NO. L4870

ROOT RIVER

MINNESOTA DEPARTMENT OF TRANSPORTATION  
UNDERWATER BRIDGE INSPECTION

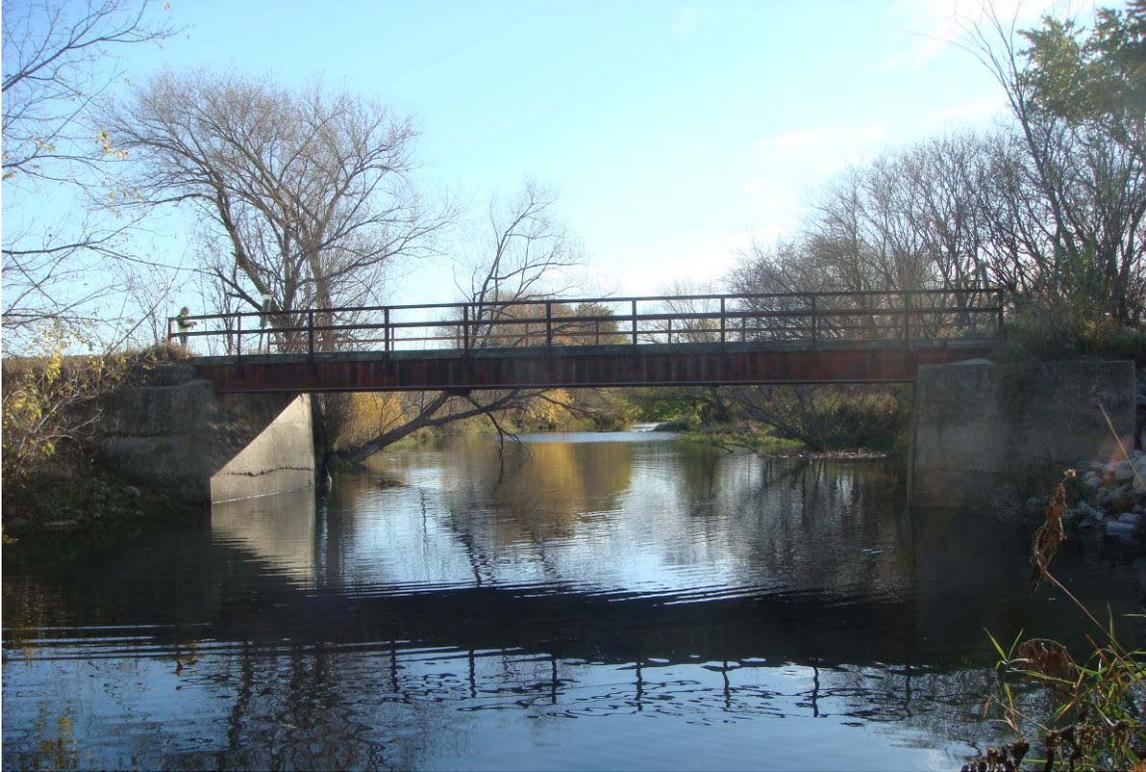
Photograph 1. Overall View of the Structure, Looking East.

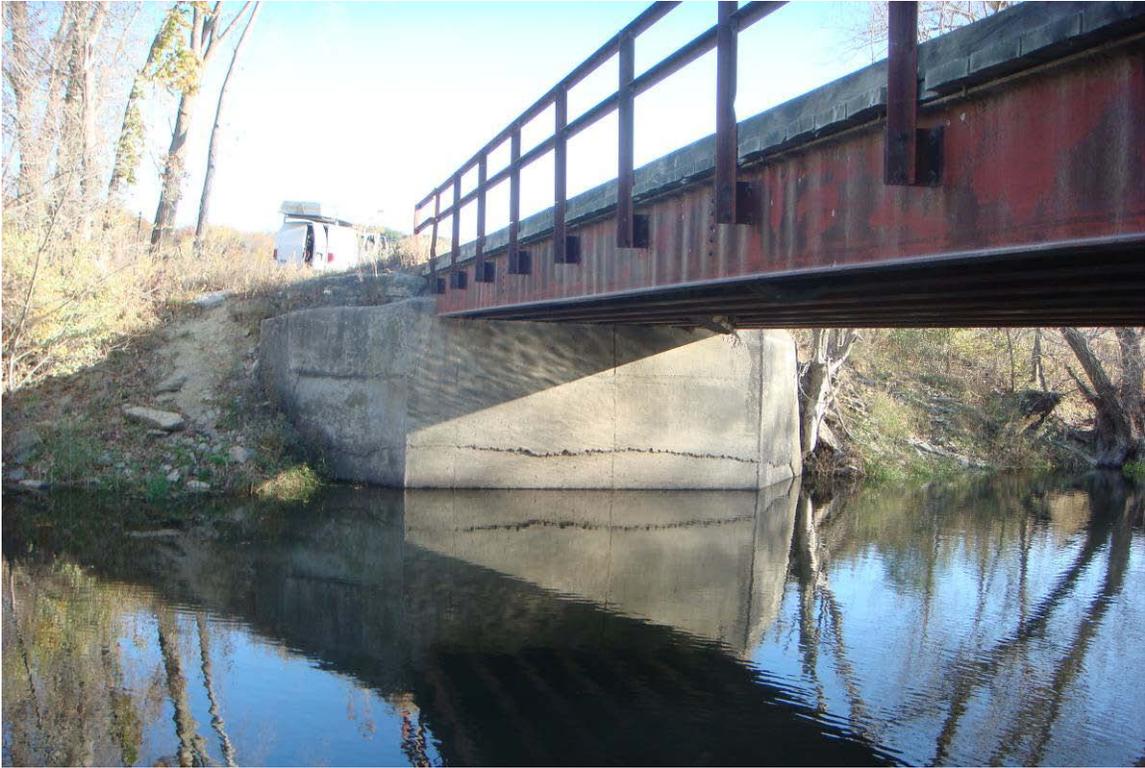
Photograph 3. View of North Abutment, Looking Northeast.

- 6 Random areas of section loss were observed on the submerged portion of the North Abutment with average penetrations of 12 inches and no exposed reinforcing steel detected.

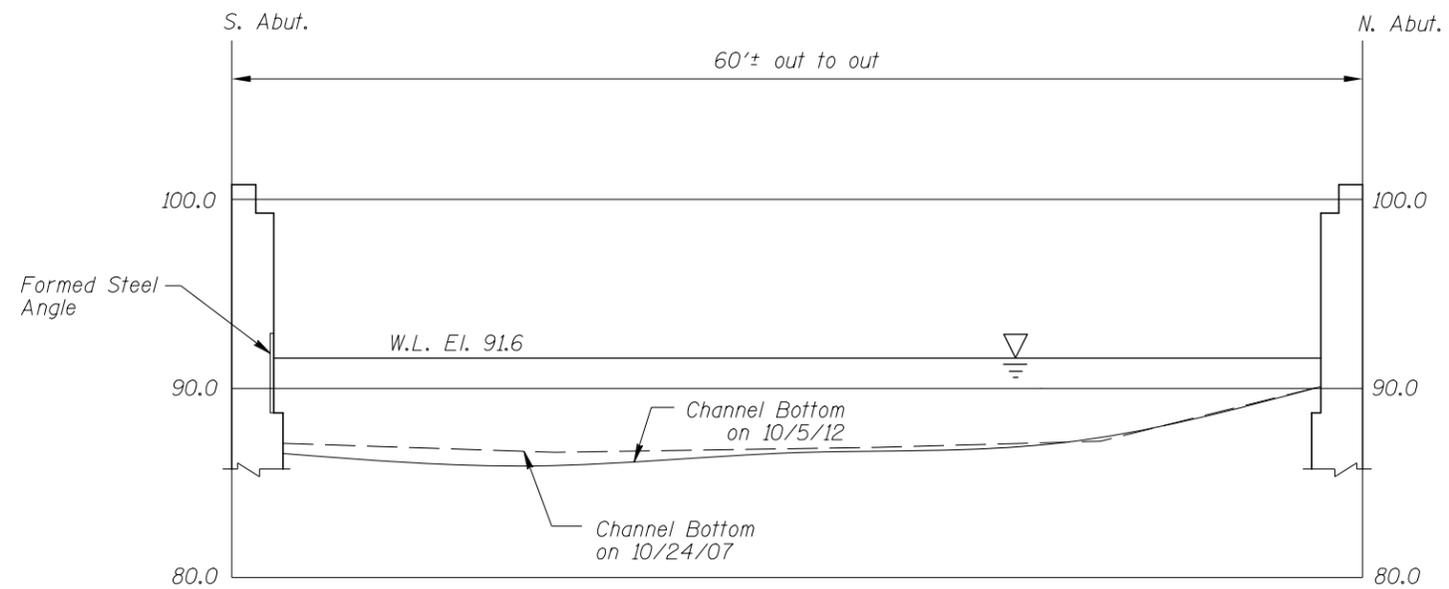
**UPSTREAM FASCIA PROFILE**  
Vertical Scale: 1"=10'-0"

- 1 The channel bottom consisted of riprap with no probe rod penetration. Along the face of the South Abutment there was up to 6 inches of infill.
- 2 An area of poor consolidation was observed on the east corner of the South Abutment from 1.5 feet below to 6 inches above the waterline with 5 inches of maximum penetration.

- 3 A 6 inch band of poorly consolidated concrete was observed at the waterline extending from the downstream 1/4 point to the east wingwall.
- 4 The upstream half (from 12 feet downstream of the upstream corner to the upstream corner) of the South Abutment concrete wall facing exhibited undermining that was 1.5 feet high with up to 1.5 feet of penetration, which exposed the underlying masonry (original construction). Random areas of section loss were observed on the submerged portion of the South Abutment facing with average penetrations of 6 inches exposing heavily corroded vertical reinforcing steel near the center of the abutment.
