UNDERWATER BRIDGE INSPECTION REPORT

STRUCTURE NO. 07542

CSAH NO. 9

BLUE EARTH RIVER

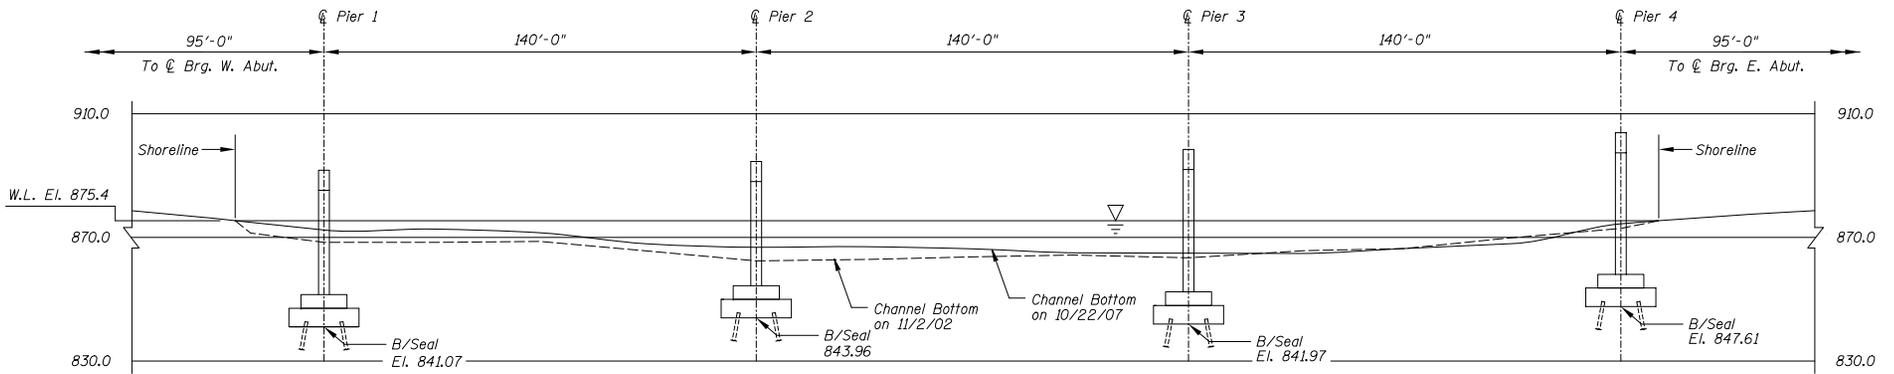
UPSTREAM FASCIA PROFILE

- The channel bottom material consisted of soft silt with up to 2 feet of probe rod penetration.
- A moderate accumulation of timber debris, consisting of logs and branches, was observed at Pier 2 and extended from the upstream nose to the midpoint on each face of the pier and from the channel bottom up 4 feet.
- Areas of minor poor consolidation and/or section loss were observed in and around the waterline at random locations on all of the piers, typically with up to 1 inch of penetration.
- The remains of the sheet pile cofferdam used during original construction were observed along the downstream nose of the pier.
