UNDERWATER BRIDGE INSPECTION REPORT

STRUCTURE NO. 2110

CSAH NO. 8

MINNESOTA RIVER

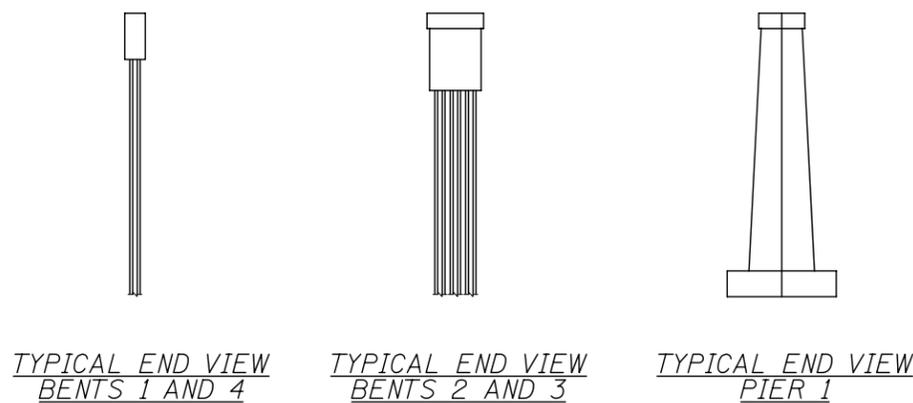
- 4 Top of footing located at -12.8 feet. Heavy deterioration was present from -12.8 feet to bedrock at -14.8 feet all the way around the footing with approximately 2 feet of horizontal penetration typical at the upstream corner and sides.

- 6 Top of footing exposed at -12.8 feet. Heavy to moderate deterioration was present from -12.8 feet to bedrock at -14.8 feet all the way around the footing. Horizontal penetration was approximately 12 inches at upstream nose and sides and 8 inches towards the downstream nose.

- 8 Scaling at all piles of Bent 3 starting 1 foot below the waterline to -3 feet, with 1 inch maximum penetration.
- 9 Spall with impending spall on pile from pile cap down 5 feet, up to 1.5 foot wide with 1.5 inches maximum penetration and exposed reinforcing steel (corroded).

- 10 Channel bottom consisted of 4 inches of soft silt over firmer silt.
- 11 A heavy accumulation of timber debris consisting of logs and branches up to 2 feet in diameter was observed at the upstream noses of Bents 3 and 4, extending from the channel bottom to 1 foot above the waterline.

- 15 On the downstream face of the northern most pile of Bent 1 at the upstream end, pile exhibited section loss (1.5 inches) from under the pile cap to 1.5 feet above waterline with exposed and corroded reinforcement.

Repair the footing of Pier 1 by forming a new enlarged encasement around existing footings keyed into river bed.

Patch the spalls on the piles of Bents 2, 3, and 4 with epoxy grout.
