UNDERWATER BRIDGE INSPECTION REPORT

STRUCTURE NO. 07569

BLUE EARTH RIVER

MINNESOTA DEPARTMENT OF TRANSPORTATION  
UNDERWATER BRIDGE INSPECTION

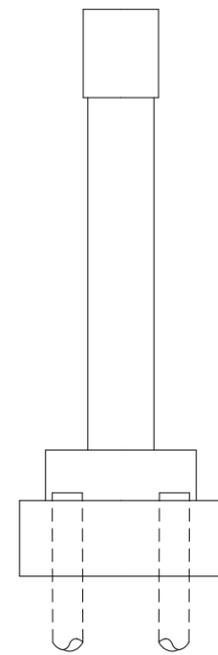
TYPICAL END VIEW OF PIERS

- 1 The channel bottom material around the substructure units consisted of sand, gravel, and 2 to 4 feet diameter cobbles with up to 1 inch of probe rod penetration.
- 2 Light accumulation of timber debris was observed around the upstream nose and along the east face of Pier 2, extending from the channel bottom to 1 foot above the waterline.
- 3 Scour depression with a 5 foot radius and 2.5 feet of depth was observed around the upstream nose of Pier 2.
- 4 Overall the concrete of the piers was in good condition and only exhibited random vertical cracks.
- 5 Vertical bank erosion was observed along the river bank, consisting of up to 15 feet high vertical cut embankments.
- 6 A 3 feet radius scour depression 1.5 feet deep was observed at the upstream end of Pier 3.
