UNDERWATER BRIDGE INSPECTION REPORT

STRUCTURE NO. 08529
COTTONWOOD STREET
OVER THE
COTTONWOOD RIVER
DISTRICT 7 – BROWN COUNTY

SEPTEMBER 12, 2012
PREPARED FOR THE
MINNESOTA DEPARTMENT OF TRANSPORTATION
BY
COLLINS ENGINEERS, INC.
AND
WSB & ASSOCIATES, INC.
JOB NO. 2107

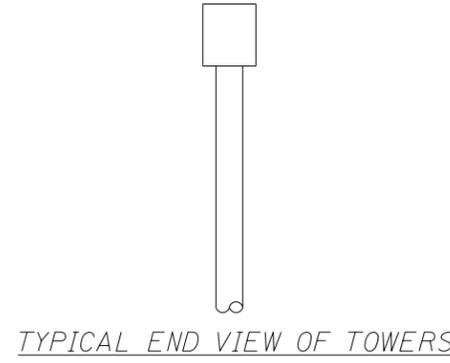
MINNESOTA DEPARTMENT OF TRANSPORTATION UNDERWATER BRIDGE INSPECTION		
STRUCTURE NO. 08529 OVER THE COTTONWOOD RIVER BROWN COUNTY		
INSPECTION AND SOUNDING PLAN		
Drawn By: BJR	COLLINS ENGINEERS	Date: SEP. 2012
Checked By: BRL		Scale: 1"=20'
Code: 742308529		Figure No.: 1

- ① Steel piles exhibited 20% coating failure with light surface corrosion.
- ② Minor scour depressions around piles 1 foot deep and 1 foot radius.
- ③ The channel bottom material consisted of silty sand silt allowing 6 inches of probe rod penetration.

- 1. Piers 1 and 2 were inspected underwater.
- 2. At the time of inspection on September 12, 2012, the waterline was located approximately 15.2 feet below the top of pier cap at upstream end of Pier 2. This corresponds with a waterline elevation of 798.4 feet according to design plans dated February 29, 1994.
- 3. Soundings indicate the water depth at the time of inspection and are measured in feet.
- 4. Soundings were taken parallel to the bridge at 1/4 point intervals between the substructure units.
