UNDERWATER BRIDGE INSPECTION REPORT

STRUCTURE NO. 32501  
CSAH NO. 4  
OVER THE  
DES MOINES RIVER  
DISTRICT 7 – JACKSON COUNTY

SEPTEMBER 26, 2012  
PREPARED FOR THE  
MINNESOTA DEPARTMENT OF TRANSPORTATION  
BY  
AYRES ASSOCIATES & COLLINS ENGINEERS, INC.  
JOB NO. 7423

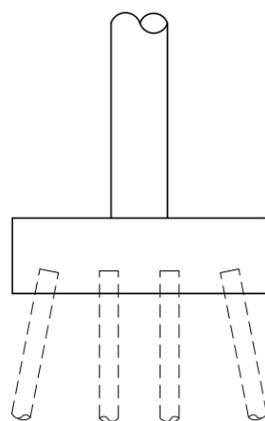
TYPICAL END VIEW OF PIERS

- ① Large rocks were observed on the channel bottom around the perimeter of Pier 1. The rocks extended 4 to 5 feet off the face of Pier 1.
- ② Overall the concrete surface of Pier 1 was smooth and sound.
- ③ A 10 inch diameter log was observed at the upstream nose of Pier 1.
