UNDERWATER BRIDGE INSPECTION REPORT

STRUCTURE NO. 52504

CSAH NO. 24

MINNESOTA RIVER

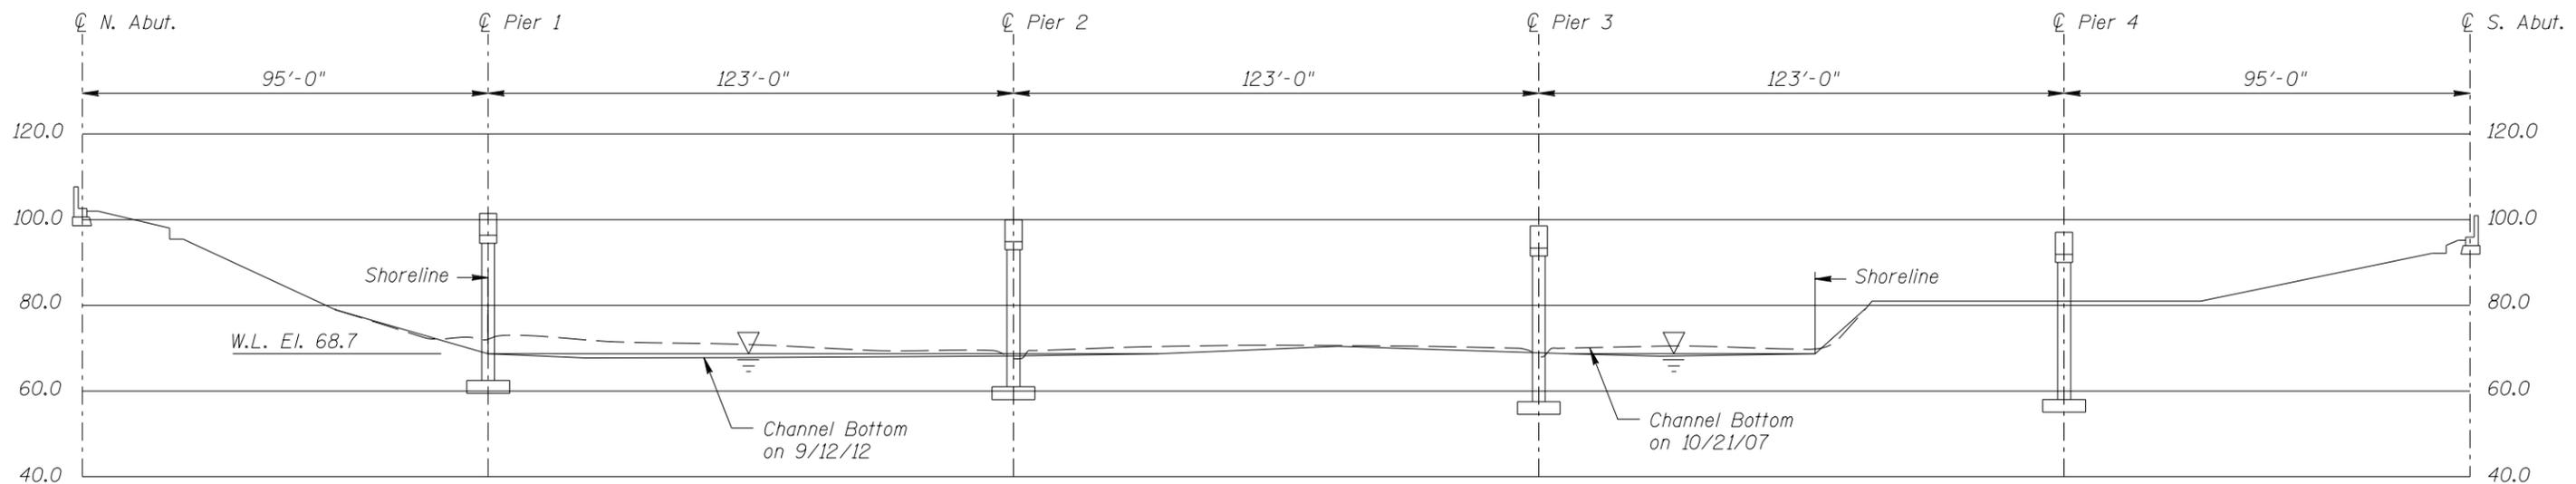
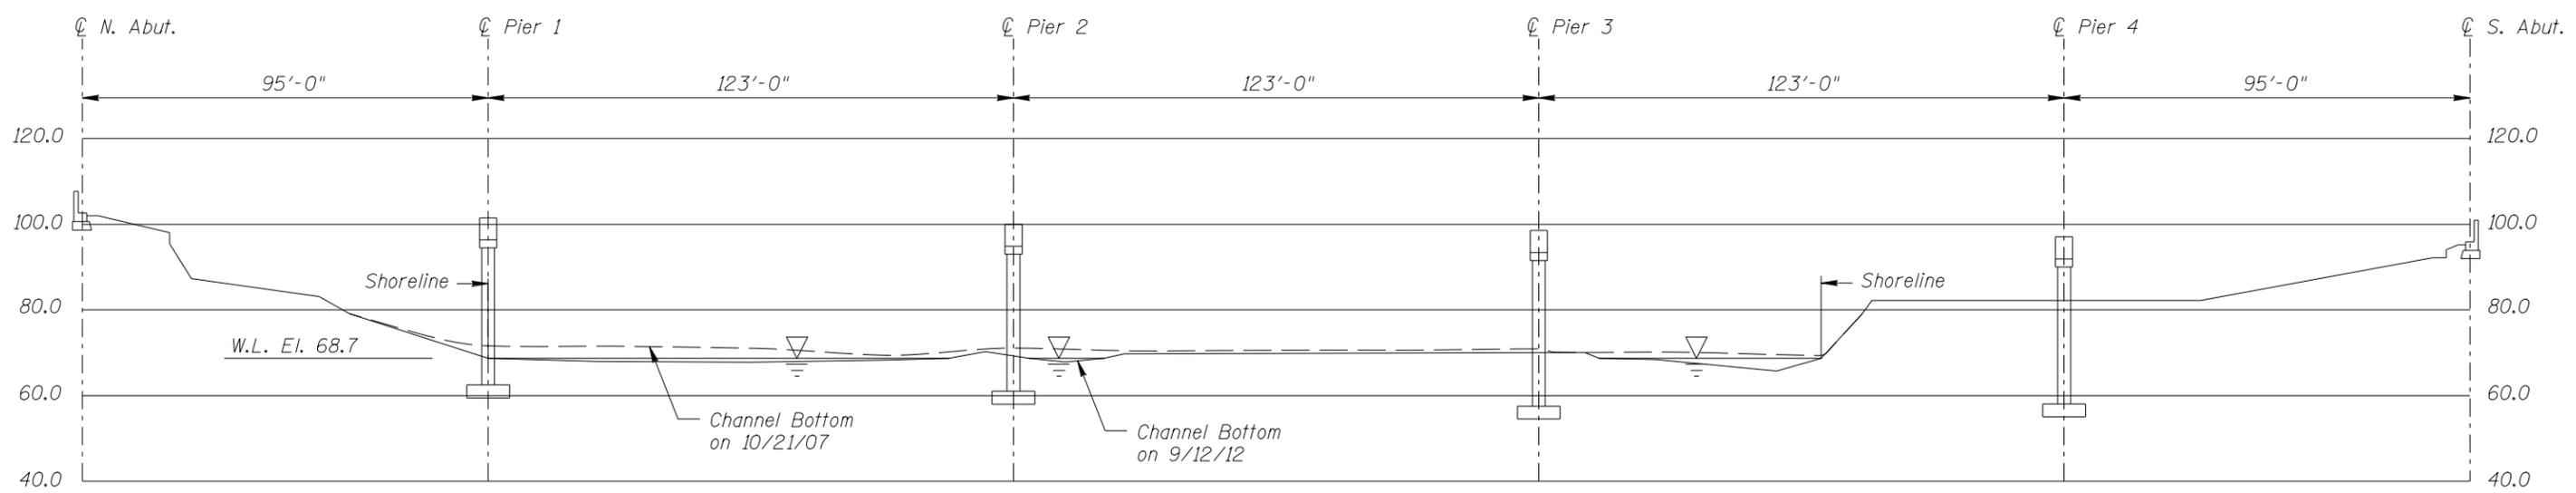
- 1 The channel bottom material around the pier consisted of sand with up to 1 foot of probe rod penetration.
- 2 The riverbanks beneath the bridge consisted of silty sand along the shoreline with riprap in front of the abutment walls.
- 3 The upstream and downstream shorelines exhibited steep vertical erosion of the banks.
- 4 A scour depression was observed around the upstream nose of Piers 2 and 3 and measured up to 2 feet deep by approximately 6 feet in radius.
