UNDERWATER BRIDGE INSPECTION REPORT

STRUCTURE NO. 7105

DES MOINES RIVER

MINNESOTA DEPARTMENT OF TRANSPORTATION
UNDERWATER BRIDGE INSPECTION

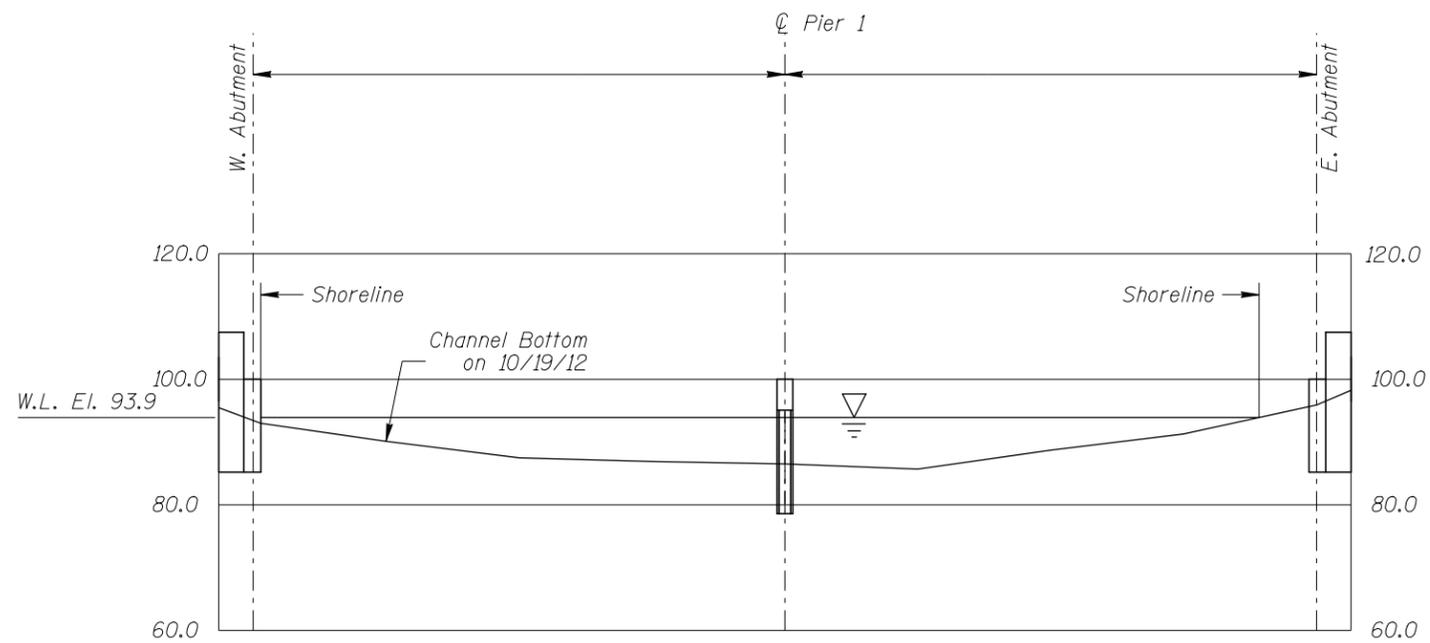
UPSTREAM FASCIA PROFILE

- ① The concrete columns of Pier 1 were sound and in good condition with no structurally significant defects.
- ② Random areas of honeycombing were observed at the downstream column of Pier 1 up to 10 inches in diameter and 1 inch deep.
- ③ The concrete at the West Abutment was sound and in good condition with no structurally significant defects.
- ④ Moderate debris, consisting of abandoned piles and boulders, was observed around each column from the streambed up 4 feet extending 4 feet away from the columns.
