UNDERWATER BRIDGE INSPECTION REPORT

STRUCTURE NO. 7150

BLUE EARTH RIVER

SEPTEMBER 11, 2012

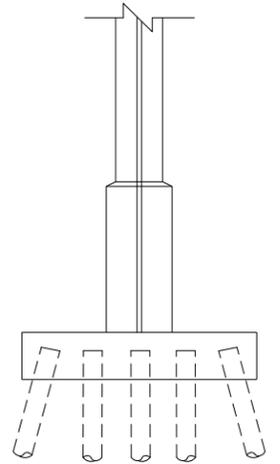
TYPICAL END VIEW OF PIERS

- An area of section loss, 6 inches wide by 1.5 feet high with a penetration of up to 1/4 inch, was observed at 1.5 feet above the waterline on the downstream nose of Pier 1.

- A band of light to moderate scaling was observed 5 feet across the downstream end from 3 feet to 1 foot above the waterline with penetrations up to 1/2 inch deep.

- A moderate to heavy accumulation of timber debris was observed along both faces and the upstream nose of Pier 2 extending from the channel bottom to 8 feet above the waterline. The debris extended up to 25 feet off the pier nose and up to 8 feet off the pier faces.
