UNDERWATER BRIDGE INSPECTION REPORT

STRUCTURE NO. 7274

LE SUEUR RIVER

SEPTEMBER 11, 2012

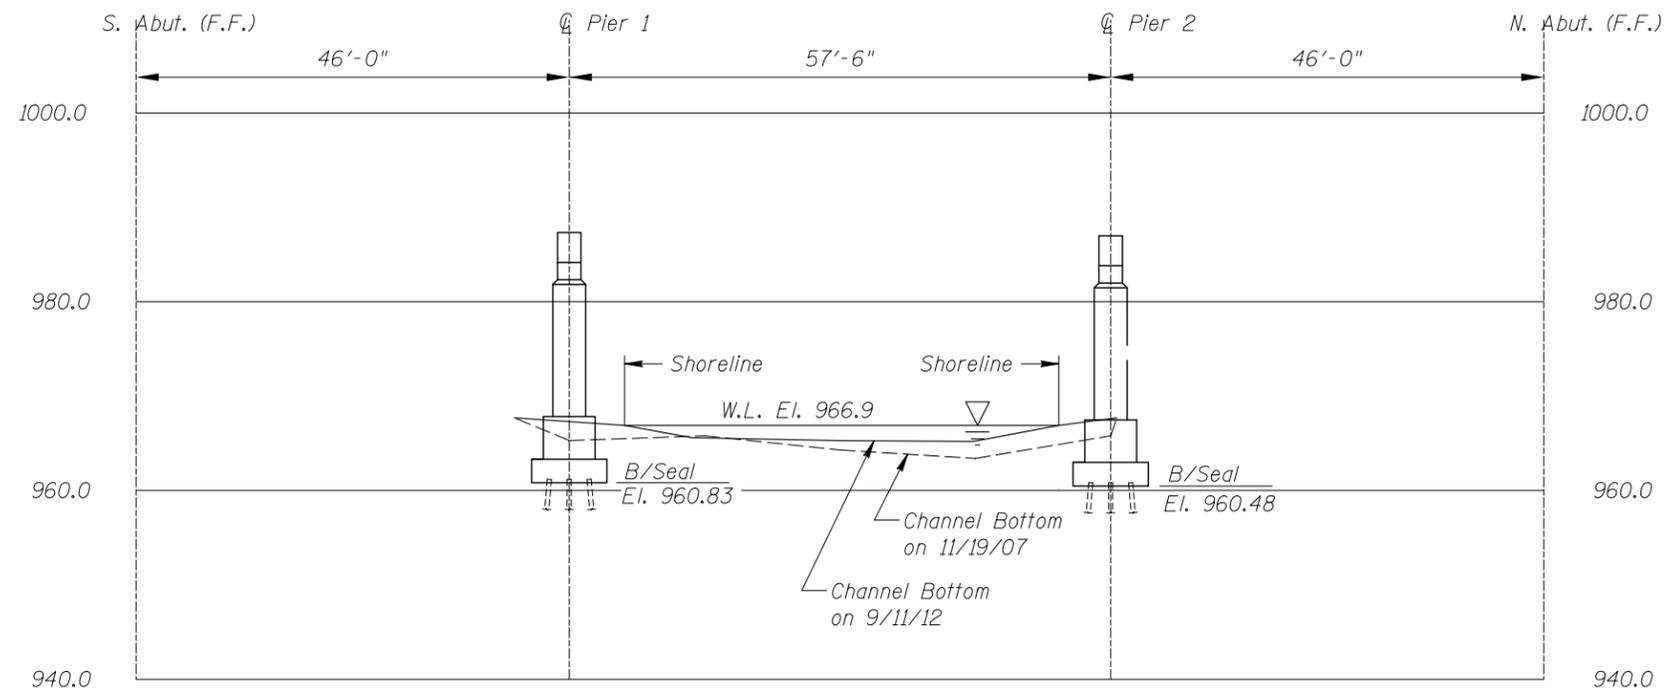
UPSTREAM FASCIA PROFILE

- (A) The top of the diaphragm was exposed along the south face of Pier 2 with up to 2.1 feet of vertical face exposure at the upstream end, and there was heavy section loss with exposed aggregate and reinforcing steel along the entire exposed portion.
- (B) Two horizontal steel reinforcing bars were completely exposed and were no longer embedded in the concrete diaphragm at Pier 2 and four vertical bars were exposed at the diaphragm of upstream column of Pier 2.
- (C) The top of the diaphragm was exposed along the north face of Pier 1 with up to 2.2 feet of vertical face exposure at the upstream end.

REMARKS: Overall, the concrete columns were in good to satisfactory condition. However, the concrete diaphragm of Pier 2 was in fair to poor condition and exhibited heavy loss of section. The top of the diaphragm at both piers was exposed with up to 2.2 feet of vertical face exposure at the upstream ends. The top of the exposed diaphragm at Pier 2 exhibited heavy section loss with up to 1 foot of penetration and exposed aggregate and reinforcing steel was present along the entire exposed portion. The channel bottom appeared stable with no evidence of significant scour.

- (A) Ideally, the deteriorated concrete of the diaphragm at Pier 2 should be repaired. Continue to monitor the diaphragm deterioration until repairs are accomplished.

Ideally, the deteriorated concrete of the diaphragm at Pier 2 should be repaired by removing the unsound concrete and reforming with a concrete mix designed to promote high durability and low permeability. Continue to monitor the diaphragm deformation until repairs are accomplished.
